## TREE MANAGEMENT REPORT FOR DEVELOPMENT APPLICATION PURPOSES

Initial Issuance: **November 16, 2020**

Project: **Proposed Arcana Film Studio**  
**44390 Bayview Road Agassiz BC**

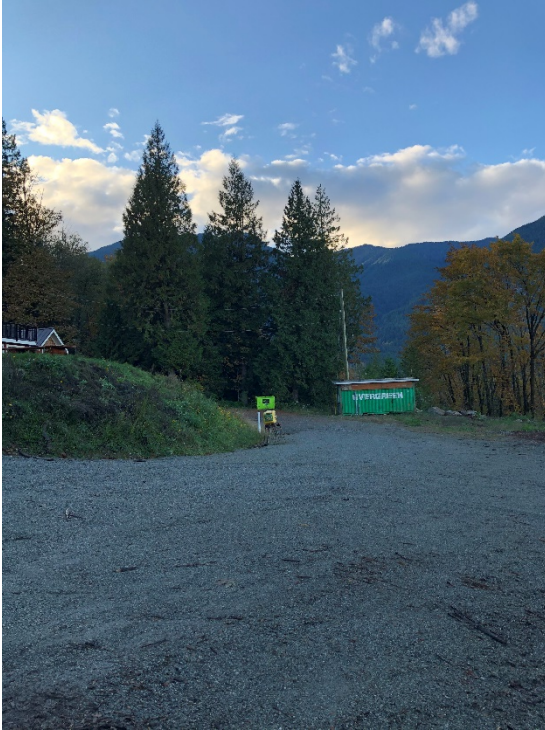
Photo 1 West Buffer

The proposed 20m buffer along the northern and western perimeters of the site has a sparse stand of trees, remnant from the native forest stand, and many of which have been previously topped. There is significant exposure to northerly winds, however both of these zones appear to have been exposed to these winds for many decades, and the trees have generally acclimated and growth to have developed superior structural form characterized by increased trunk taper, crowns to near ground level and shorter stouter general form. The site changes from clearing is expected to have negligible impacts to the wind exposure to these trees, however these zones should be inspected thoroughly by the project arborist during the land clearing using Tree Risk Assessor Qualification (TRAQ) methods to identify any high risk trees that may require treatment to mitigate risks to the site.

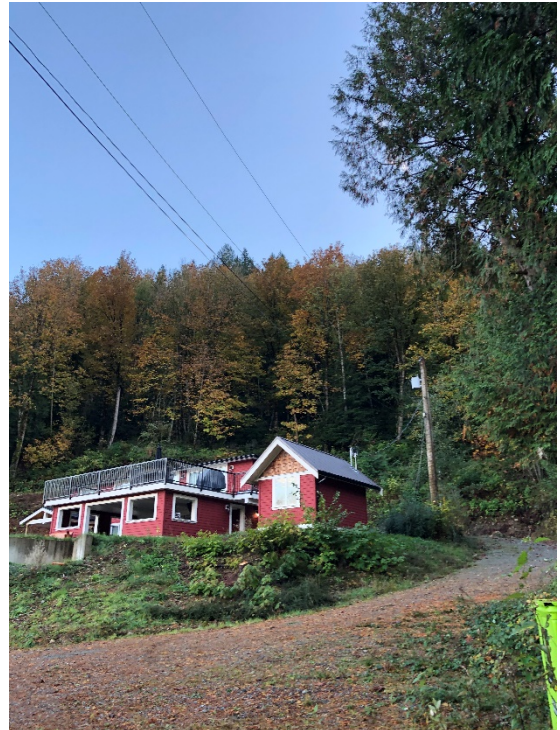
Photo 4 South Tree Stand

The approximate alignment of the proposed clearing interface was estimated through range finder reviewed to the extent possible, with access limited by topographic obstacles in certain locations and with the limitation that the actual alignment of the buffer and the property line were not surveyed in the field. The buffer in this section of the site will form a continuous stand with the adjacent crown lands to the south. The interface appears to contain some trees that have overt defective form issues such as dieback and/or decay from natural causes, and selective removal of vulnerable trees will be necessary. In order to manage the risks associated with those defective trees, this buffer should be inspected thoroughly by the project arborist during the land clearing using TRAQ methods to identify any high risk trees that may require treatment to mitigate risks to the site.

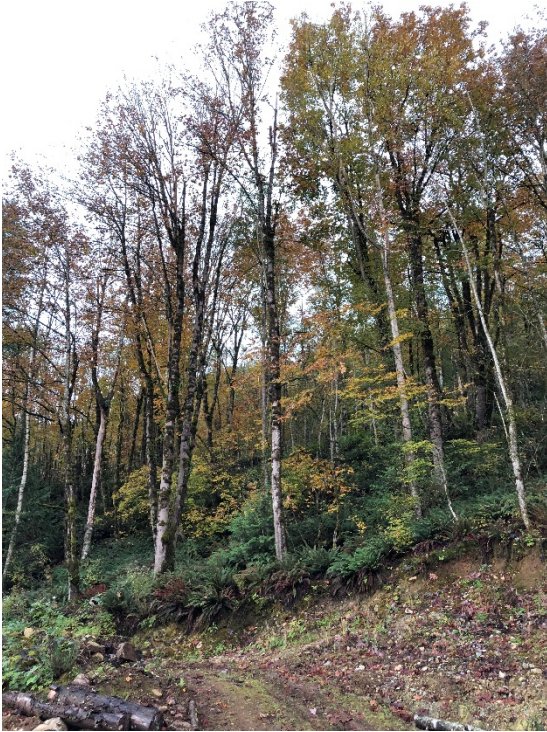
**Photo 5 Interior Stand Conditions**

The forested portion of the site contains a closed canopy forest of predominantly bigleaf maple, along with minor components of other native species. The primary canopy is generally 30m tall, with cedar extending up to 35m tall and fir extending up to 40m tall.

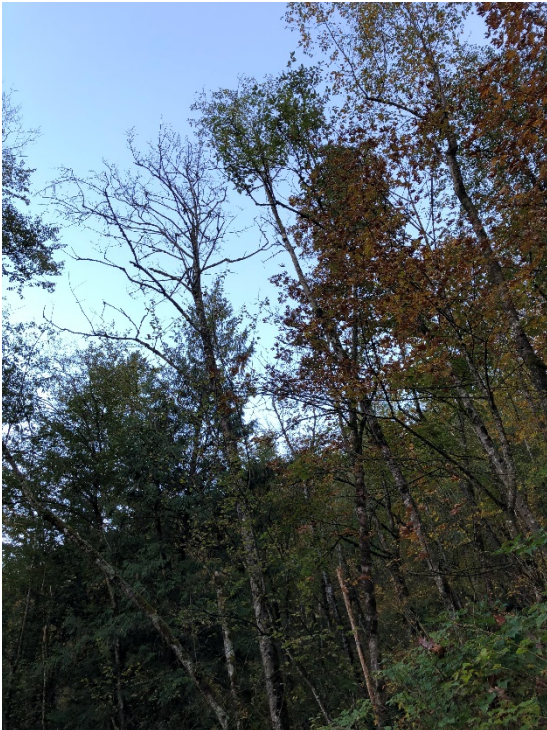
**Photo 7 SPEA Interface**

The proposed clearing interface with the SPEA is in a zone of forest stand that is more sparse than the main clearing area and, combined with the micro-topography (i.e. small ravine), these growing site conditions have exposed individual trees to greater wind stresses over time. The primary canopy trees within the SPEA have developed a stronger form as a result. There are some individual trees that have pre-existing defects such as but not limited to; understory or suppressed class trees with spindly and top heavy form, significant lean toward the development area of the site, overt decline or dead trees, trees with wounds and decay, etc.

For a comprehensive Wildlife and Danger Tree Assessor (WDTA) methods of assessment to identify the Danger Trees, the clearing interface along the SPEA alignment will need to be advanced. At present, I have estimated that 10 Danger Trees will require treatment (felling or conversion to wildlife stems), however this quantity may change depending on the actual location and proximity of the defective trees once the clearing alignment is known. A comprehensive assessment by the project arborist is required at that time.

For the ESA, the root protection setback for trees to be retained within the SPEA is prescribed to be 3.0m from the SPEA line. This RPZ is expected to form the SPEA Protection Zone Boundary. A temporary tree protection barrier should be installed at this alignment to reduce risks of encroachment of clearing and construction activities.

This 3.0m setback will be a no grubbing zone where trees may be felled but stumps and ground cover will be left intact. Any grading work within 1.5m of this RPZ should be supervised by the project arborist in order to minimize root damage with the RPZ. Root pruning may be required along this interface.
