THURBER ENGINEERING LTD.

File: 14463

**45900 SLEEPY HOLLOW ROAD, CULTUS LAKE
GEOTECHNICAL RECOMMENDATIONS FOR SITE DEVELOPMENT
REVISION 1**

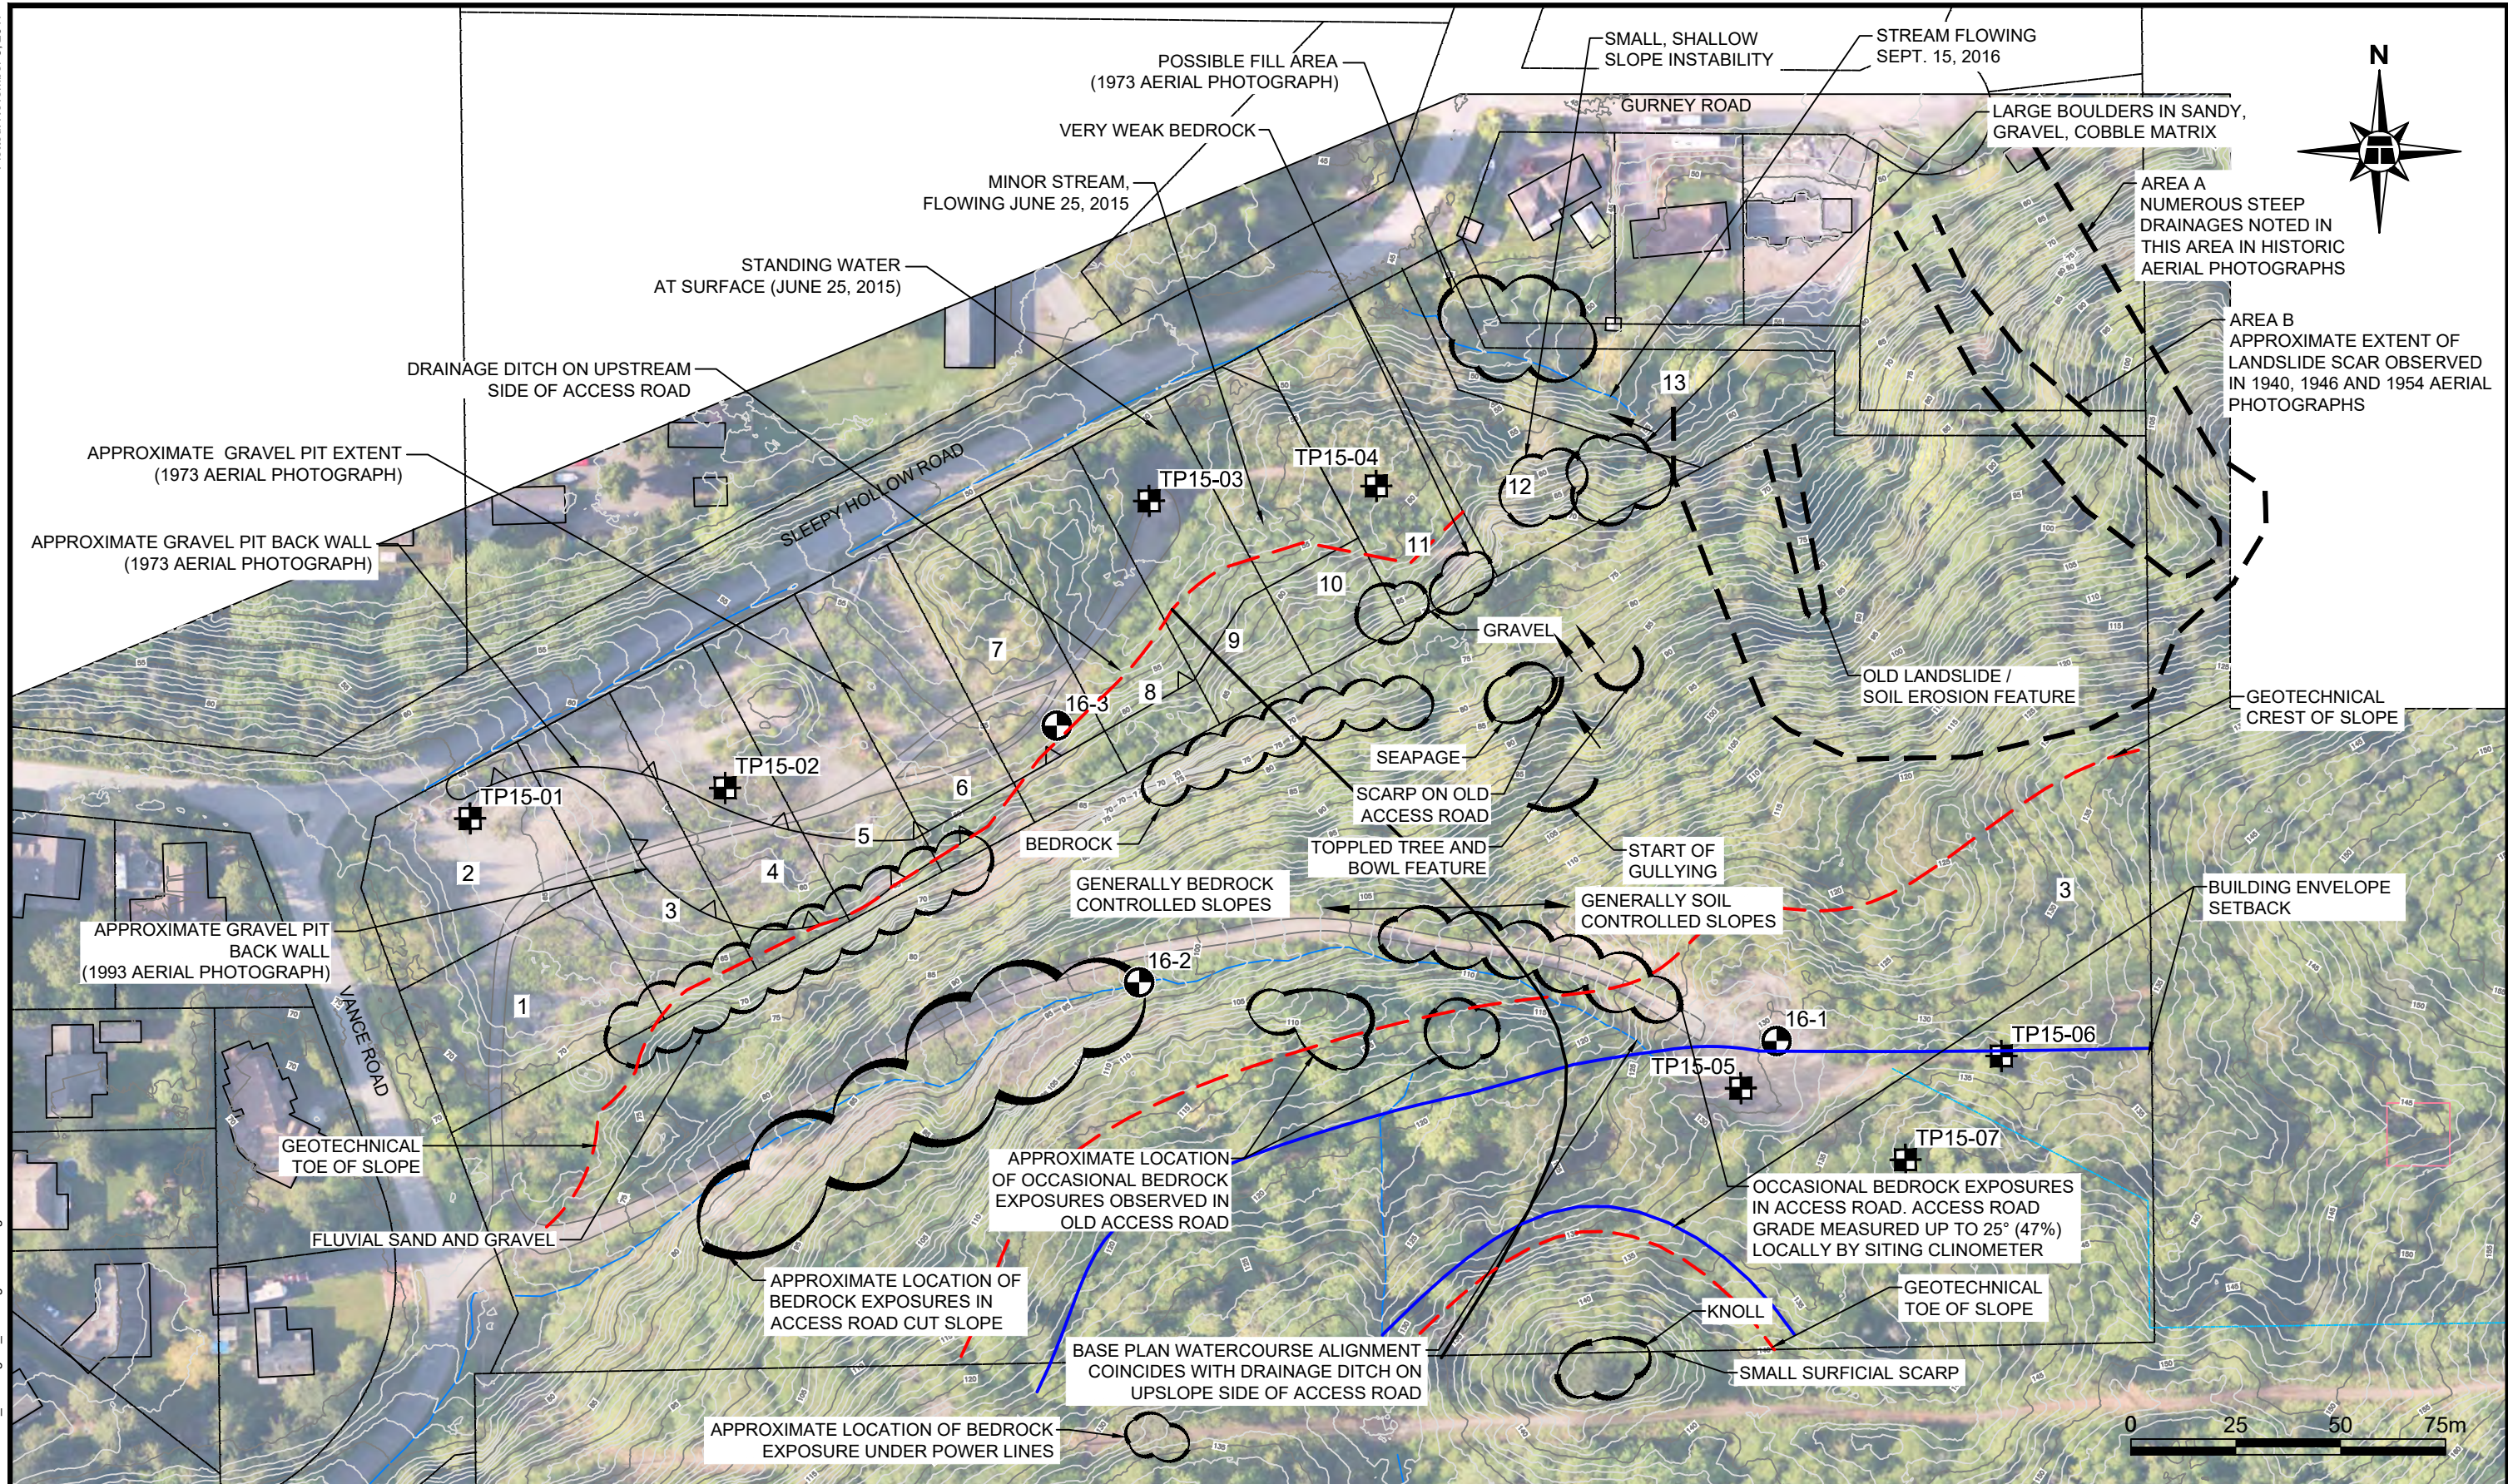
The key observations from the API are discussed below and annotated on Dwg. 14463-2, as appropriate. Further discussion and detail is provided in Thurber's 2015 report.

The earliest available photograph from 1940 shows a landslide scar in the steep slope area near the northeast corner of the site. The landslide transported material north-westwards towards Gurney Road, as shown on Dwg. 14463-2. The landslide scar is visible in the 1946 and 1954 aerial photographs, but is masked by vegetation and indistinct in photographs later than 1954.

The approximate extent of the gravel pit activity observed in the 1973 aerial photograph is shown on Dwg. 14463-2. The 1983 aerial photograph shows that about 60 to 70% of the 1973 gravel pit extent is tree covered. The 1993 aerial photograph shows the gravel pit extending marginally to the southeast and southwest of the 1973 aerial photograph extents. Photographs after 1993 show the gravel pit to be inactive and the gravel pit extent is partially masked by vegetation.

The site reconnaissance of the Lower Area and the slopes above it to the south served to confirm our previous observations. The slopes above the western portion of the Lower Area (Lots 1 to 9 on Dwg. 14463-2) are steep and comprise colluvium and talus. There is minor bedrock outcrop at the top of the slopes, immediately below the access road to the Upper Area. There is also steep, near vertical, sand and gravel slopes below the access road that are typically 1 m to 2 m high. These near vertical slopes are likely scarps of previous shallow, planar failure and erosion. However, no evidence of previous significant instability was noted within this area.

The slopes above the eastern portion of the Lower Area do not appear to be bedrock controlled and thus are not as steep as the slopes above the western portion. However, these slopes show signs of old landslide features. In addition to the old landslide features, there are other signs of potential and visible slope instability including natural water springs that flow from the slopes, gullying, oversteepened slopes, bowled features / shallow instability and overturned trees. It was previously noted that the lot at the east end of Gurney Road was raised approximately 2 m to 3 m above Gurney Road on coarse granular material indicative of slope deposits and possibly landslide debris.

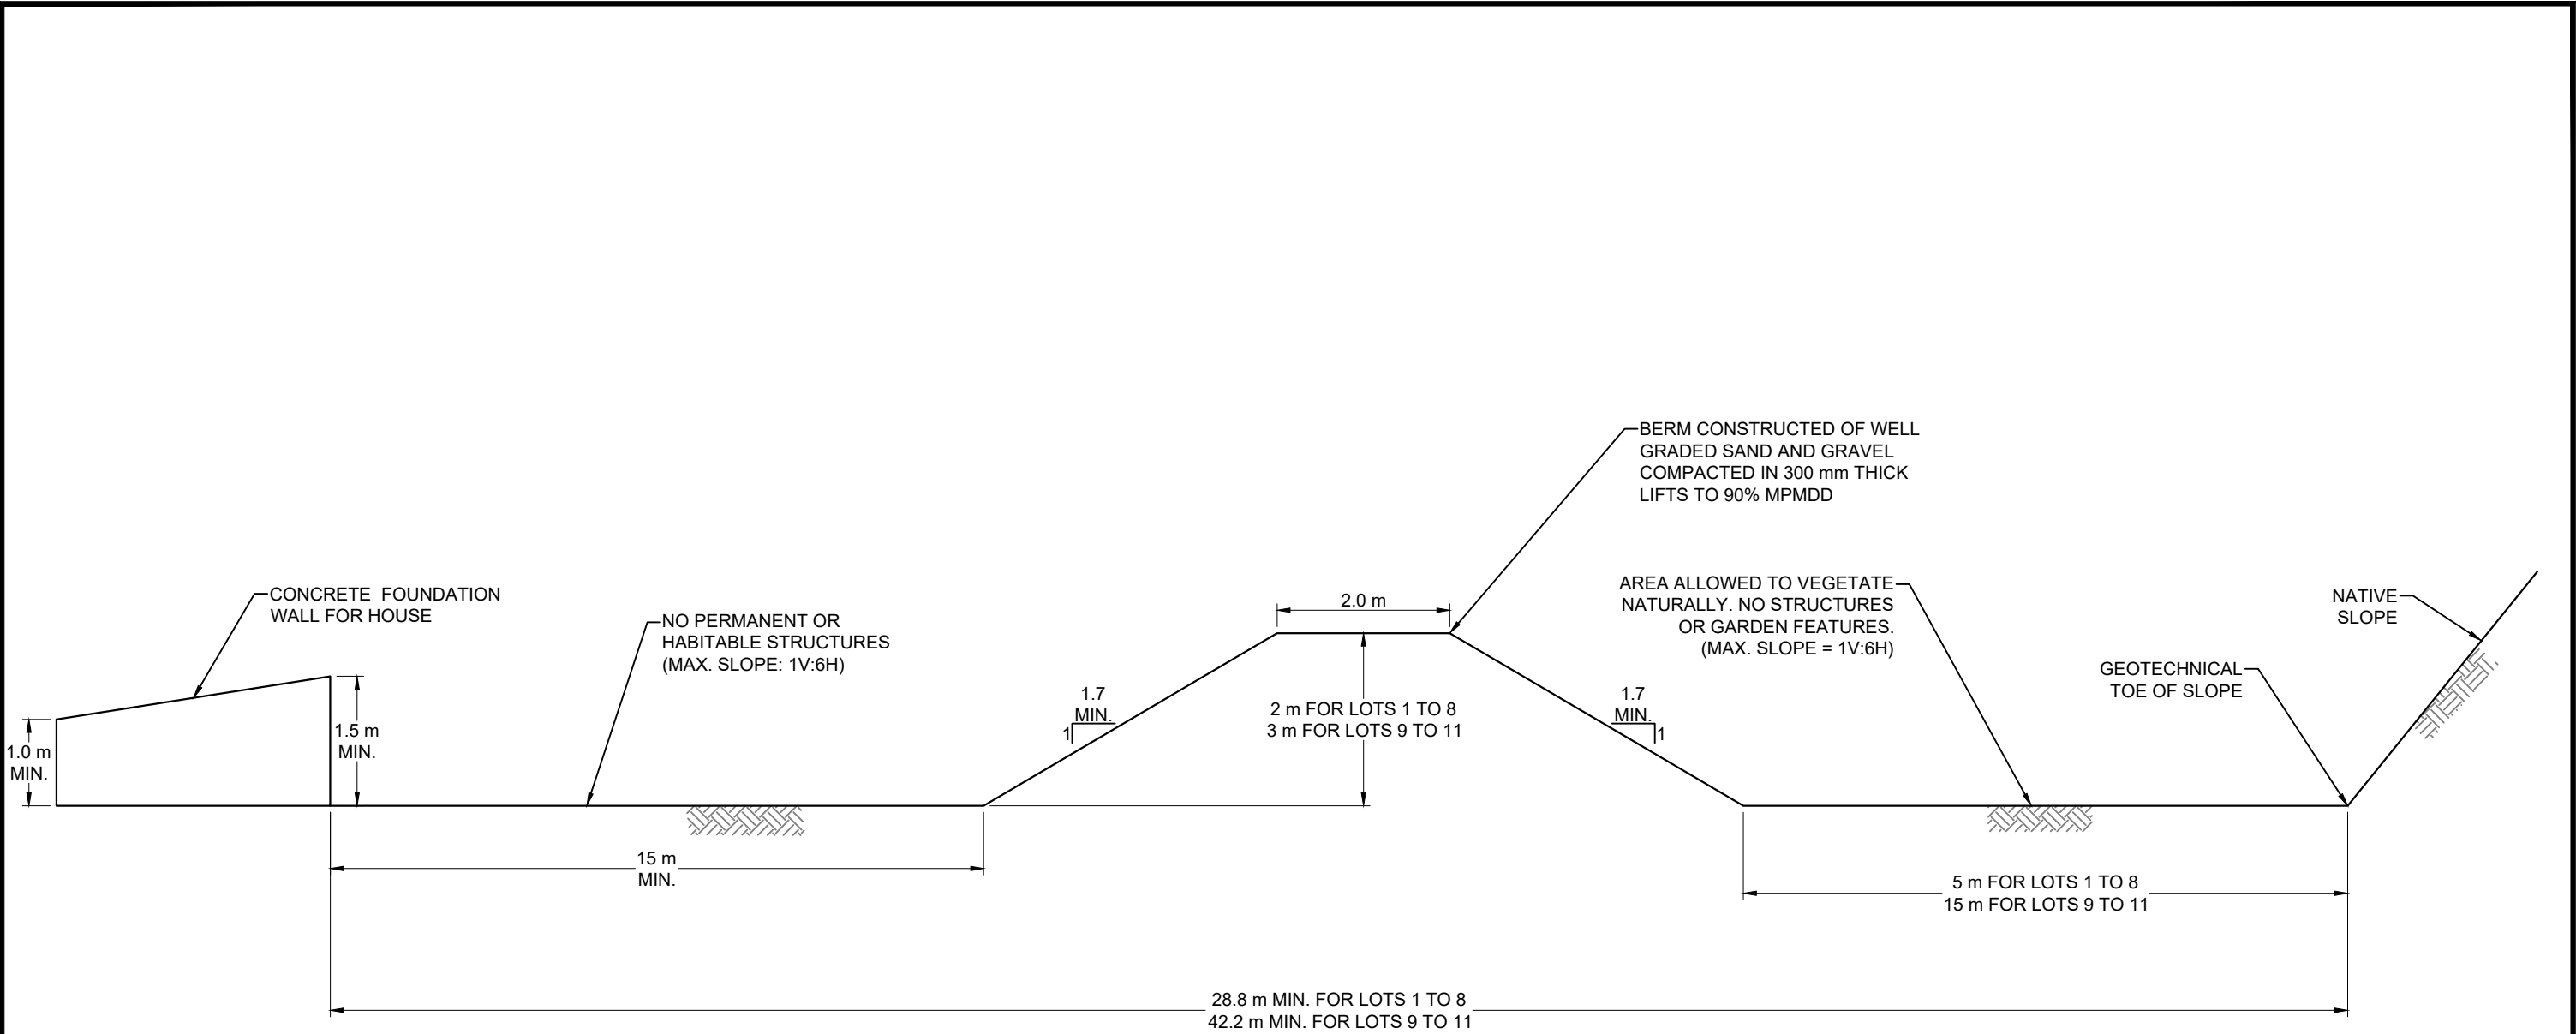
GEOTECHNICAL HAZARD MITIGATION DETAIL

Historic landslides were observed on the eastern slopes above the Lower Area in the vicinity of Lots 12 and 13. Within Lots 12 and 13 the proposed house location is likely to be at the south side of the lot near the steep slopes. It is our professional opinion that development of these lots is not feasible due to existing sloping ground and not enough space to setback house sites from the toe of slope. Therefore, we do not recommend house construction on Lots 12 and 13.

Small surficial landslides and rockfall is expected to occur from the slopes to the south of the proposed lots. To provide storage for the small frequent events, we recommend a flat (maximum 6H:1V) bench at base of slope before the berm. This area should be allowed to vegetate naturally with no structures or gardens.

To retain smaller landslides and rockfall we recommend a berm be constructed. The berm should have 1.7H:1V or flatter side slopes with a minimum 2 m wide bench on top.

We recommend that all houses be constructed with concrete walls above ground level. The concrete wall should be a minimum of 1.5 m high above ground on the back of the house and 1 m high above ground on the sides. These above grade concrete walls will provide an additional level of protection from upslope hazards.

Lot specific geotechnical hazard mitigation is provided in Table 2 and shown on Dwg. 14463-3.

Lot	Berm Setback from Geotechnical Toe of Slope (m)	Berm Height (m)	House Setback from Berm Toe (m)	Raised Concrete Foundation Wall
1 to 8	5	2	15	Yes
9 to 11	15	3	15	Yes
12 to 13	House Construction Not Recommended
