**Introduction**

This report provides a professional agrologist's assessment regarding a 4.36 ha agricultural property is now continually inundated with water and where up to 11,500 m<sup>3</sup> of structural fill had been deposited without permission. This report makes the following recommendations to allow the property to be farmed.

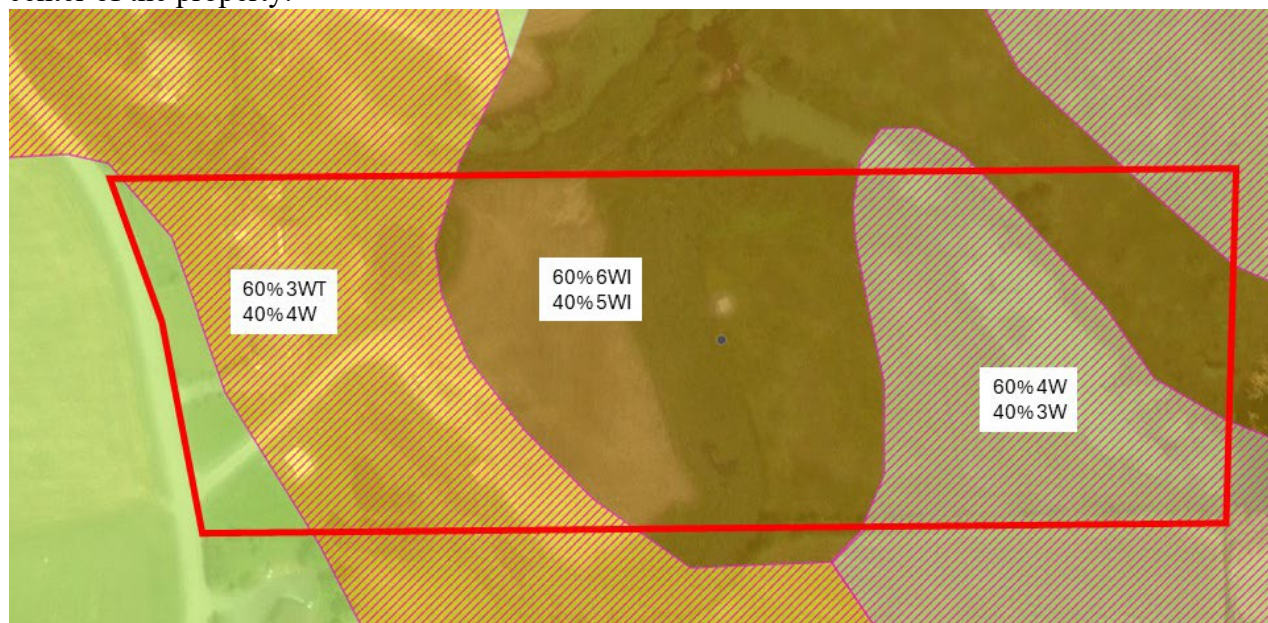
Figure 5. Agricultural capability of the property showing most of the land being wet and flooded for most of the year (BC SIFT)..

Following the change in water management at Hatzic Lake, the land capability is more consistent with Class 6WI or even Class 7 WI in some areas of the property.

The current agricultural capability of the land on this property is estimated to be Class 6WI and Class 7WI, as indicated by the high-water table during mid summer.

The soil deposit will increase the agricultural capability of this property to a Class 2, depending on the quality of the topsoil that can be placed on this property.

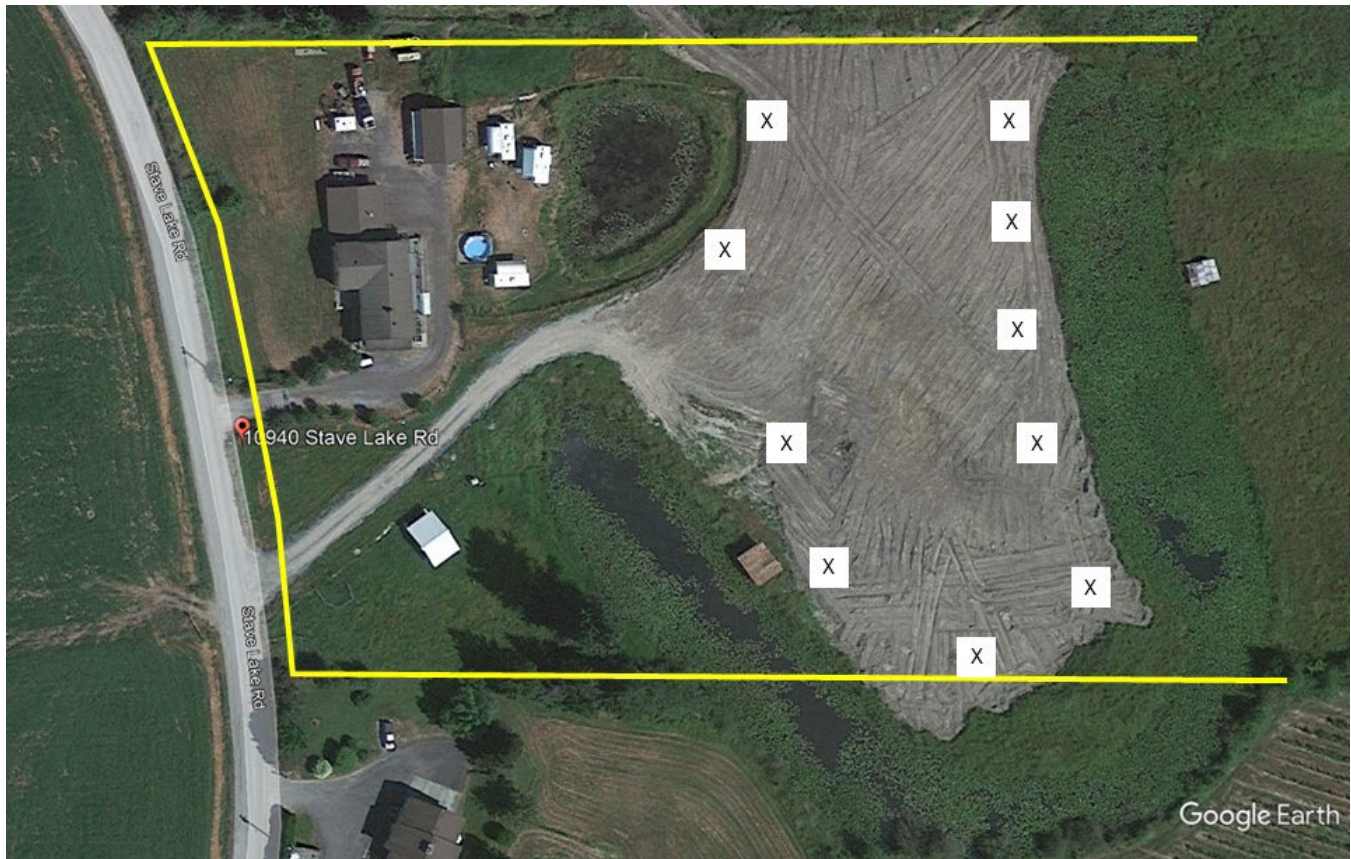
A total of 10 test holes were excavated on August 2, 2023 in the area where structural fill had been imported.

It was not possible to dig test holes on the remainder of the property as the land was still inundated with water despite the lack of precipitation for several months. This verifies the impact of the silt

*Figure 6. Aerial photo of the western portion of the property showing where the test holes had been excavated and inspected.*

accumulation in Legace Creek due to the lack of dredging since 2015 and the ongoing silt deposits resulting from logging further upstream. It also confirms the impact of the changes in water level management of Hatzic Lake during the summer, which impacts properties upstream.

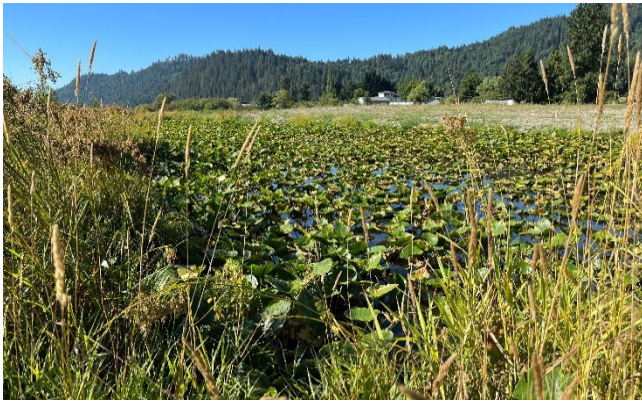
*Figure 7. View of the waterway adjacent to the filled area, indicating how close the water level is to the surface in mid-summer (August 2).*

The water table was at the soil surface during the middle of the summer (August 2), verifying the owner's concern that the water management had changed, and grazing or harvesting forage on the property was no longer possible even during the summer months.

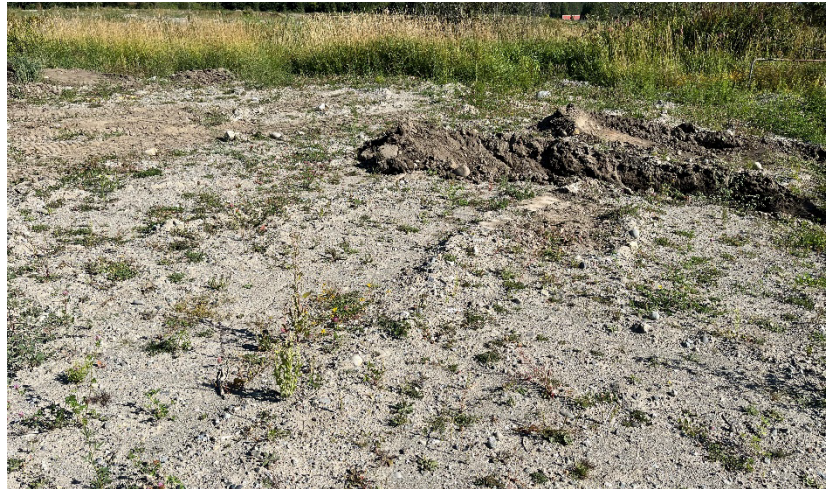
Figure 8 shows the material that had been imported. It is evident that this is structural material.

The 10 excavations indicated that most of the material was clean, however there were some large rocks, some pieces of concrete and a small amount of other debris.

*Figure 8. Photo of the east boundary of the fill area showing one of the excavations.*

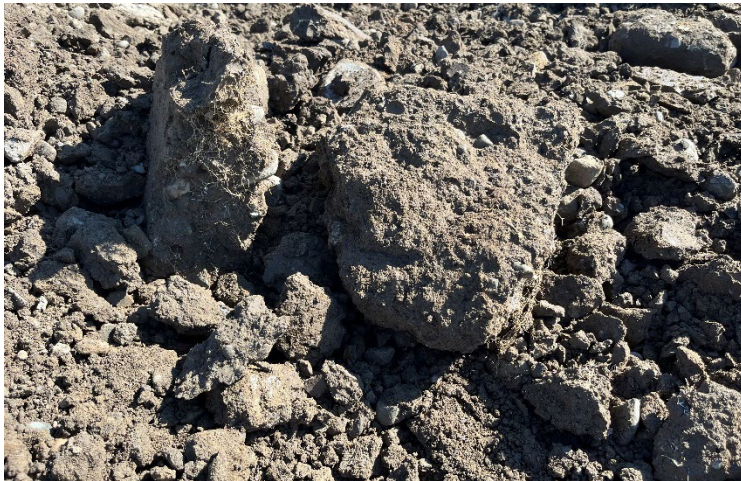
*Figure 9. Photo showing some larger rocks and pieces of concrete in the imported fill.*

Removing 0.75 m of the imported structural material and relocating it to the area to the east would allow easier removal of larger rocks and other debris that was imported with the fill.

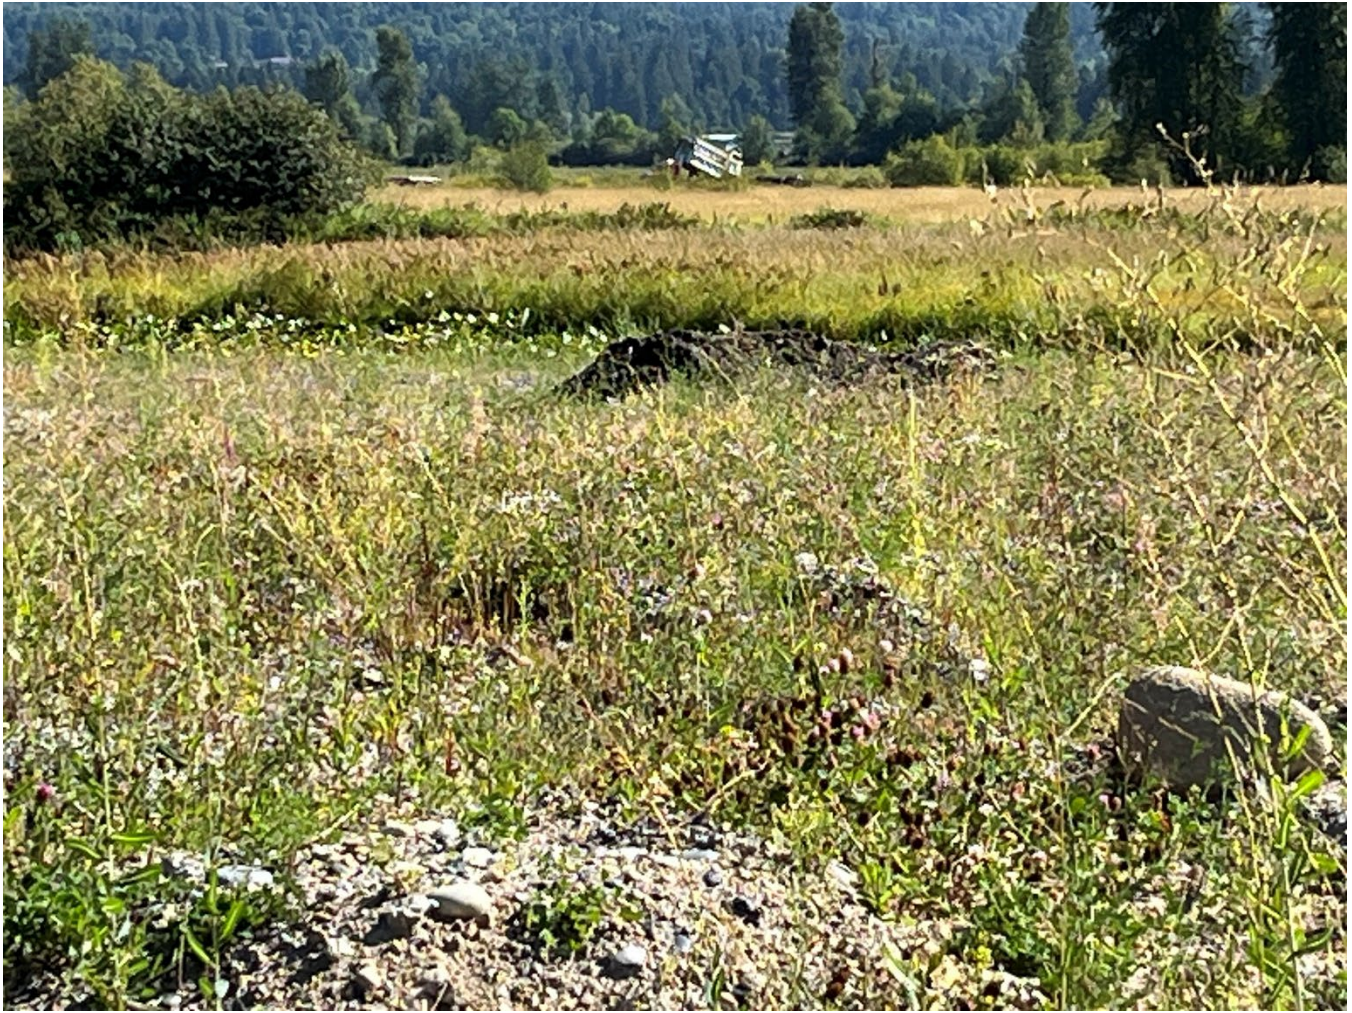
*Figure 10. Photo showing fill area with some larger rocks on the surface.*

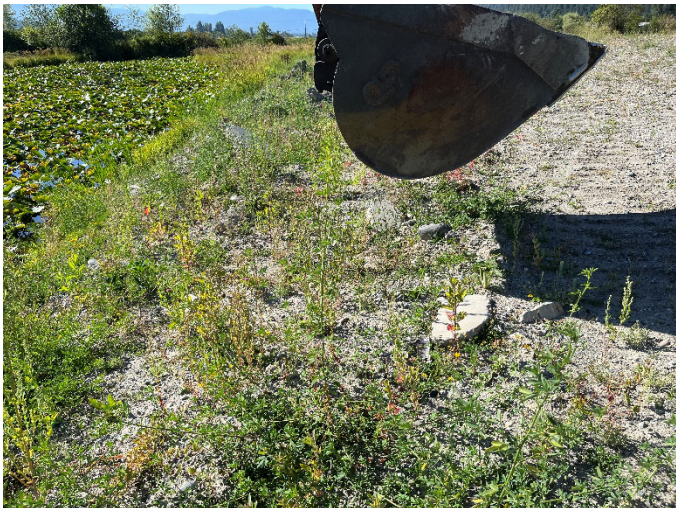
*Figure 11. Photo showing some pieces of concrete in the fill material that had been imported.*

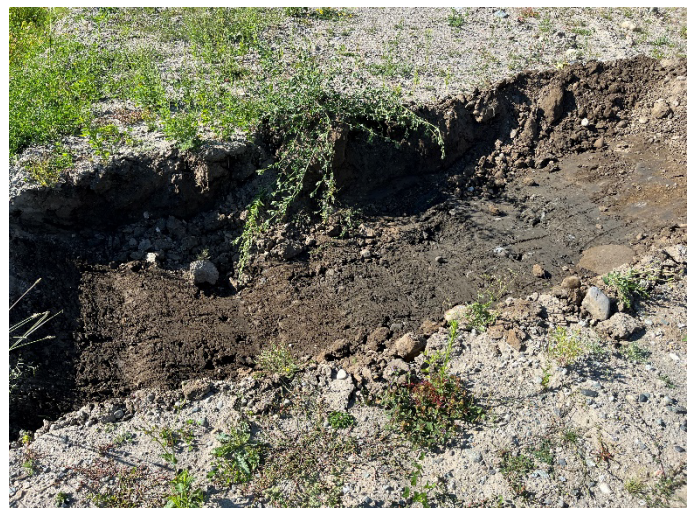
*Figure 12. Photo showing the depth of fill and that most of the fill was free of debris.*

The depth of imported soil was up to 1.5 m and consisted only of structural fill. The estimated volume of imported soil was 11,500 m<sup>3</sup>.

Relocating 50% of the imported soil to the estimated 7500 m<sup>2</sup> agricultural area on the east side of the property would increase the elevation on more of the property, allowing more agricultural production.

Following the relocation of some of the structural fill, and removal of rocks and other debris, an additional layer of 0.5 m topsoil is required to further improve the agricultural capability of the soil. The total amount of additional topsoil required is 6,500 m<sup>3</sup> of topsoil over a total area of 13,000 m<sup>2</sup>.
