NHC Ref. No. 3003939

6 August 2018

**Re:**             **51515 Chilliwack Lake Road Natural Hazards Assessment**

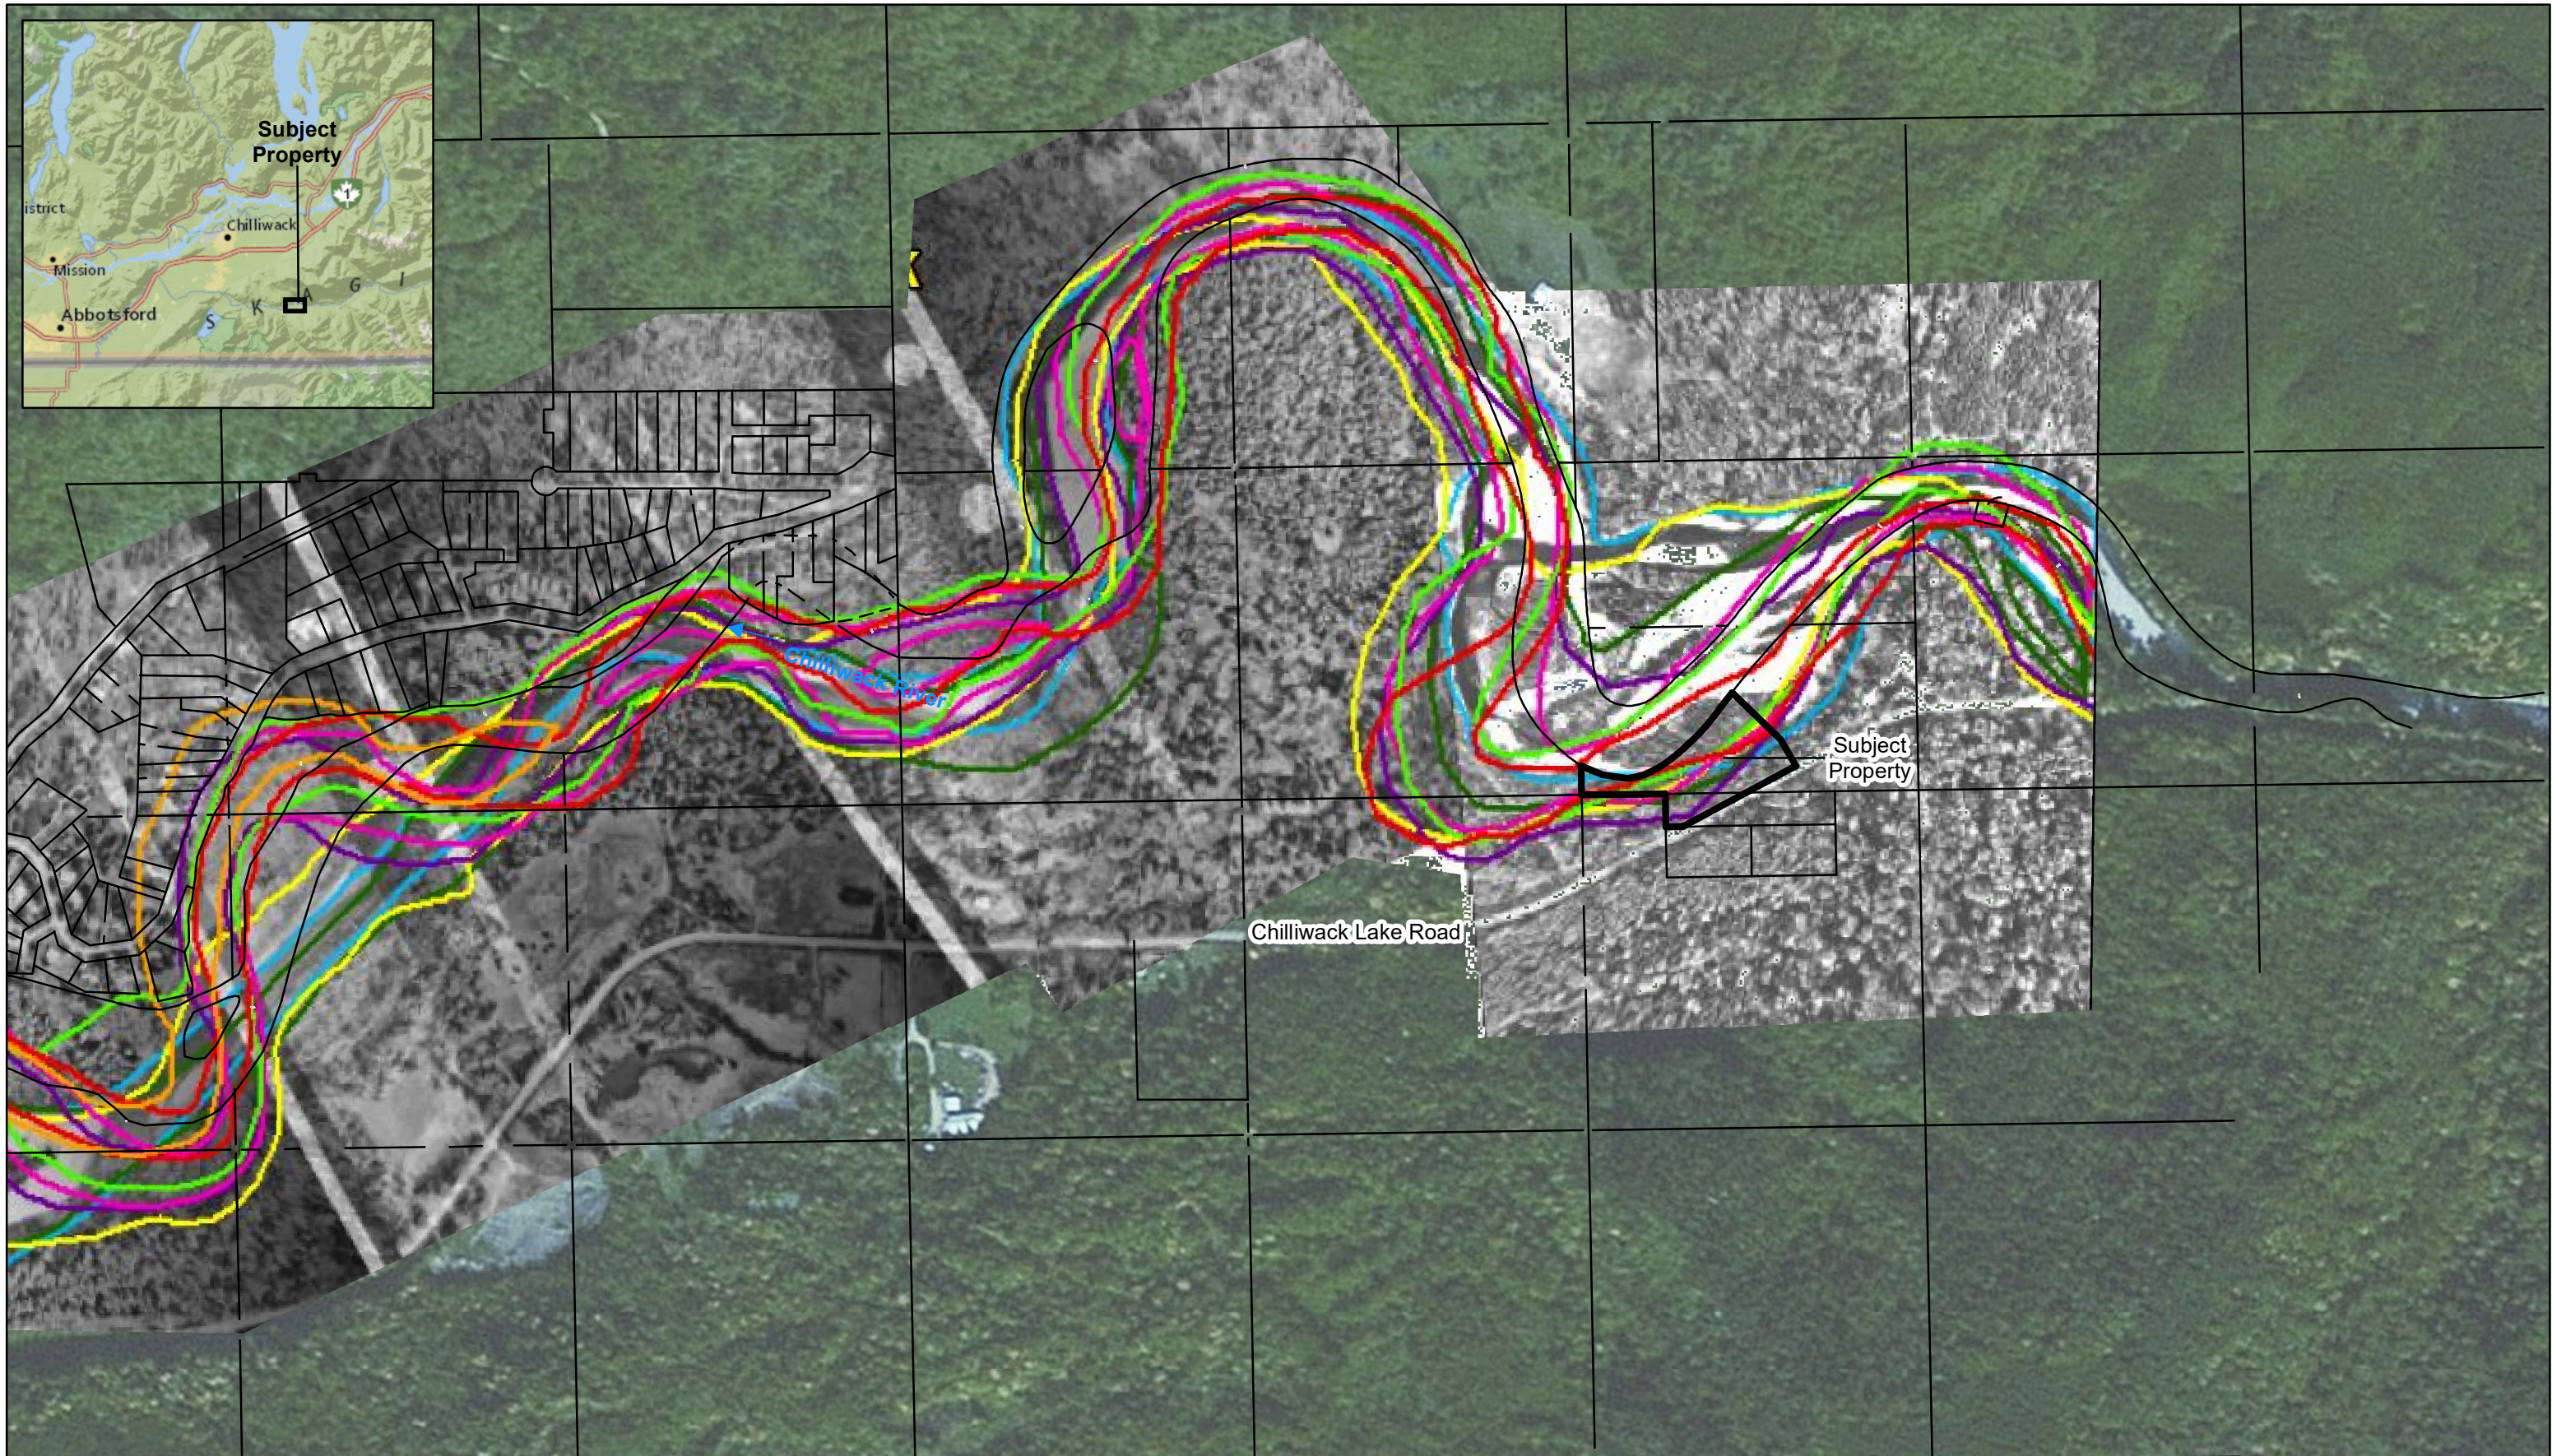
Figure 3: Overlay of Channel Changes 1940 to 2008

In 2009 EBA Engineering Consultants evaluated the various alignments of channel occupancy based on air photos from 1940 to 2008 for the Chilliwack River from the Vedder Crossing Bridge to just upstream of the subject property. This information is shown on Figure 3 and it illustrates that since 1940 the river in proximity to the property has occupied a large area extending over most of the 200 year floodplain boundary. The earliest air photos show that the active channel of the river was relatively narrow and occupied the left side of the floodplain adjacent to the subject property. The left bank of the active channel appears to have defined the northern boundary of the lot when this area was initially subdivided. Evidence of this is shown on Figure 1 and Figure 2 as the line defining the river is the same as the northern property boundary. However the historical air photos show this left bank continued to erode south until it reached the current bankline as defined approximately by the 200-year floodplain limit which cuts through the middle of the subject property as shown on Figure 1, Figure 2 and Figure 3.

Between 1963 and 1979 the active channel of the Chilliwack River started to migrate away from the left bank as a large bar formed along the toe of the slope adjacent to the subject property. Then between 1979 and 1983 the active channel avulsed to approximately the middle of the floodplain and further away from the left side of the floodplain and hence the subject property. By 1993 the active channel was well established in the centre of the floodplain but by 2004 the river avulsed to the right (north) side of the floodplain. By 2008 the active channel was well established along the right side of the floodplain and the large bar along the left bank adjacent to the subject property was well established and heavily vegetated. Currently the active channel remains along the right side of the floodplain and the left side of the floodplain continues to support mature vegetation. Figure 4 shows the EBA determined maximum extent of active channel occupancy from 1940 to 2008 as well as the 200 year floodplain limit. This analysis demonstrates that the Chilliwack River in proximity to the subject property is very active and covers a wide floodplain. It is important to note that the EBA analysis is an overall general assessment of the river system and has limited application at a detailed site specific large scale due to the scale of the historical air photos used for the analysis. For example, the 1983 active channel

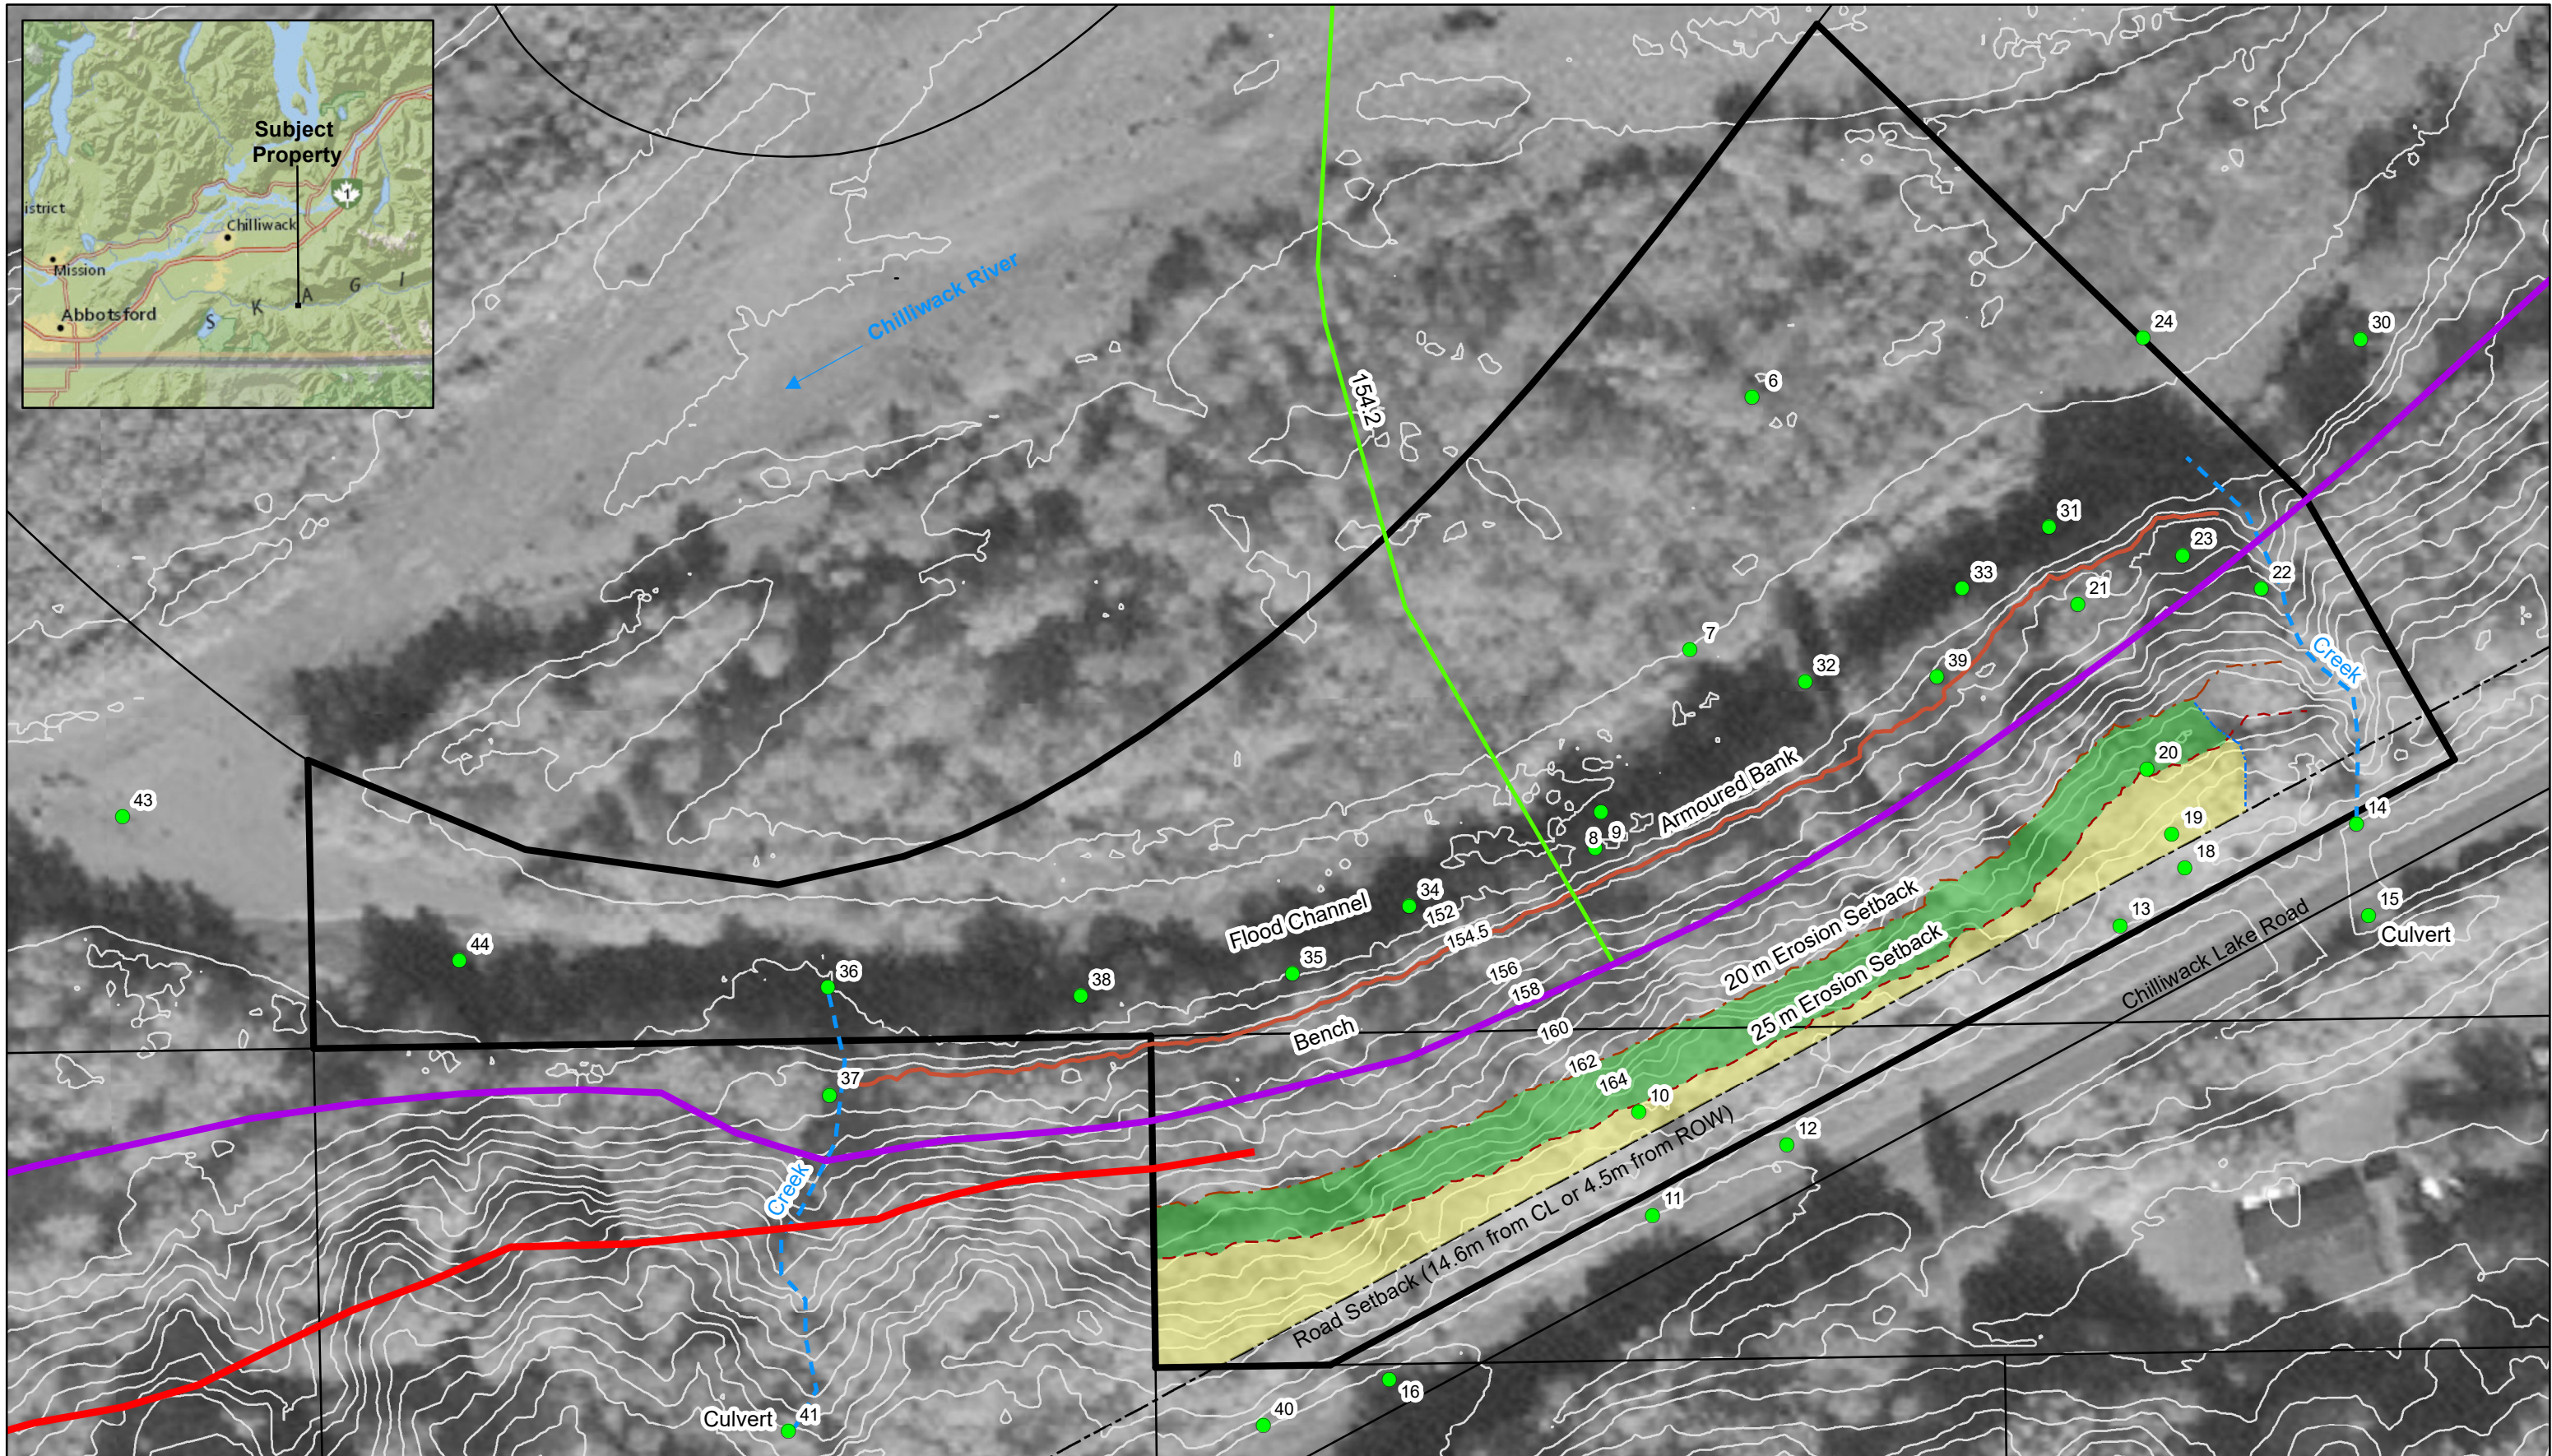
<p><b>51515 CHILLIWACK LAKE ROAD NATURAL HAZARDS ASSESSMENT SUBJECT PROPERTY WITH 1M CONTOURS</b></p>				<p><b>FIGURE 5</b></p>

The property is subject to inundation along the northern portion of the lot which lies within the 200-year floodplain. As shown on Figure 5 the existing 200-year flood limit traverses the hillside part way up the slope within the property. The isoline that lies within approximately the middle of the property is at an elevation of 154.2 m and joins the floodplain limit. The isolines represent the Flood Construction Level (FCL) which includes freeboard. Figure 5 shows that the position of the 200-year floodplain limit does not line up with the position of the 154.2 m contour line. This is likely because the contours shown on Figure 5 are based on 2015 Lidar data and the 200-year floodplain limit is based on floodplain mapping from 1981 which utilized air photography from 1976. The 1981 limit is a general overview line and based on far less detailed topographic data compared to the 2015 Lidar data. As a result the 1981 flood limit is located approximately 10 m south (upslope) from the location of the 154.2 m contour. Therefore, the location of the 154.2 m contour generated from the Lidar should be considered a more accurate site specific 200-year floodplain limit compared to the location of the 1981 limit.

The 154.2 m contour traverses the hillside a few meters above the toe of the slope within the armoured bank which is situated between the toe of the bank and the bench (Figure 5). For the purpose of this assessment, a line has been shown on Figure 5 highlighting the 154.5 m contour to represent the

The 154.5 m contour identified by the orange line on Figure 5 should be considered the FCL on this property the purpose of identifying a safe building site. Hence specific only to flood hazards, development should only be considered above this elevation which would be south or upslope of the 154.5 m contour.

As mentioned in Section 4 the armoured bank may not have been engineered, may not be to current standards and is not owned or maintained by a level of government. The 25 m setback, which is measured from the 154.5 m contour line, is shown on Figure 5 and Figure 6. A detailed inspection of the existing armouring is recommended to determine if the protection is adequate. If deficiencies are identified in the existing bank protection then some upgrading will be required in order to implement the 25 m setback. Possible deficiencies include sections of the bank where the armour rock is too small, not thick enough, does not have an appropriate underlayer, is too steep, or where armouring is absent altogether.

The 25 m setback provides limited area for developing on this property once the required roadway setback is taken into consideration. As shown on Figure 5 there is a small area along the east end of the lot just west of the creek adjacent to the road (approximately 9 m wide) and another small but slightly larger area in the southwest corner also adjacent to the road (approximately 13 m wide). Of these two potential locations the west site is recommended as it would be protected from a longer upstream reach of the existing bank protection. The eastern site would have minimal upstream bank protection and could be subject to erosion from the neighbouring property which is not armoured along the bank.

The upgraded riprap for 20 m setback option should extend the length of the existing riprap which is from the eastern creek to past the potential location for a home which is approximately adjacent to photo reference point 38 (Figure 5). The upgraded riprap should tie into the left bank of the creek outlet to minimize outflanking from the Chilliwack River and the riprap should be keyed into the bed and extend vertically to the FCL of 154.5 m. The existing bench near the toe of the slope should remain to provide machine access for future maintenance and repair. Machine access on the subject property from the road to this bench does not exist but should be established and maintained. Access along the left side of the floodplain via the Allison Pool Campground gate several hundred metres upstream may be possible but can't be guaranteed or relied upon.

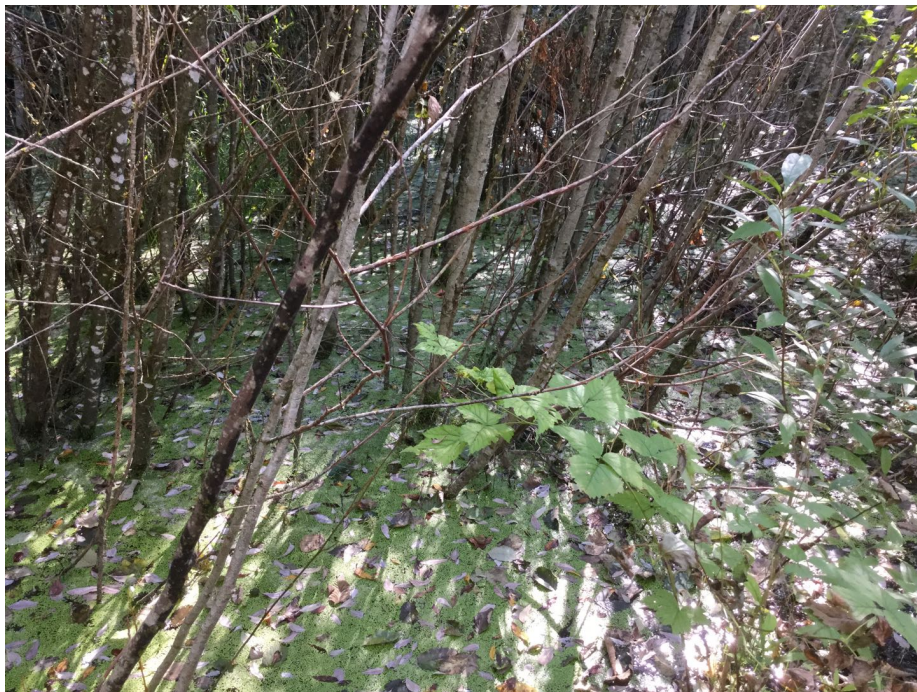
**Photo 30** Isolated ponds exist along the toe of the left bank near the outlet of two creeks situated near the east and west boundaries of the property.

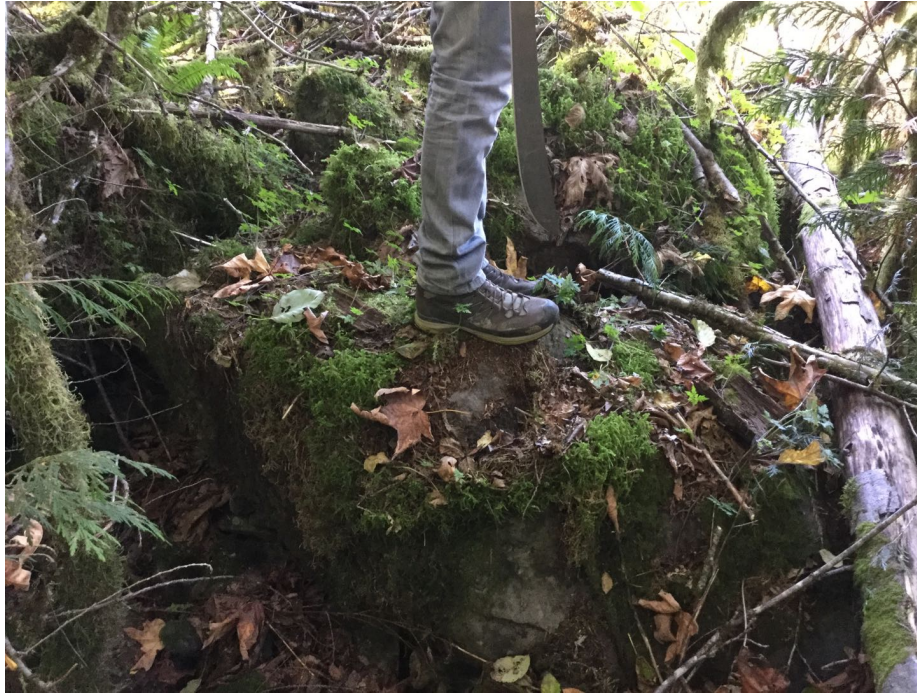
**Photo 21** The toe of the bank was armoured with large angular boulders that were covered with moss and vegetation. Many of the larger boulders average 1 m or greater in diameter.

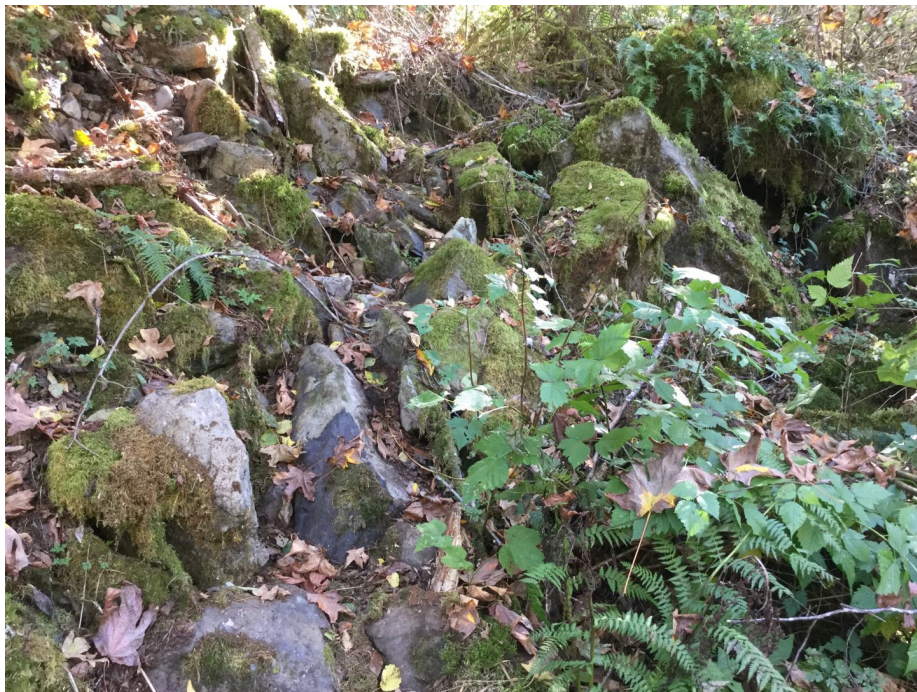
**Photo 34** The armoured bank averages 3 m high and all of the rock appears to be angular quarried rock.

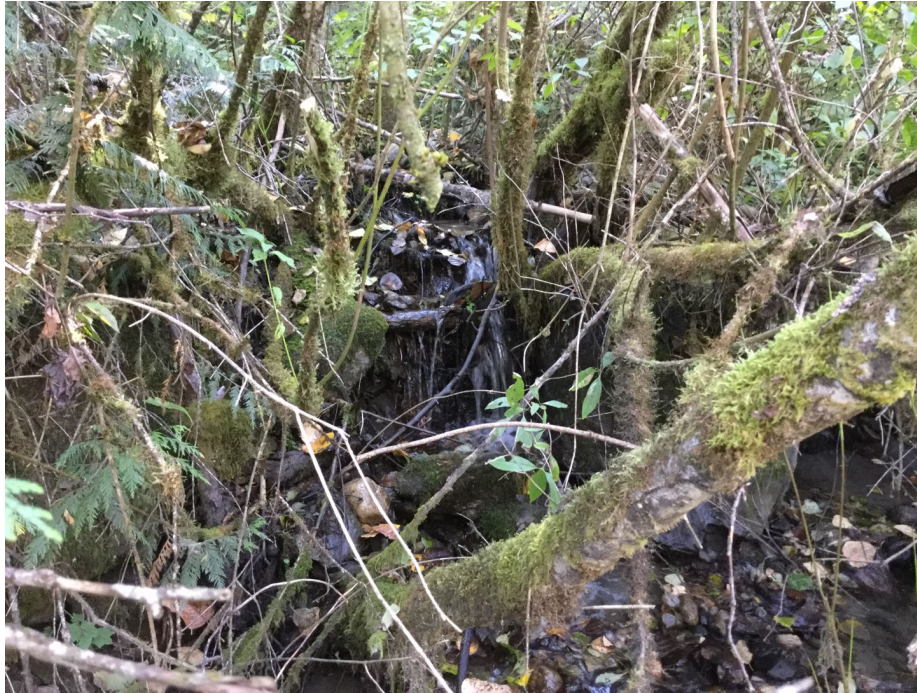
The northern (riverside) half of the subject property is situated within the Chilliwack River floodplain. This portion of the property is generally flat with well vegetated gravel bars that would be inundated during flood events (Photo 6). This area was generally dry at the time of the site visit as the active channel is located on the opposite (right) side of the floodplain. Some small areas of isolated ponds exist along the toe of the left bank near the outlet of two creeks situated near the east and west boundaries of the property (**Photo 30**). A well-defined flood channel averaging 15 m wide is located along the toe of the bank which runs through the property (Figure 5 and Figure 6). This flood channel was dry during the site visit and can be easily identified on both the large scale contour figure (Figure 5) and the Lidar figure (Figure 6). The toe of the bank was armoured with large angular boulders that were covered with moss and vegetation. The bank protection is likely several decades old. Many of the larger boulders average 1 m or greater in diameter (Photo 21) and all of the rock appears to be angular quarried rock (Photo 34). The armoured bank averages 3 m high and the upstream end of the armouring is at the outlet of the creek near the upstream (eastern) end of the property and extends downstream to the creek near the western end of the property (Photo 36). The bank at the downstream end of the property does

**Photo 36** Armoured bank at the outlet of the creek near the western end of the property.

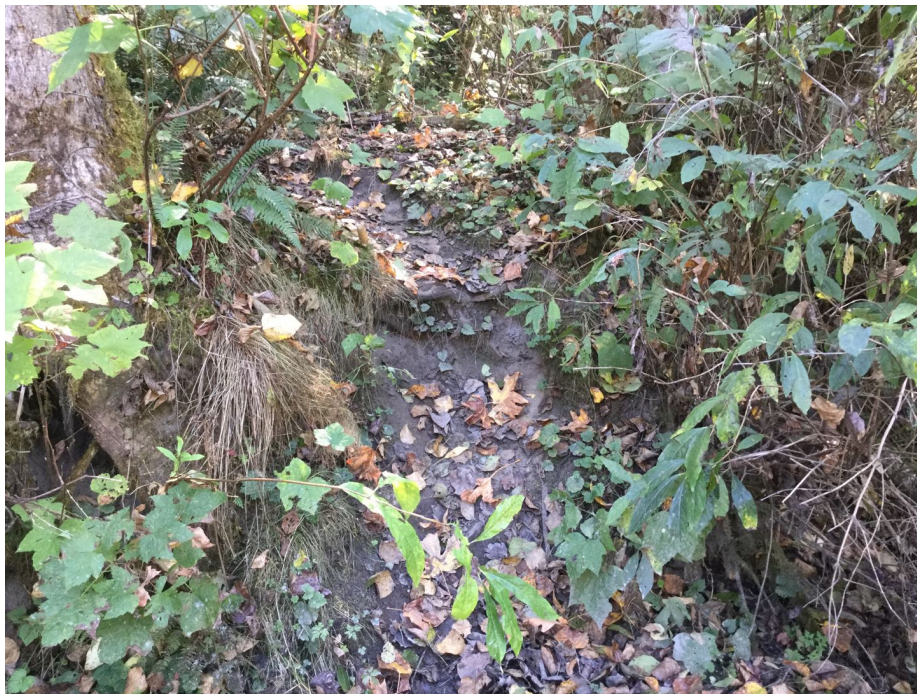
not appear to be armoured. The exposed bank material is predominately fine grained (Photo 44). Surficial geology mapping of the area identifies the bank of the subject property to be glaciolacustrine silts and clays (Hayco, 1992).

**Photo 44** The bank at the downstream end of the property does not appear to be armoured .The exposed bank material is predominately fine grained.

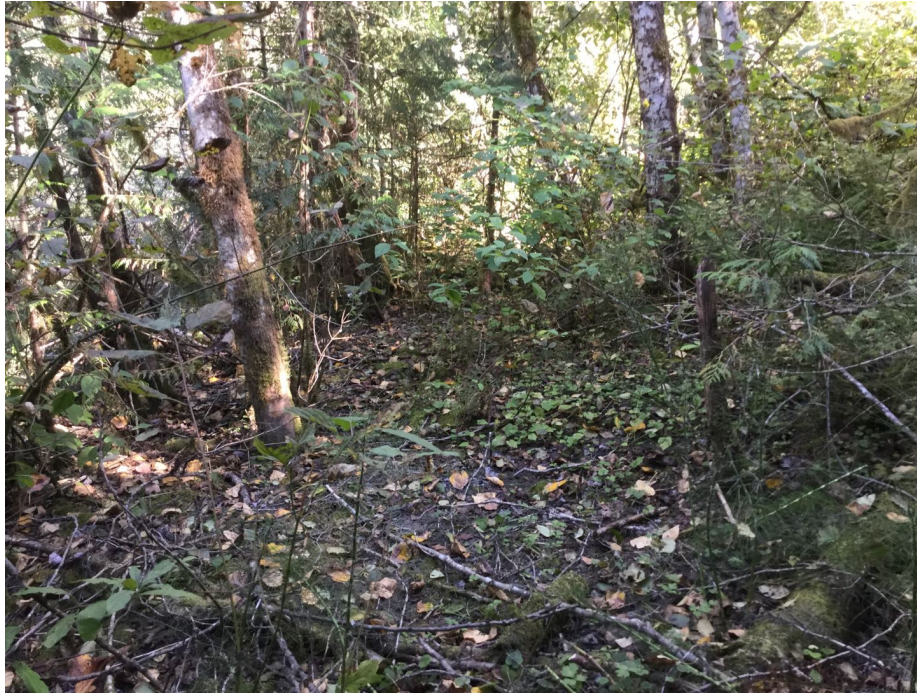
Upslope of the 3 m high armoured bank is a bench which averages 3 m wide (Photo 37). This flat bench can be easily identified on both the large scale contour figure (Figure 5) and the Lidar figure (Figure 6). The flat bench is less defined at the upstream end of the property where several large boulders used for the bank armouring are situated on the bench in proximity to photo reference points 21, 23 and 39 (Figure 5 and Figure 6). Upslope from the bench and downslope of the road, the hillside in the middle of the property has an average slope of 30 degrees. The slope averages 26 degrees toward the eastern end of the property. At the upslope end of the property there is a bench in the middle of the lot where the small cabin is located (Photo 10). There is also a small bench near the eastern end of the property between photo reference points 19 and 20 (Figure 4 and Figure 5).

**Photo 37** Upslope of 3 m high armoured bank is a bench which averages 3 m wide.

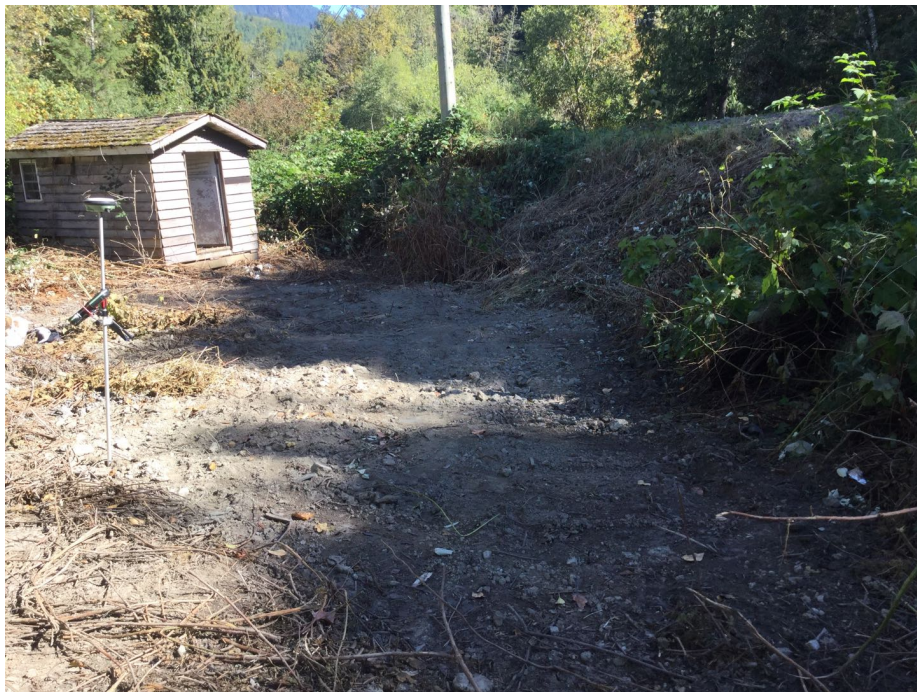
**Photo 10** At the upslope end of the property there is a bench in the middle of the lot where the small cabin is located.
