Technical Memorandum

RE: **CHILLIWACK RIVER SLESSE PARK**
Erosion Setback Line Update
Our File 2080.040-300

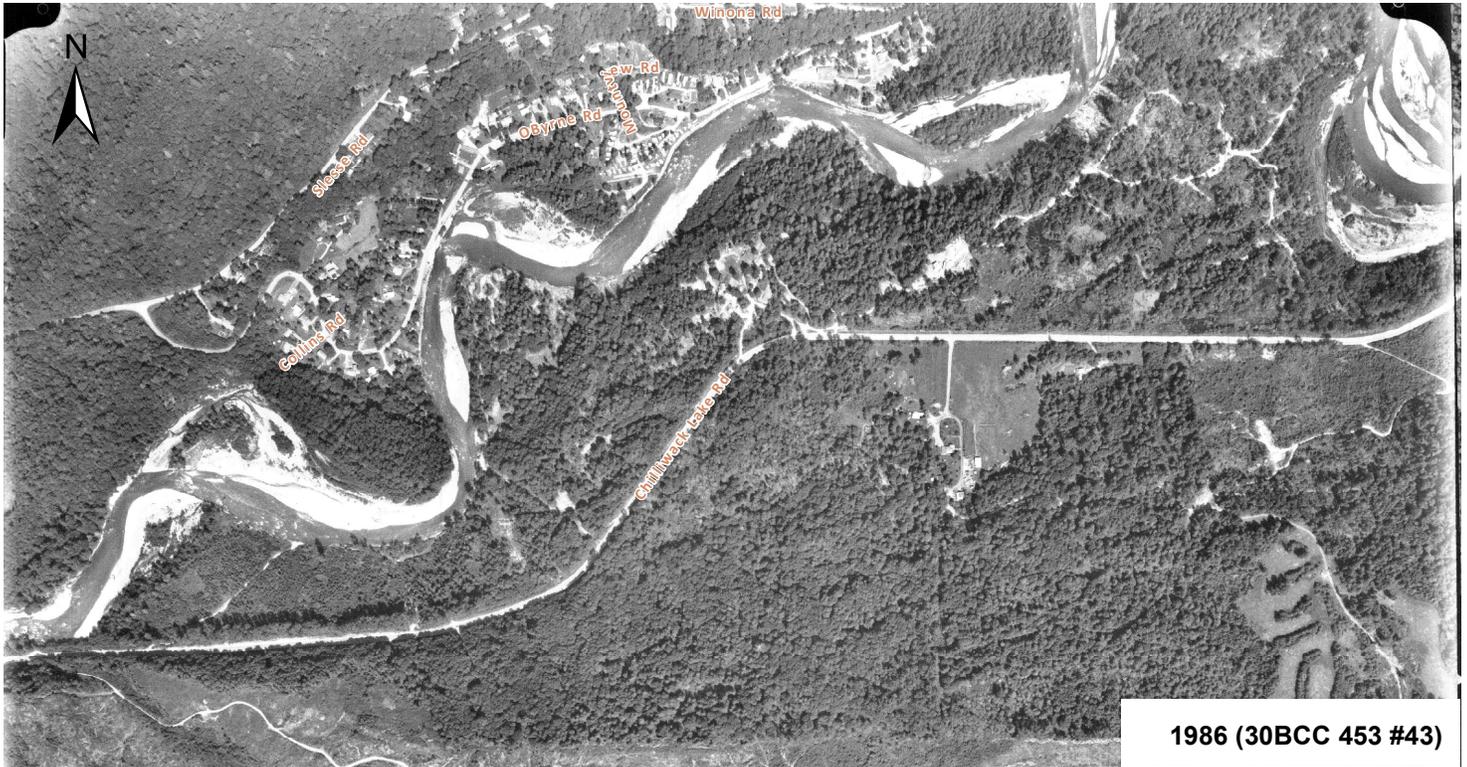
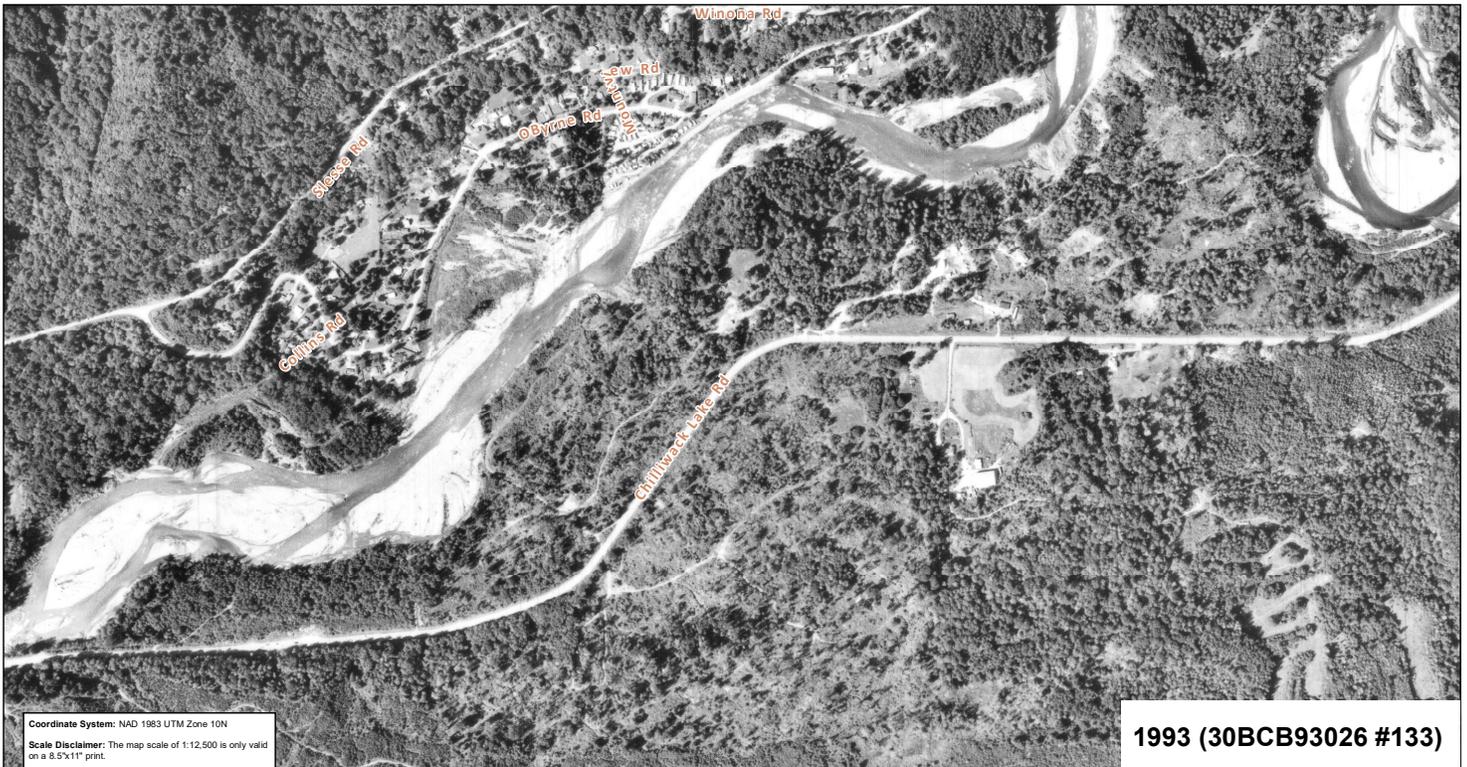
As indicated in Table 1, the largest morphologic change captured in the historical air photo record occurred in the 1990s: Hay & Co. et al. (1992) indicate that this change occurred during the November 1990 flood. Figure 3 shows a comparison of the Slesse Park reach from before (1986) and after (1993) the November 1990 event. As shown, there was a notable change in alignment (rather than progressive erosion at the outside of existing bends), as part of which two meander bends were cut off, resulting in a much straighter channel alignment.

Figure 3 illustrates the dynamic nature of the Chilliwack River and the potential for change within the study reach in a single, large flood event. In addition, the air photo review indicates that there are old

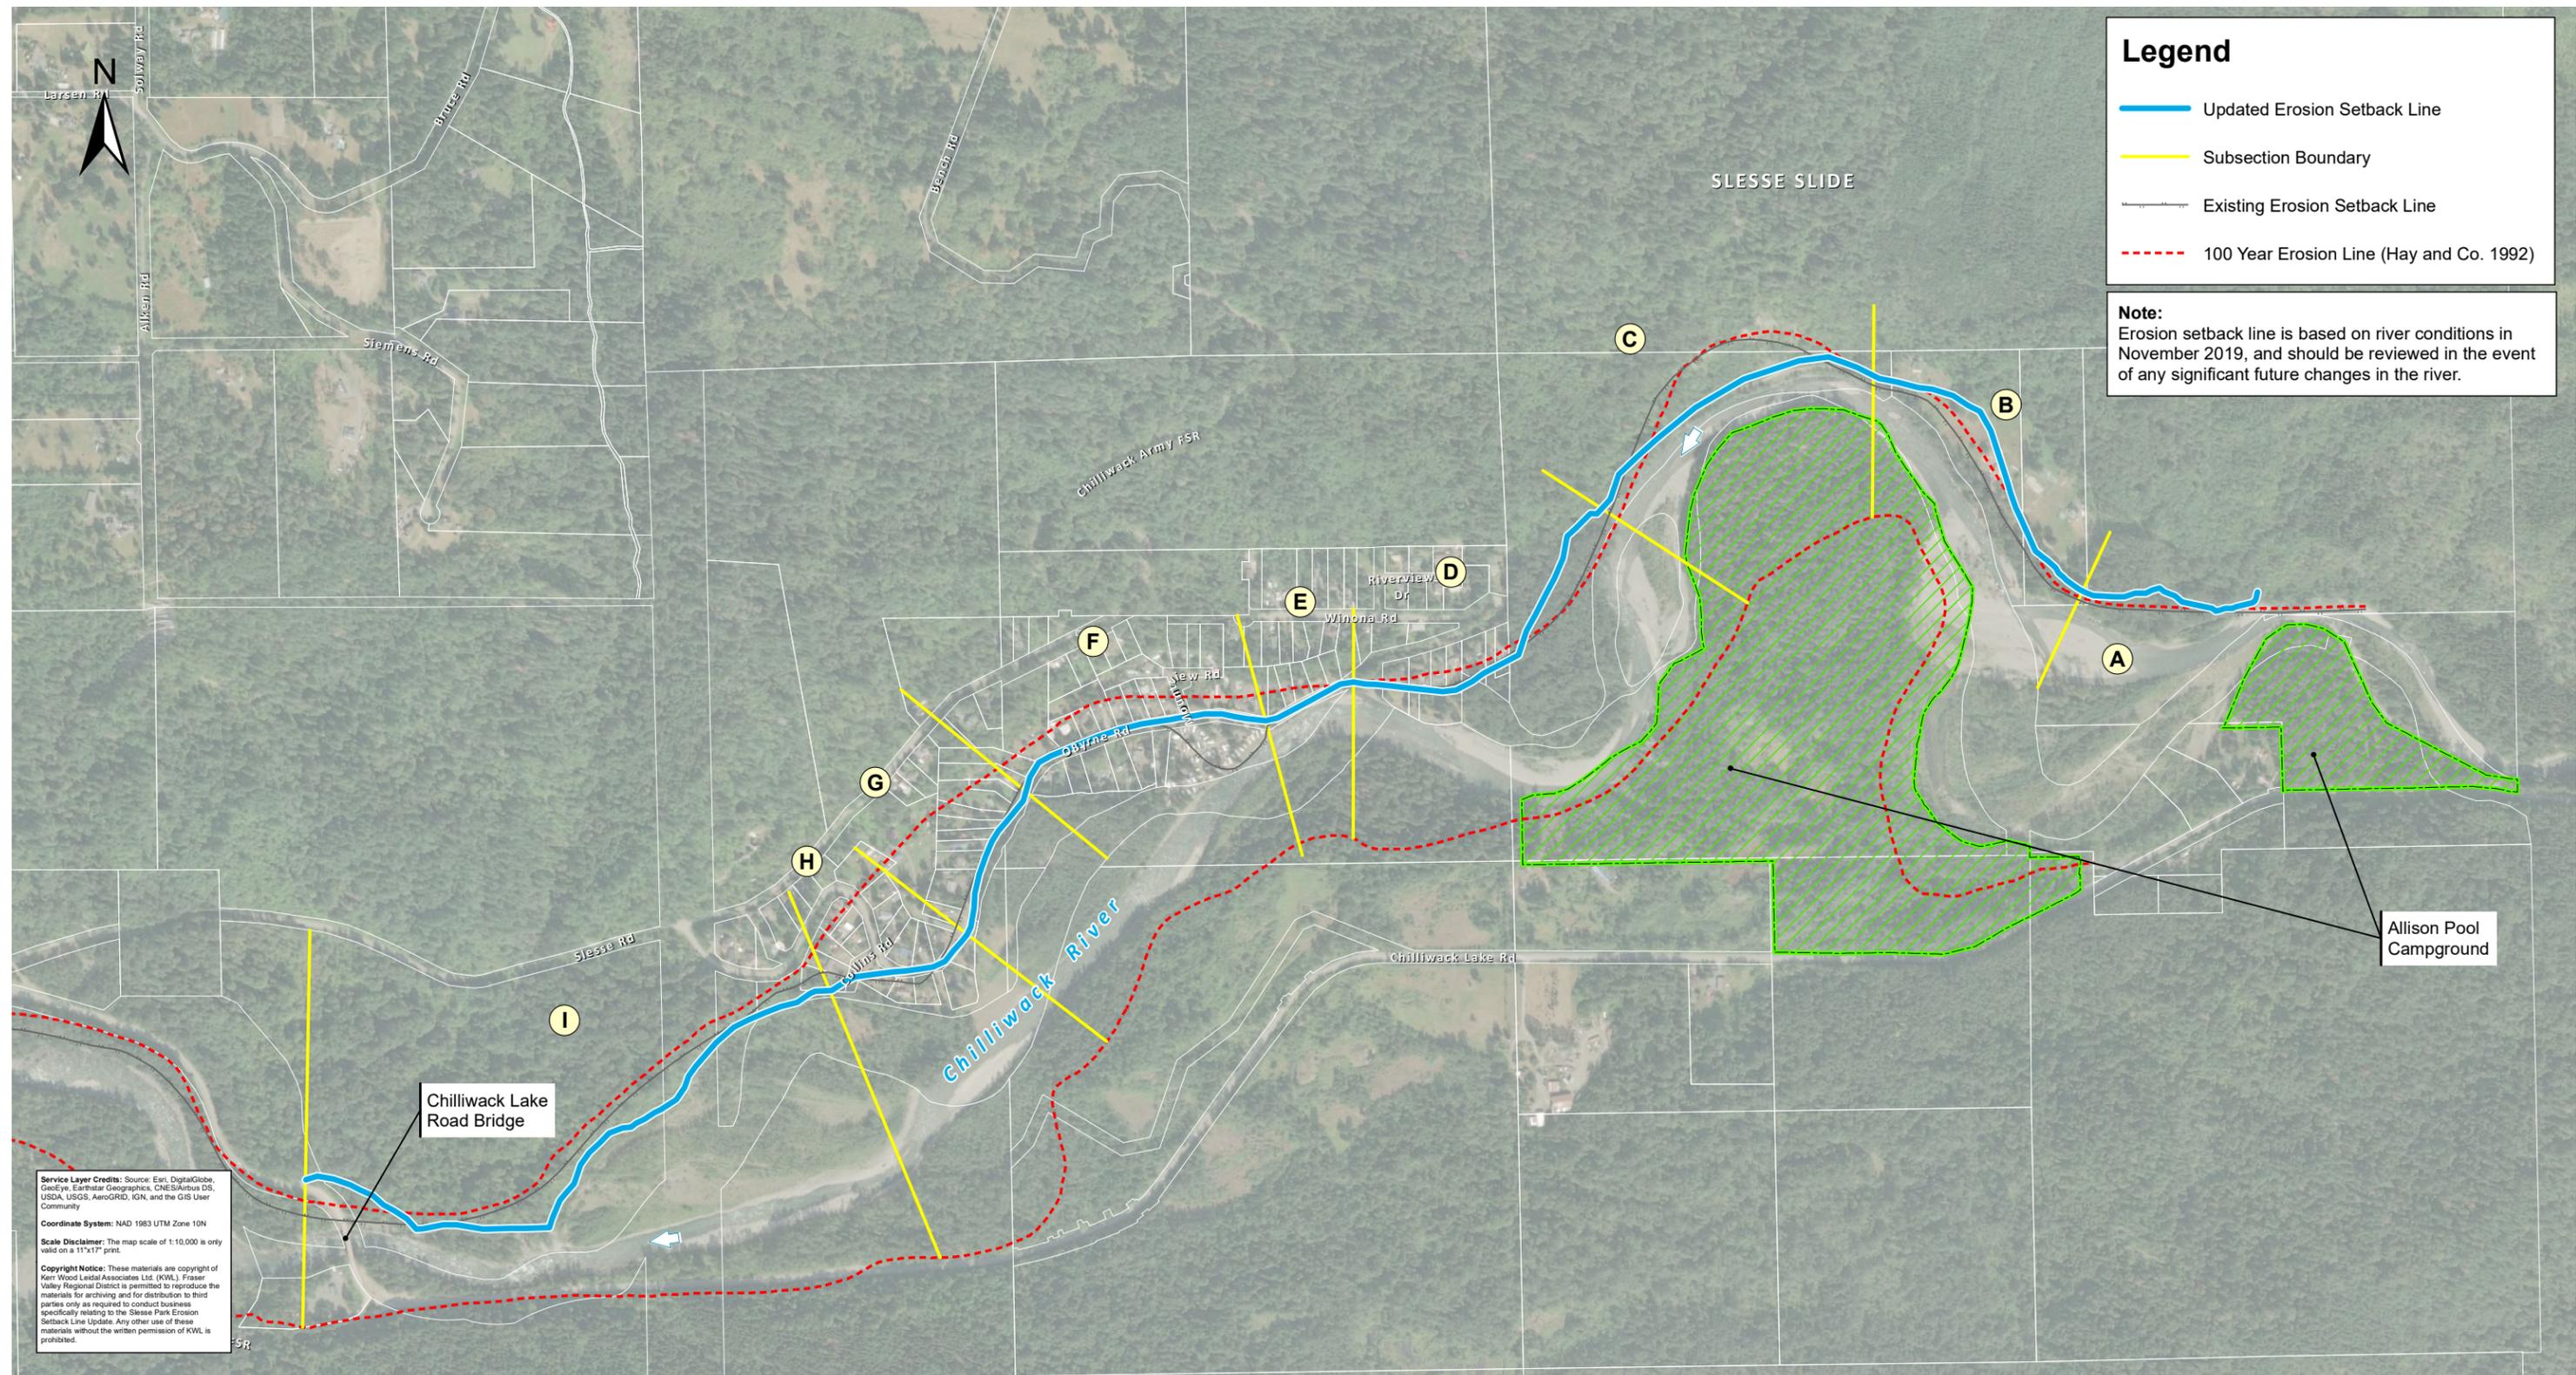
Figure 5

Table 2 describes features identified within the study reach that were considered in establishing the updated erosion setback line. Within this table, the study reach has been broken into sub-sections (identified by letters): these breaks and sub-section identifiers are also shown on Figure 5.

The updated erosion setback line for Slesse Park is presented in Figure 5.

In general, the location of the updated line does not differ greatly from the previous erosion setback line established by Hay & Co et al. (1992). Given the observed ability of Chilliwack River to dramatically change its alignment within a single large flood event, the erosion setback line must necessarily consider the potential for avulsion into older channels (including the reactivation of vegetated floodplain). As noted in Table 2, in a few locations the updated erosion setback line is now on the landside of the 100-year erosion limit line.

1. FVRD consider updating the 100-year erosion limit line to be consistent with the updated erosion setback line.
2. FVRD consider integrating the updated erosion setback line to the existing downstream erosion setback line (or some other appropriate end point).
3. The erosion setback line be assessed (and updated if required) after future major events. A major event could be classified as an event with a peak flow greater than a 50-year return period or an event that causes a significant change in the river alignment in the study area.
