To: Electoral Area Services Committee

File No: 2320-28-2020

Subject: Hemlock Valley Avalanche Assessment

HEMLOCK VALLEY SNOW AVALANCHE HAZARD ASSESSMENT

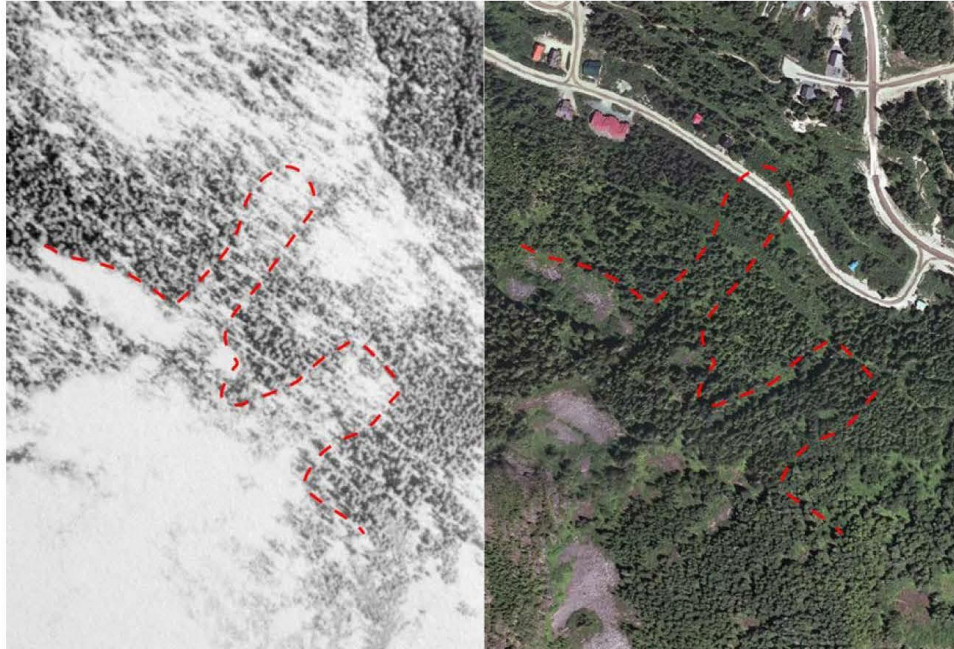
The photographs showed trim lines (location of vegetative type and age differences) of preceding snow avalanche events that occurred at least once between the years the air photos were taken. Prominent avalanche related trim lines were observed in the 1930 and 1951 air photos, as they were both taken prior to logging. Trim lines were observed close to Edelweiss Drive in two areas (Figure 2), suggesting large avalanches reached near the road pre-1930. These same trim lines were not apparent in the 2016 photograph, which suggests that avalanche events similar to the pre-1930 events have not occurred since then.

Figure 2. Comparison of aerial photographs from 1930 (left) and 2016 (right) for the Edelweiss Drive area. Red dashed line indicates the approximate location of trim lines observed in 1930 photograph.

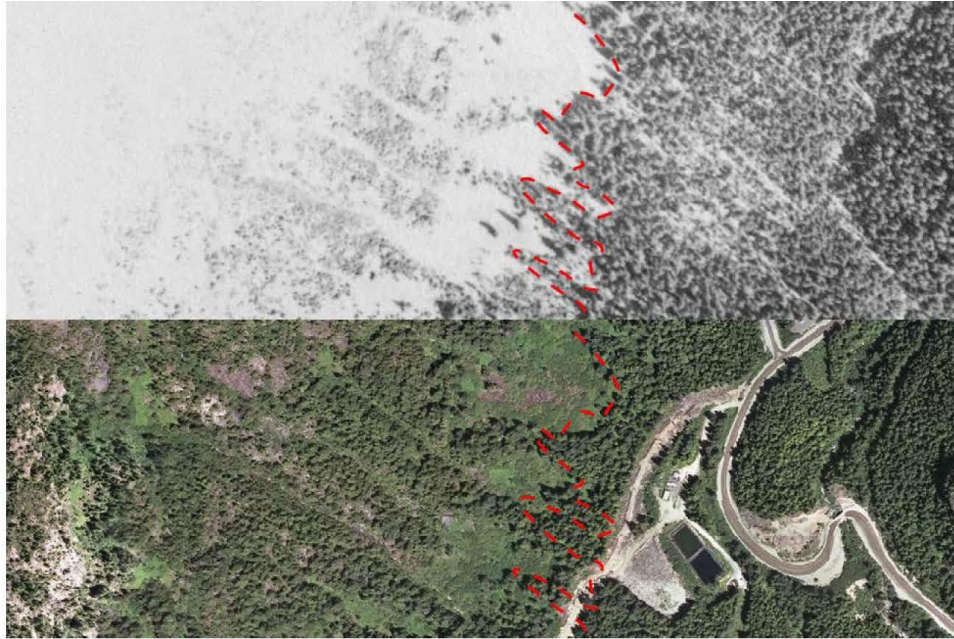
forest growth since logging in 1960's were generally similar to pre-logging conditions near the sewage lagoons area (Figure 3), although some areas could not be compared due to road and infrastructure construction since the logging activities. There was no obvious trim line in the 2003 air photo of the reported avalanche that reached the fence of the sewage lagoons in 1999 by D&E McClung Enterprises Ltd. (2010), suggesting that the avalanche debris flowed through the trees without knocking them down. This is not uncommon for a wet flow, which still has destructive potential for structures, despite not destroying the forest.

Figure 3. Comparison of aerial photographs from 1930 (top) and 2016 (bottom) for the sewage lagoons area. Red dashed line indicates the approximate location of trim lines observed in 1930 photograph.

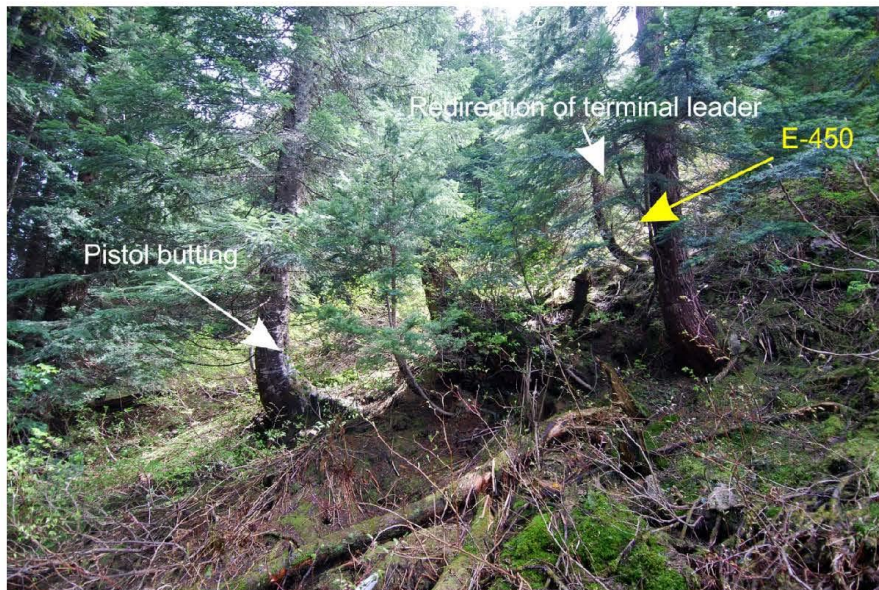
Photograph 6. Looking southeast towards vegetation damage about 90 m upslope of Edelweiss Drive within path E-450.

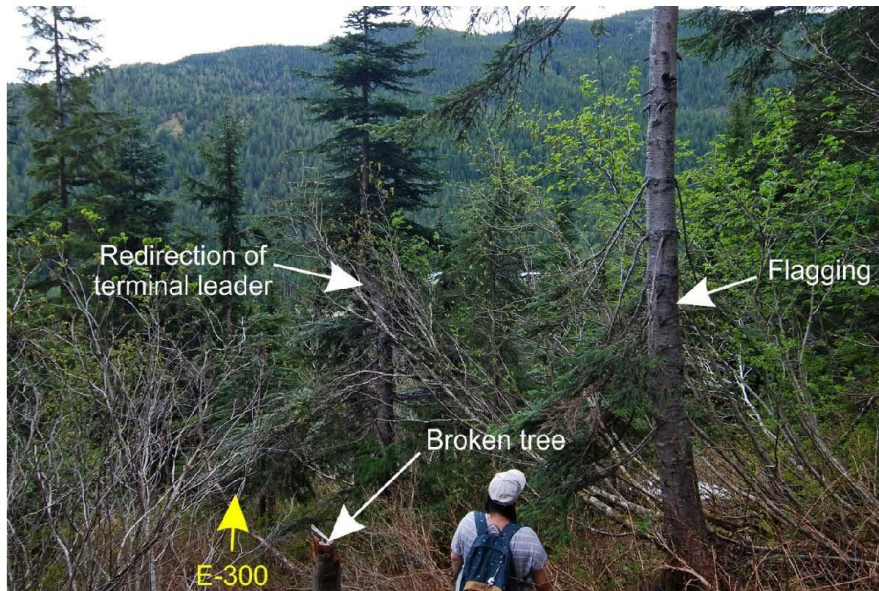
Photograph 9. Looking northeast and downslope along path E-300 towards vegetation damage in the track of the path.

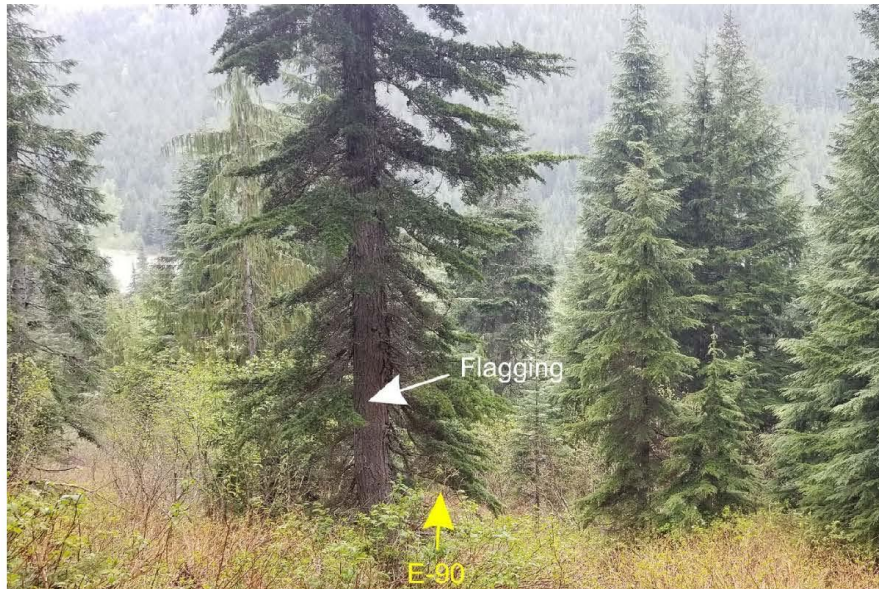
Photograph 11. Looking northeast and downslope along path E-90, looking towards vegetative clearing and damage of vegetation within the track.

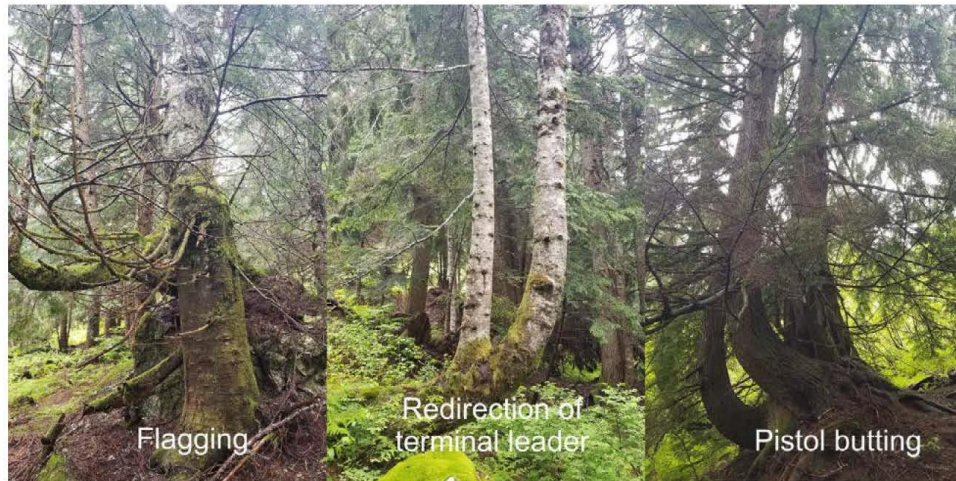
Photograph 14. Examples of vegetation damage within the runout zones of paths SL-105 and SL-200.

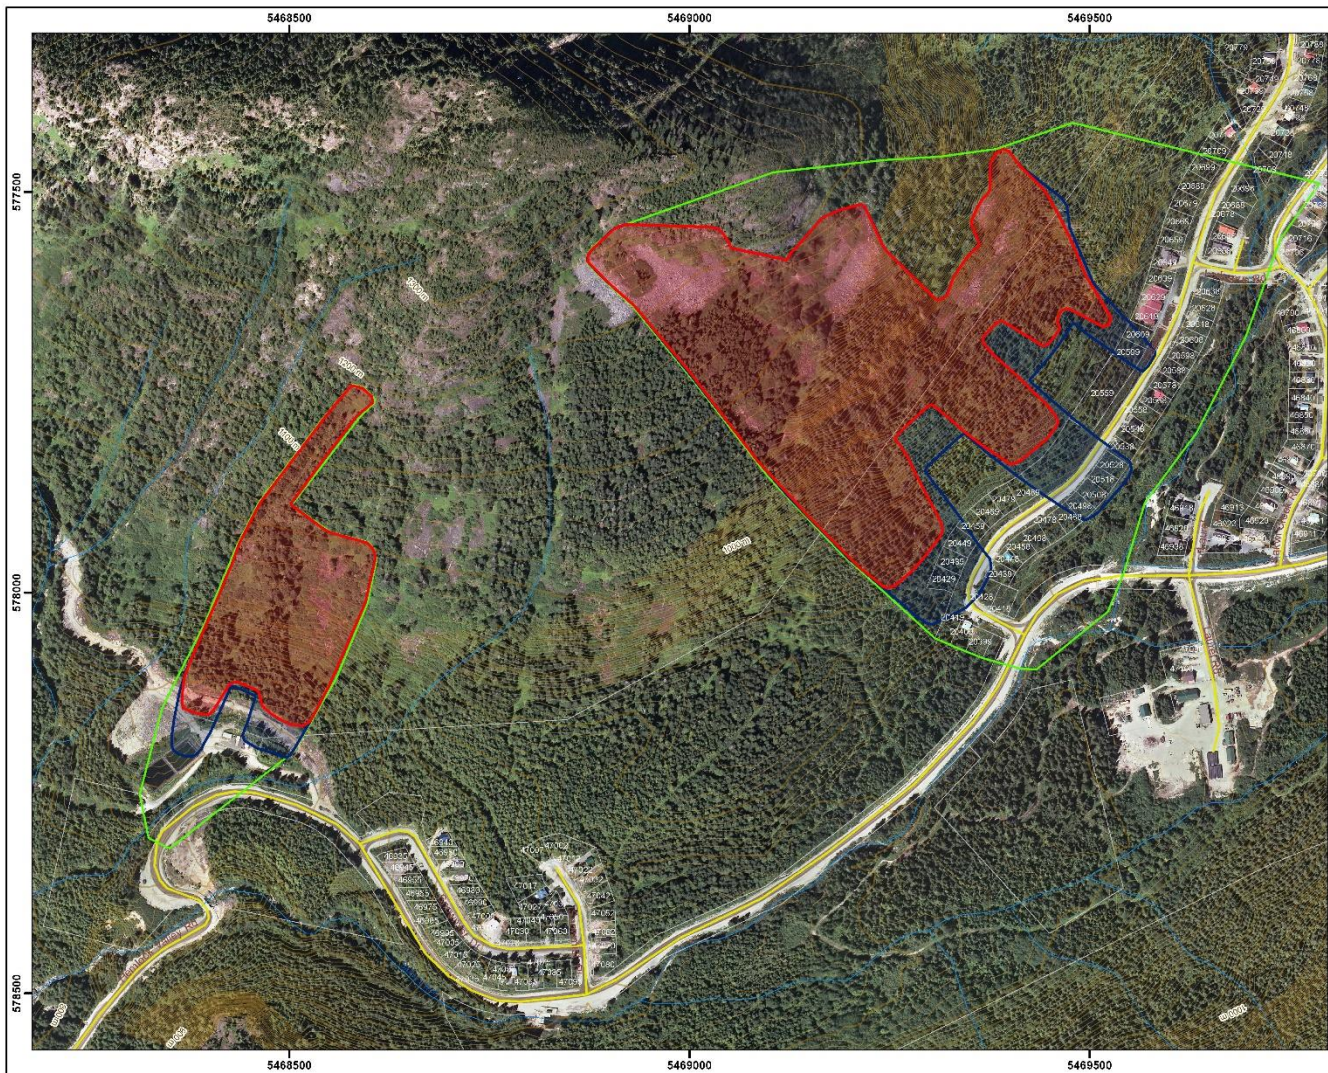
Avalanche Hazard Map

No current residential land parcels or infrastructure were identified in the Red Zone (high hazard). Hazard areas identified as being within the Blue Zone (moderate hazard) include portions or the entirety of 17 residential land parcels, an approximately 190 m length of Edelweiss Drive, the northern buildings in the sewage lagoons area, and the northwest sewage lagoon.

DAC recommends that FVRD follow the recommendations for occupied and unoccupied structures as outlined by CAA (2016). The current FVRD policy indicates that snow avalanches with a return period of up to 10,000 years should be assessed. The CAA (2016) guidelines recommend consideration of snow avalanches with a return period up to 300 years, which has been followed by most jurisdictions in Canada, and similar classifications are being applied in most U.S. jurisdictions, making this a North America-wide guideline. This guideline is also consistent with hazard map systems in European countries, including Switzerland and Austria.

Hazard boundaries may change in the future due to forest or terrain changes. Hazard boundaries should be updated should substantial changes occur.
