31 October 2008

Re: Geotechnical Investigation & Report
Proposed 42 Lot Development
Lot 3 – 1760 Columbia Valley Highway, Chilliwack, BC
Lot 4 – 1536 Frost Road, Chilliwack, BC
Lot 2 – 1766 Columbia Valley Highway, Chilliwack, BC
VGES Project No. 42906-04

VGES Project No. 42906-04

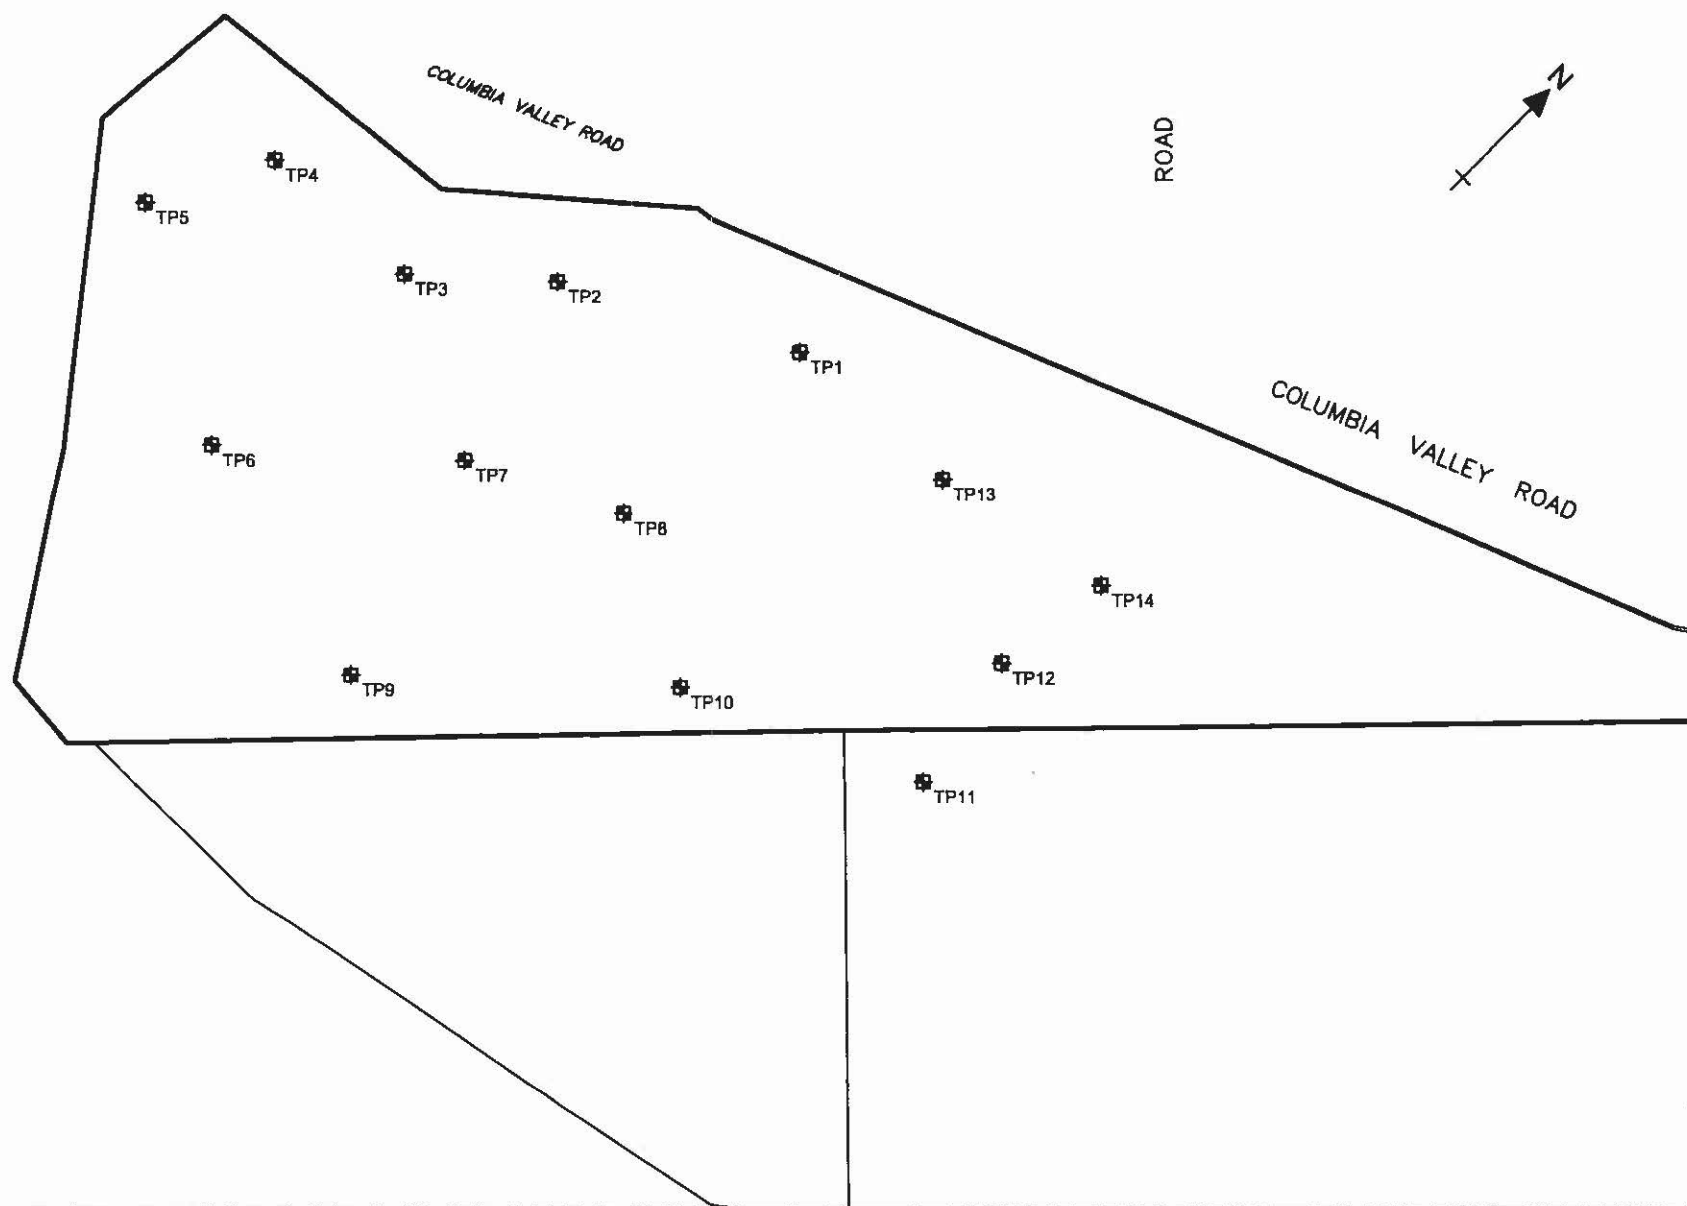
Client:	Cultus Country Investments	Title:	Test Pit Location Plan		
Location:	1700 Block of Columbia Hwy, Chilliwack, BC	Scale:	NTS	Proj. No:	42906-04
Description:	Proposed Subdivision	Drawn:	NS	Date:	June 26, 2008
		Checked:	NA	Rev. #:	0
				Sheet:	1 of 1

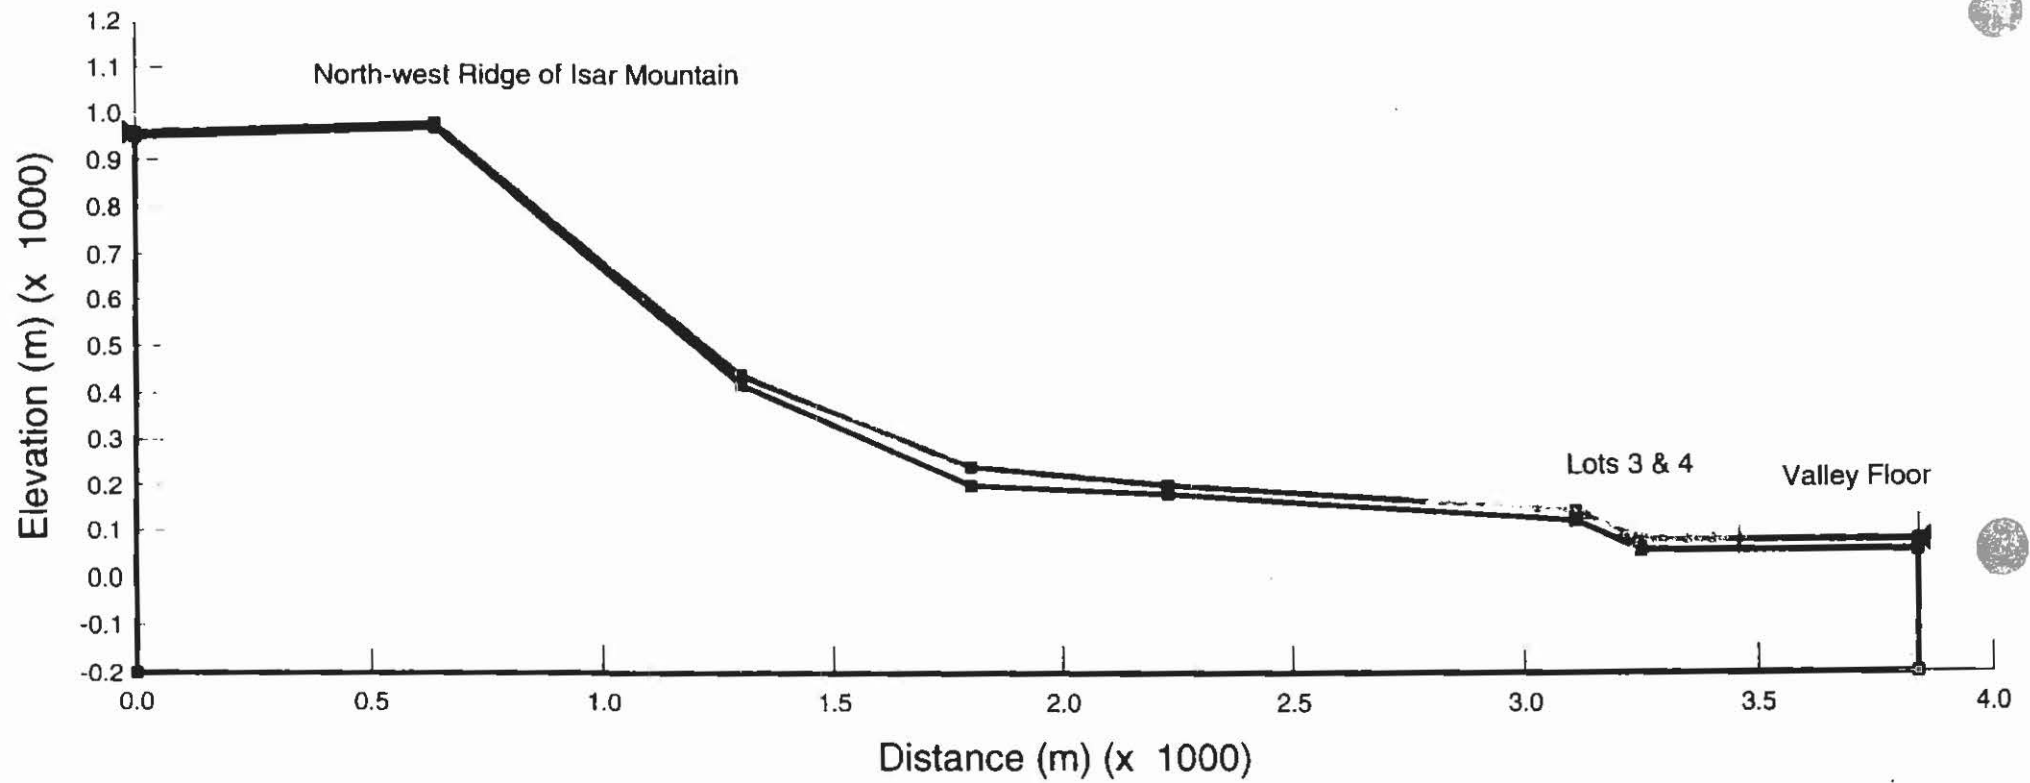
Valley Geotechnical - Abbotsford, B.C.
42906-02
John Van Geel - Cultus Country Resort
2 April 2007
Section A-A
Existing Grade - Static

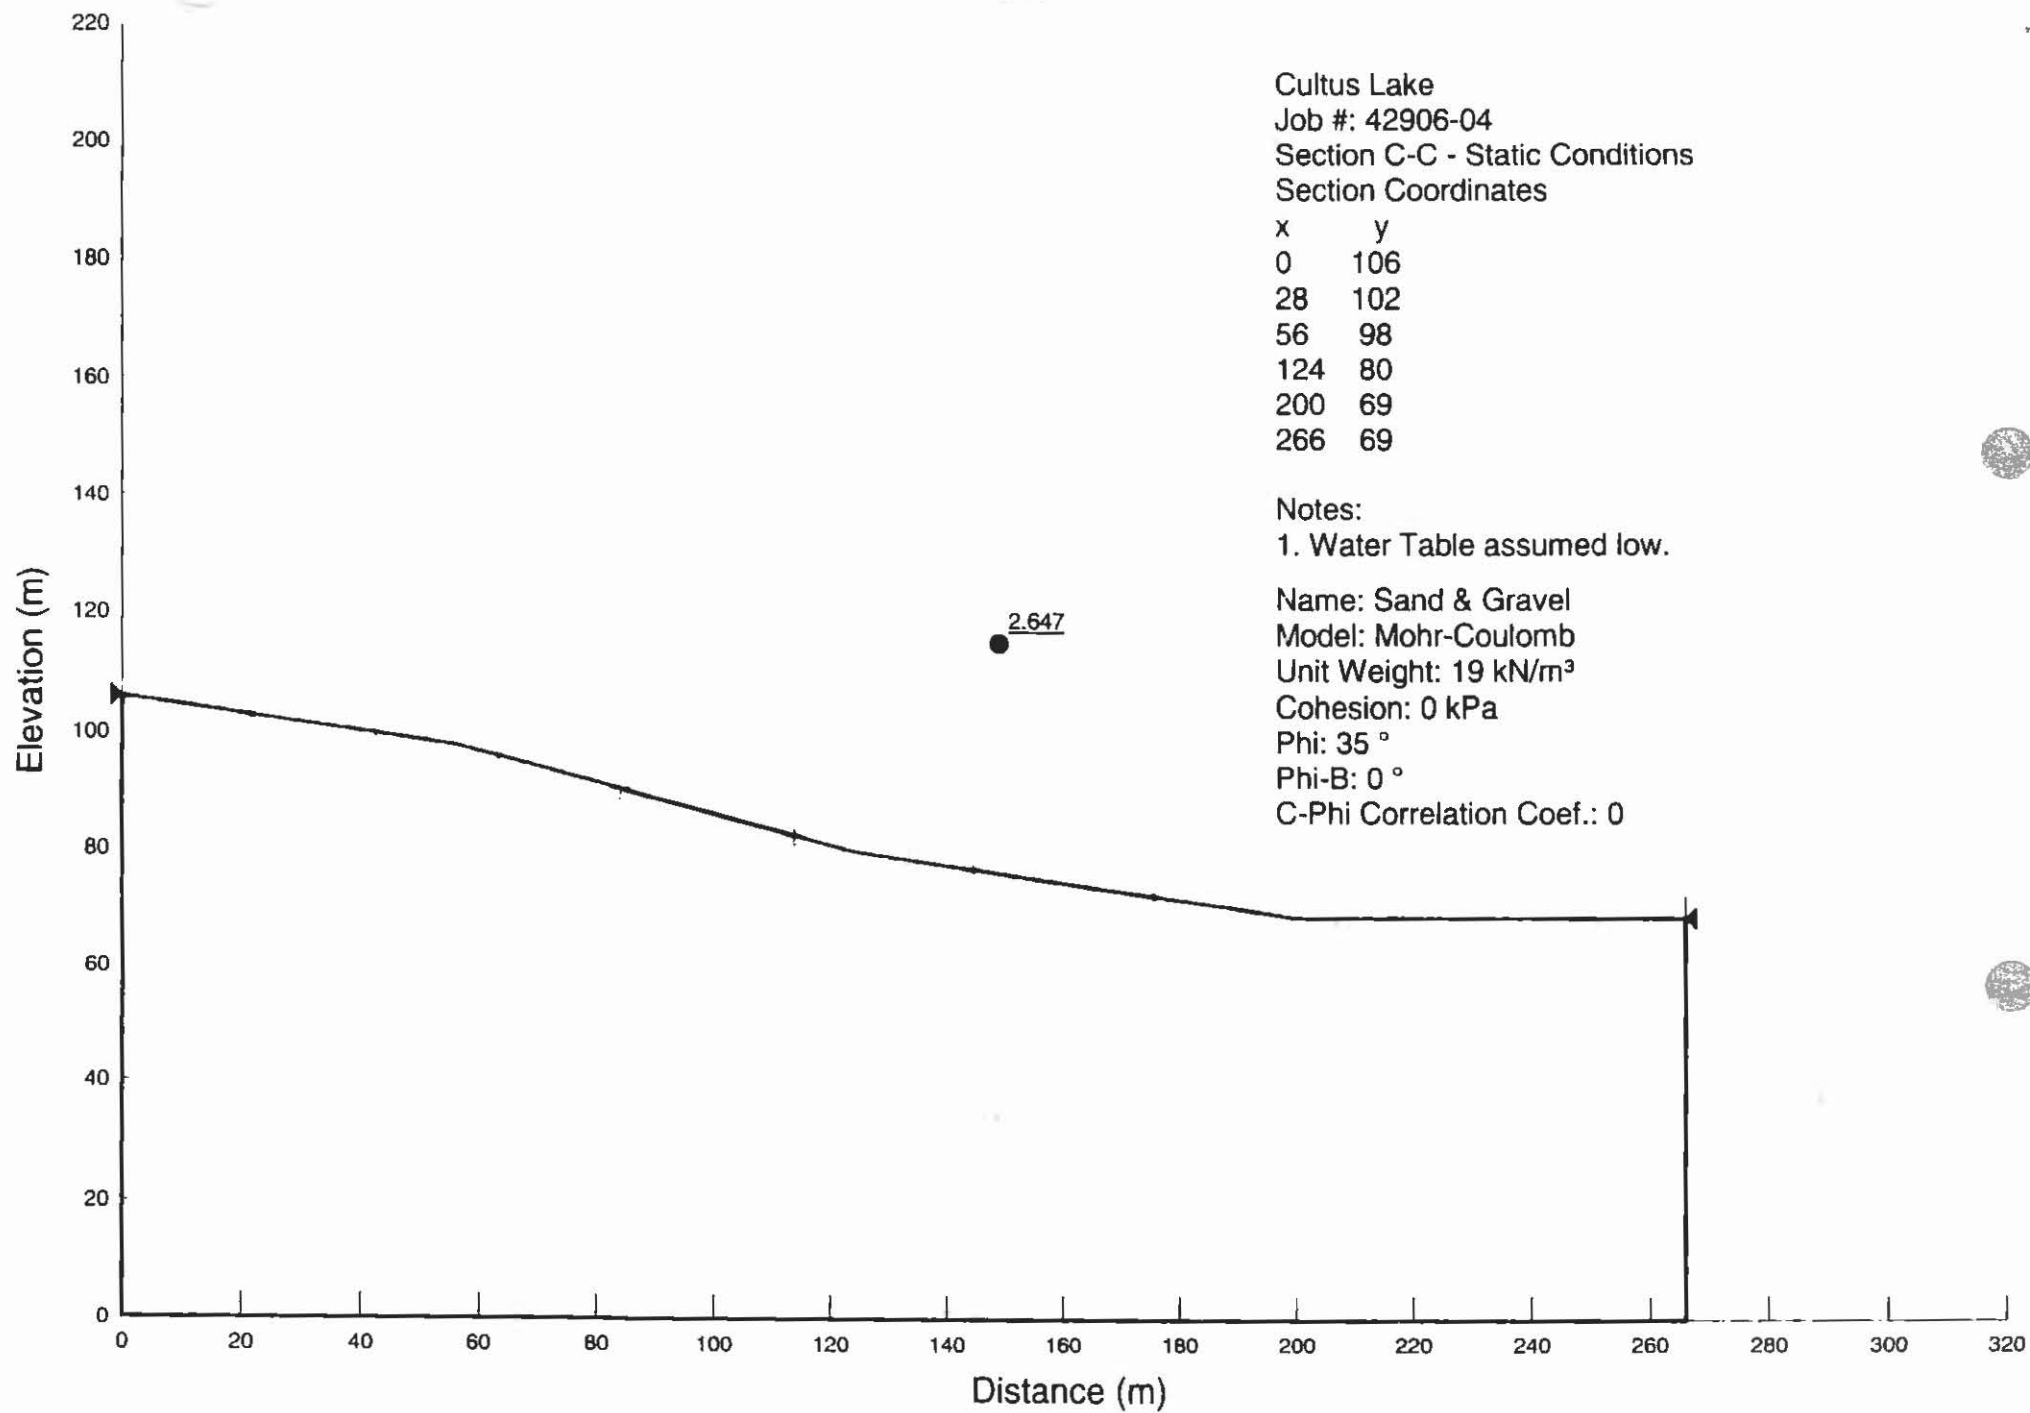
Cultus Lake
Job #: 42906-04
Section C-C - Seismic Conditions
Section Coordinates

1. Water Table assumed low.
2. Seismic Load Coefficient:
Horizontal: 0.21
Vertical: 0.00

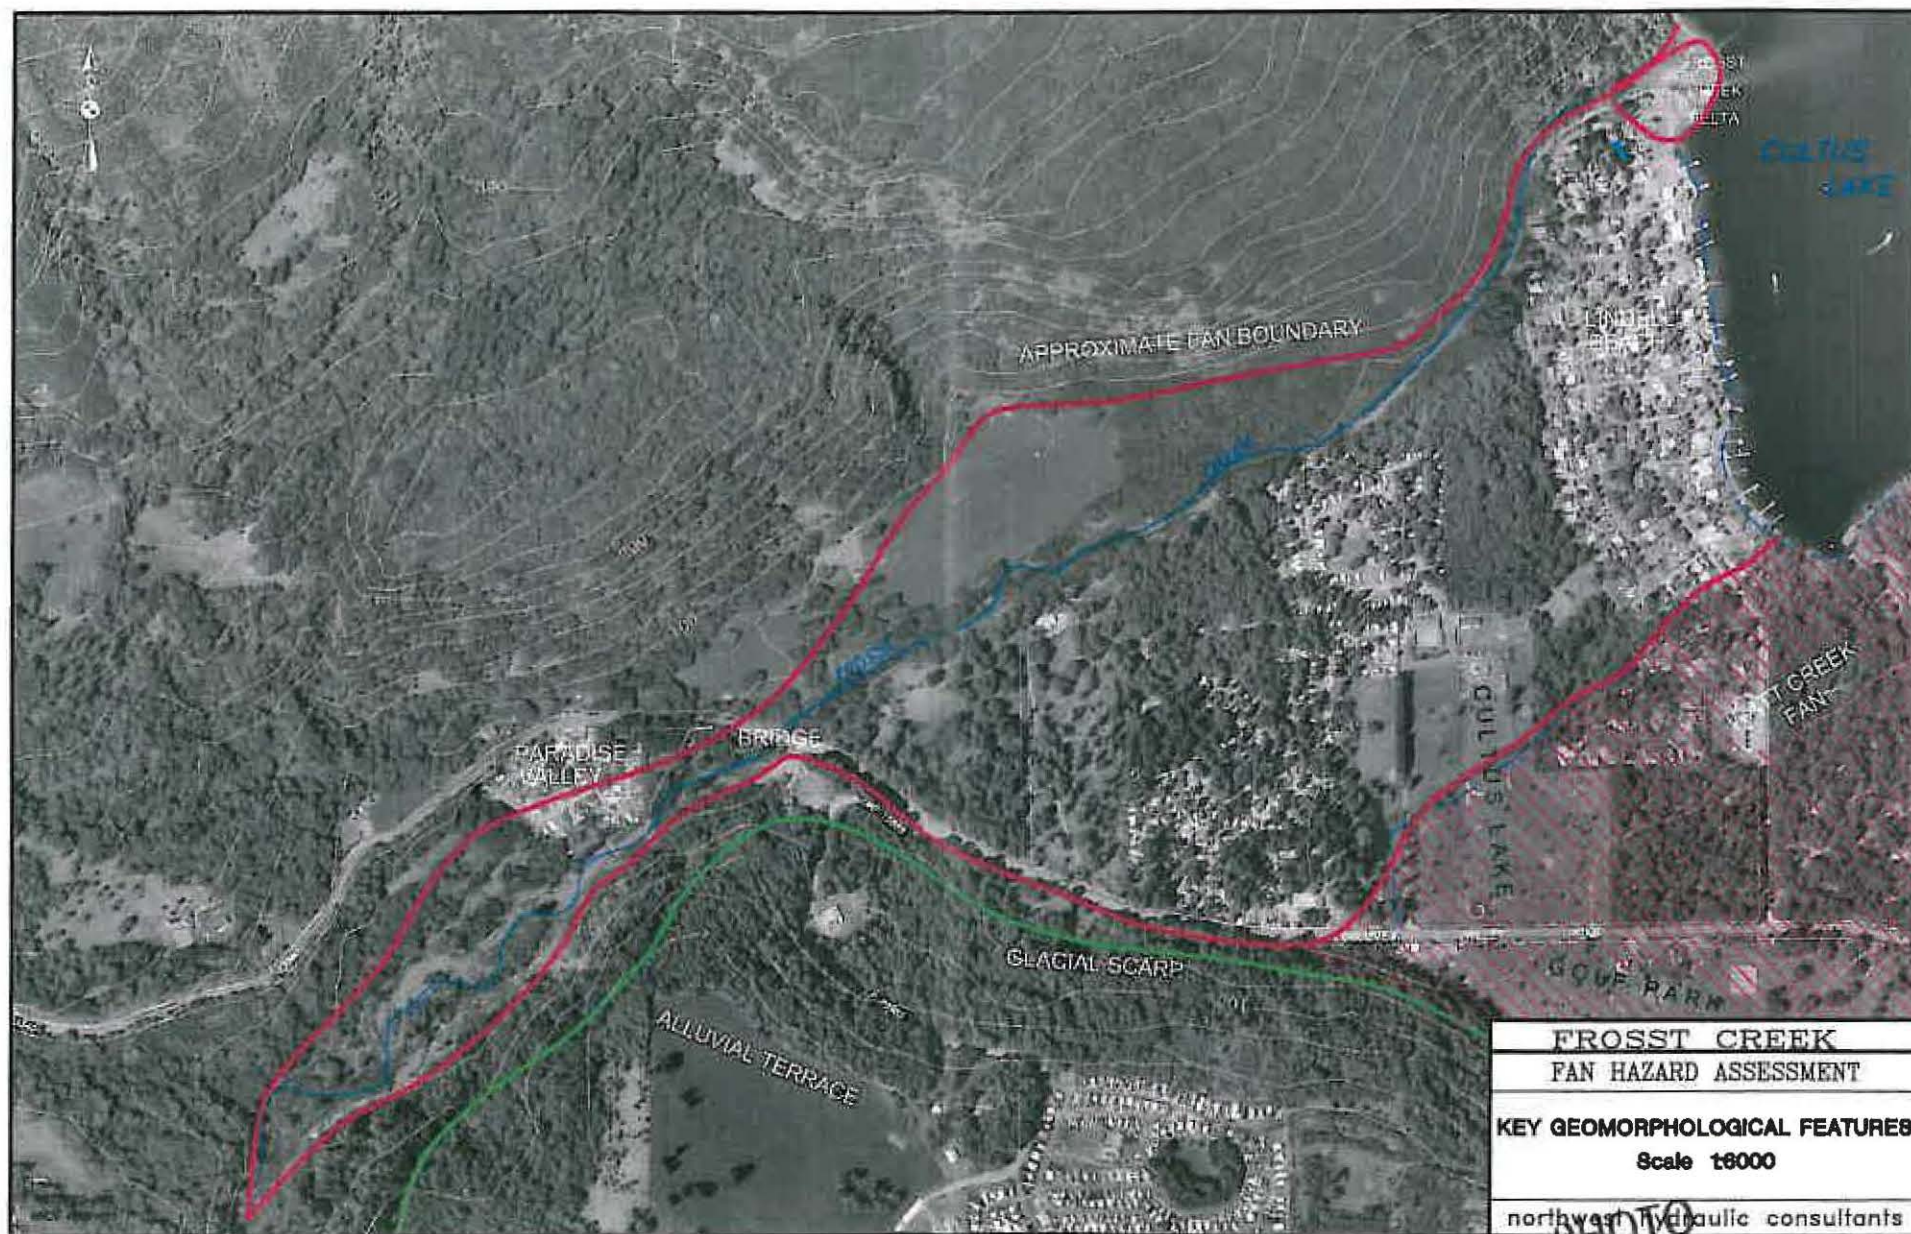
FIGURE 1

FROSST CREEK
FAN HAZARD ASSESSMENT
KEY GEOMORPHOLOGICAL FEATURES
Scale 1:6000
northwest hydraulic consultants

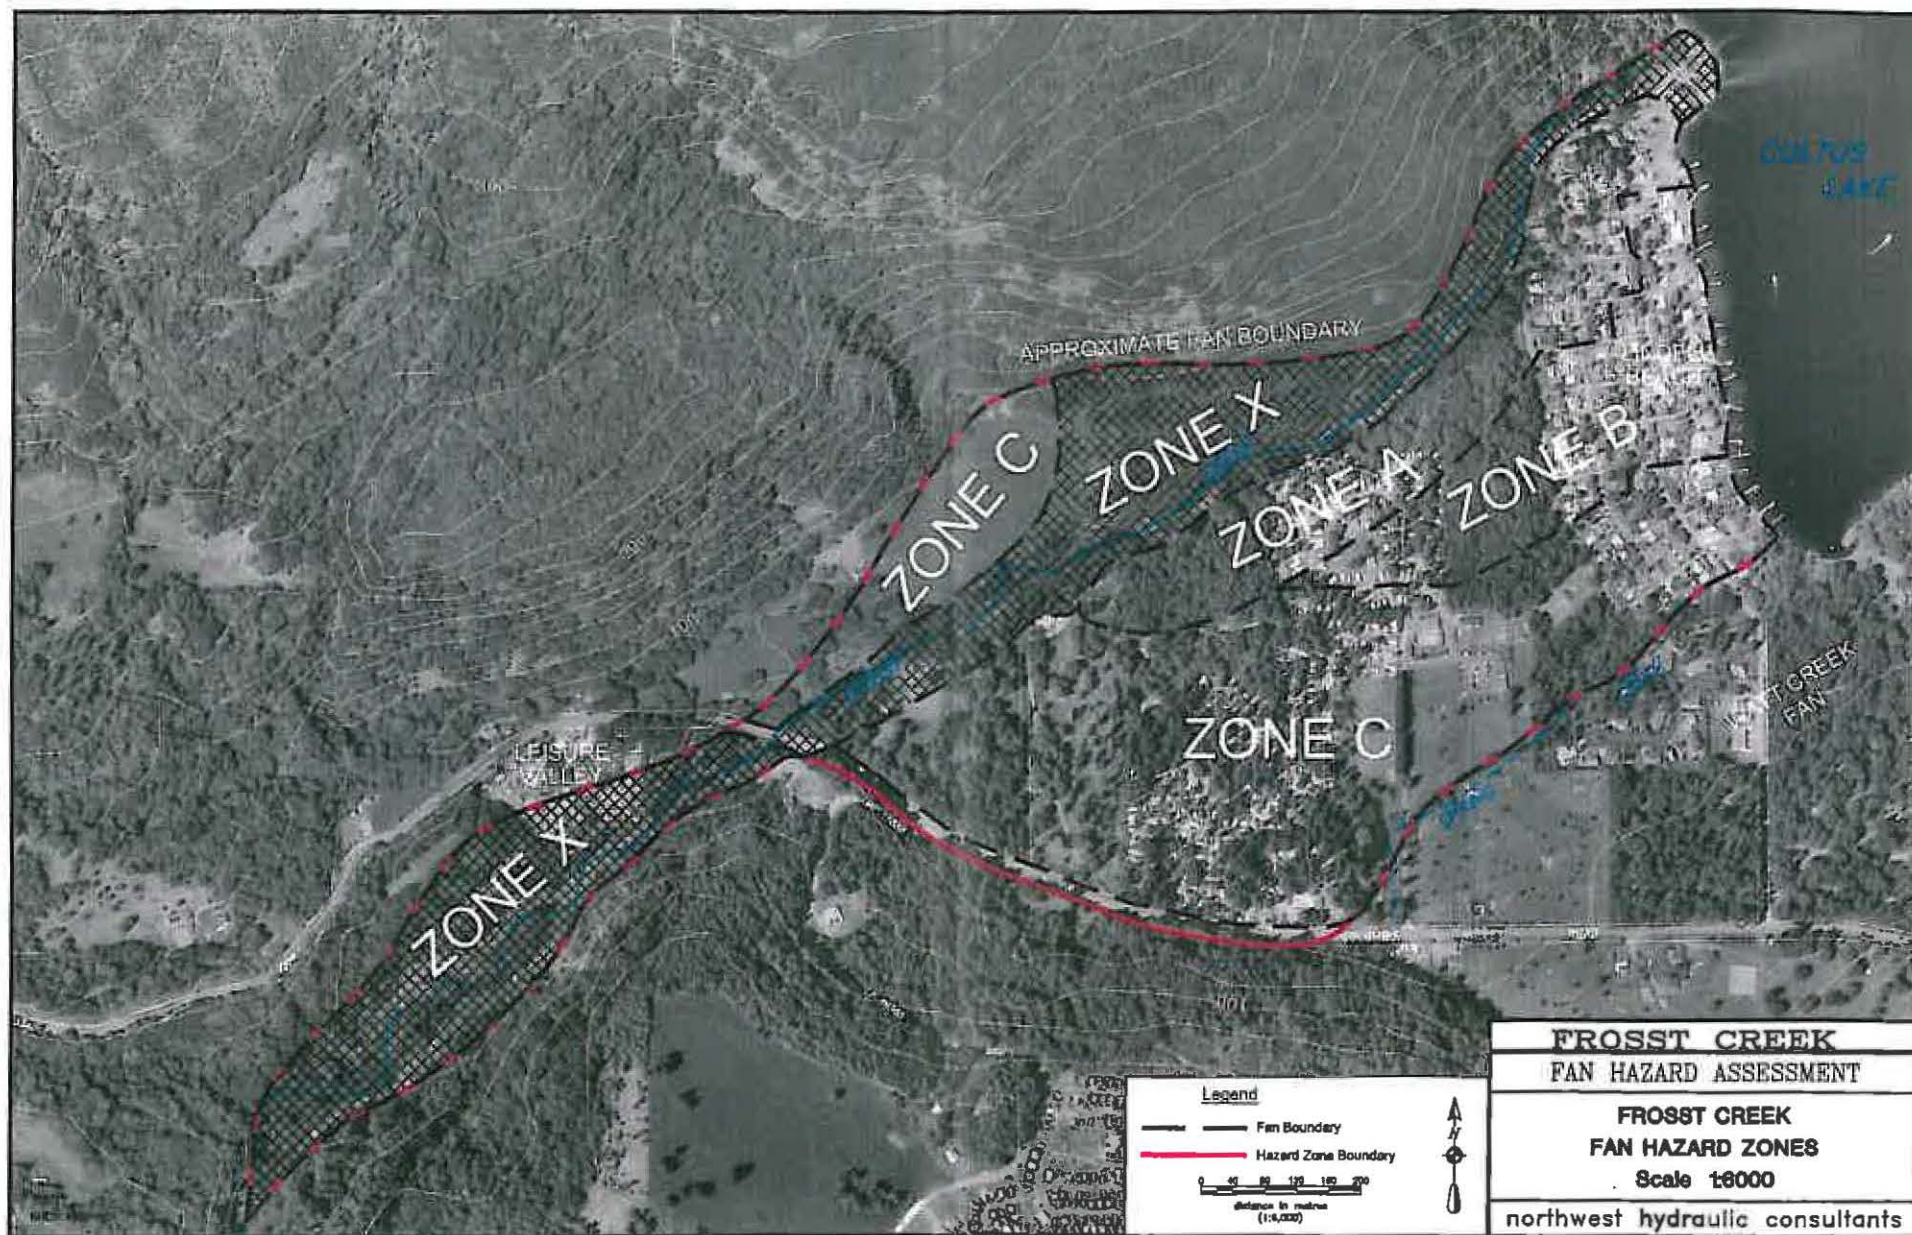
FIGURE 3

Relative hazard zones are delineated in Figure 3 and summarised in Table 4. Vertical construction elevations have been established based on a potential breach in the existing dike or in spilling of flow, debris, and sediment from the existing channel. An acceptable freeboard has been added to the calculated heights to account for expected large amounts of sediment and woody debris that would be discharged during the design flood event. Conceptual on-site floodproofing designs are provided, but based on the wide range of risk factors, site-specific assessment and design is recommended for the area.
