FVRD Electoral Areas A and B Geohazard Mapping Project

Prepared by BGC Engineering Inc. for:

June 18, 2025

Project 0409009

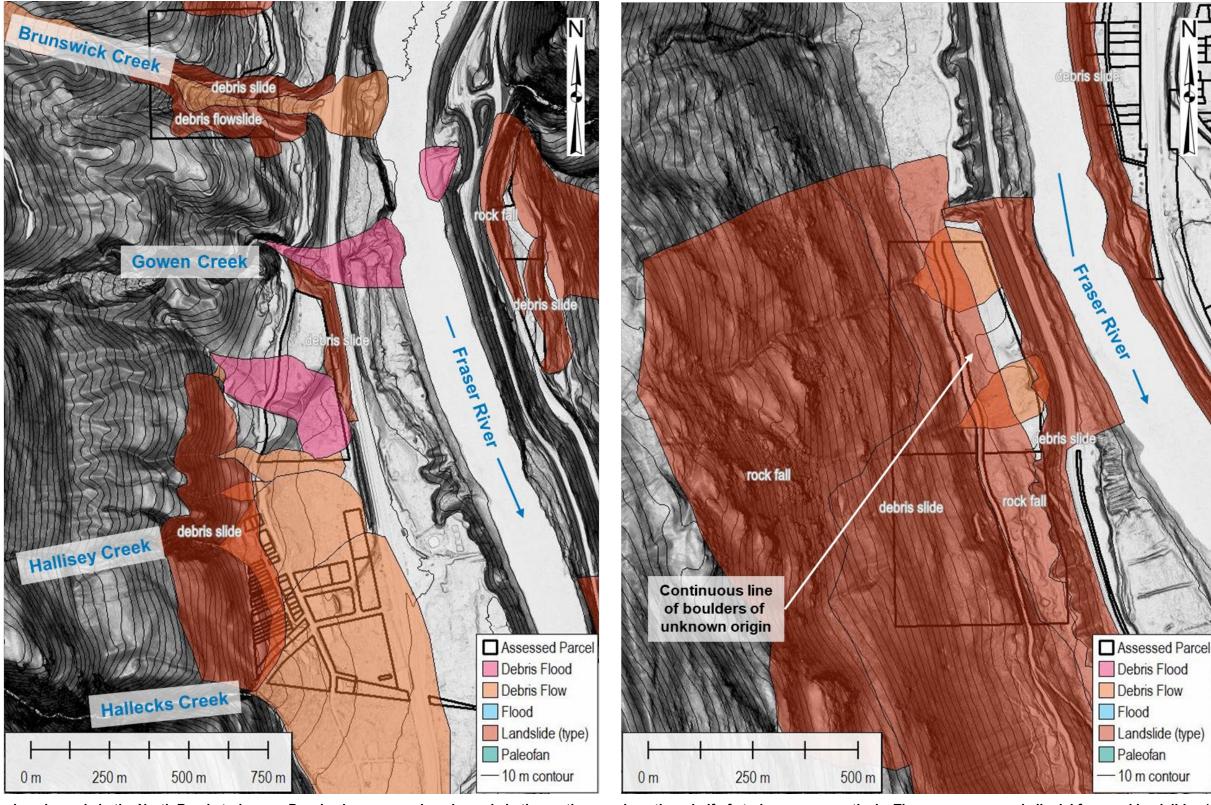
BGC observed evidence of debris-slide and rockfall activity along the steeper slopes in the southern half of North Bend (shown on right panel of Figure 4-2). BGC noted the presence of a continuous line of bouldery deposits within parcels in the southern half of North Bend (e.g., Photo D-6). The origin of these boulder deposits could not be deduced based on the field data; they could represent rockfall deposits at the base of the slope upslope of Green Ranch Road, or they could be deposits of a kame terrace deposited along the margin of the glacier that once occupied the Fraser Canyon. Due to the uncertainty of the origin of this feature, BGC has conservatively mapped this as a rockfall deposit. Further work at this site would be necessary to confirm the origin of this landform.

Figure 4-2 Mapped geohazards in the North Bend study area. Panels show mapped geohazards in the northern and southern half of study area, respectively. There are unmapped alluvial fans and landslides (outside of property boundaries provided by FVRD) within both images. Lidar from FHIMP (Government of Canada, n.d.) and dated Fall 2023 with 10-meter contours shown.

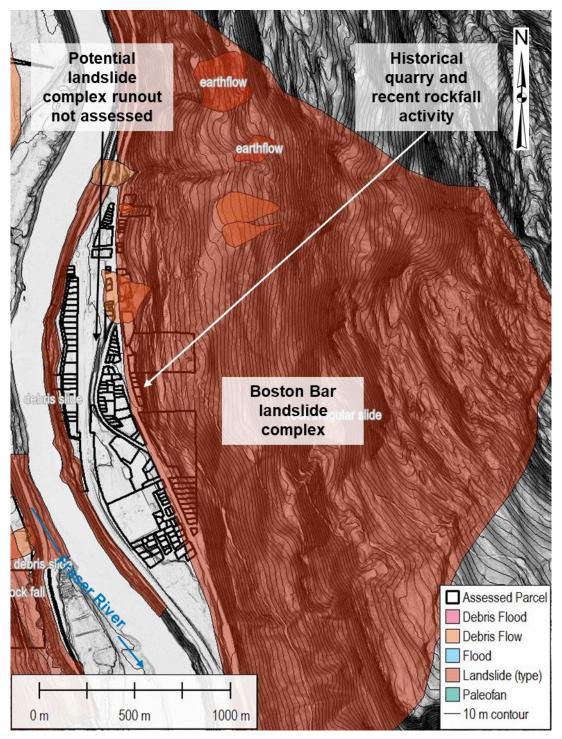
Based on the newly available lidar data, BGC interpreted that the mountainside above Boston Bar is a large (approximately 3 km wide) landslide complex of unknown age or current activity state (BGC, September 10, 2024). The landslide complex morphology indicates that there are potential rockfall, rock-slide, and earth-flow geohazards within this complex. During field work, BGC observed that the landslide complex is comprised of interbedded slaty metamorphic (argillite) and more competent metamorphosed volcanic rock. Based on the preliminary interpretation of the geomorphology of this site, BGC considers this to be a potentially "catastrophic" landslide⁸ for FVRD planning policies. The polygon is classified with a "rockslide" geohazard process, which is the most conservative geohazard type for the observed geomorphologies.

Figure 4-3 Mapped geohazards in the Boston Bar study area. Lidar from FHIMP (Government of Canada, n.d.) and dated Fall 2023 with 10-meter contours shown.

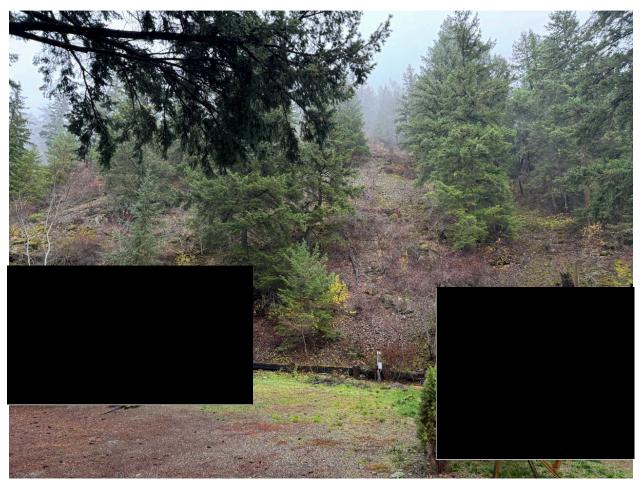
Photo D-1 Looking east at a Canyon Alpine parcel and the hillslope above the mobile homes. This area was mapped with rockfall and debris slides. Photo taken by BGC on November 13, 2024.

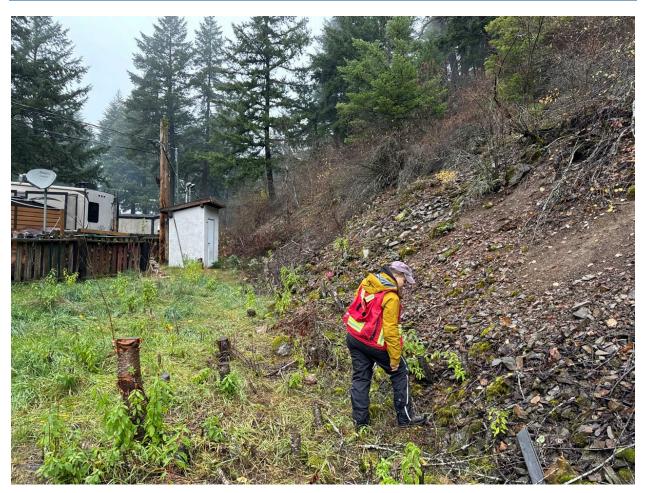
Photo D-2 Looking north along the hillslope above the mobile homes at a parcel in Canyon Alpine. This area was mapped with rockfall and debris slides. Photo taken by BGC on November 13, 2024.

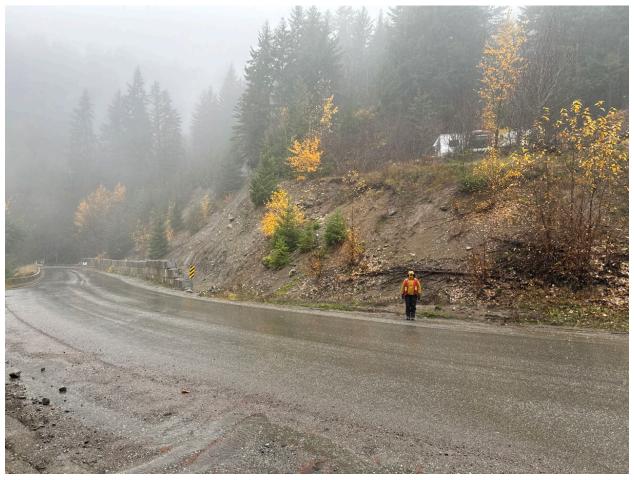
Photo D-3 Example debris slide hazard in North Bend. Photo taken by BGC on November 13, 2024.

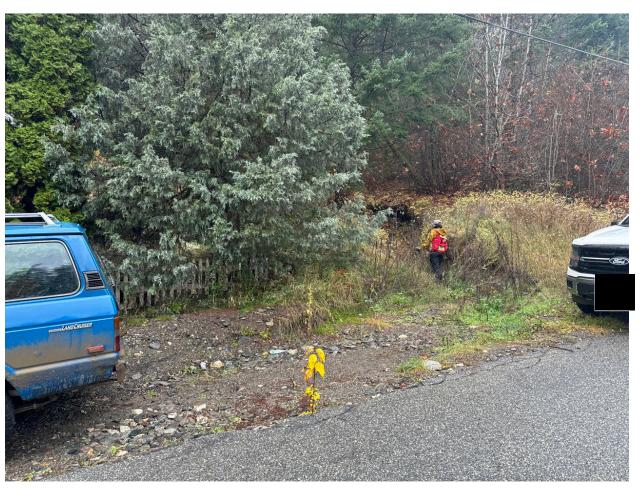
Photo D-4 Looking west at a debris flood avulsion channel in North Bend along Hallisey Creek that was active during the November 2021 atmospheric river. Photo taken by BGC on November 13, 2024.

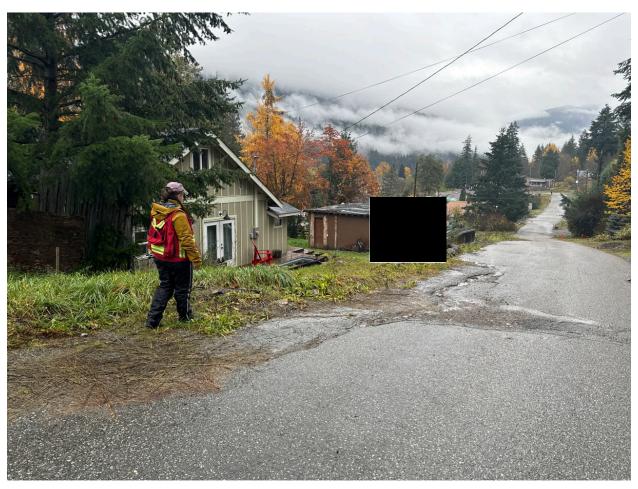
Photo D-5 Looking southeast along N Bend Crescent road in North Bend. Note the sand bags along the road that were presumably placed during the November 2021 atmospheric river. Photo taken by BGC on November 13, 2024.

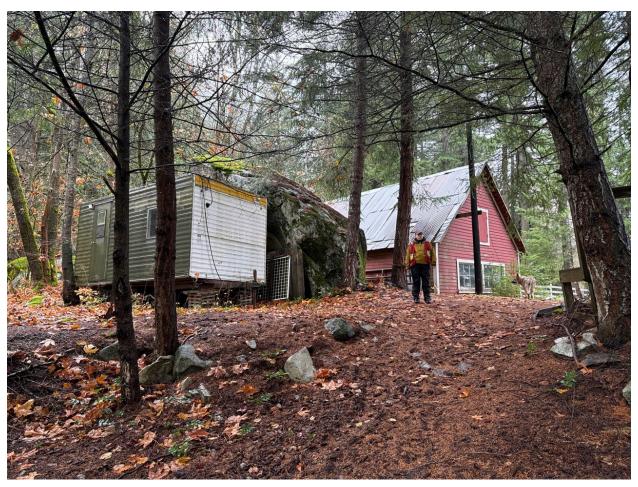
Photo D-6 Looking north at a trailer-sized boulder within a parcel along Green Ranch Road at North Bend. The origin of this and other boulders in the area could not be deduced based on the field data; they could represent rockfall deposits at the base of the slope upslope of Green Ranch Road, or they could be deposits of a kame terrace deposited along the margin of the glacier that once occupied the Fraser Canyon. Photo taken by BGC on November 13, 2024.

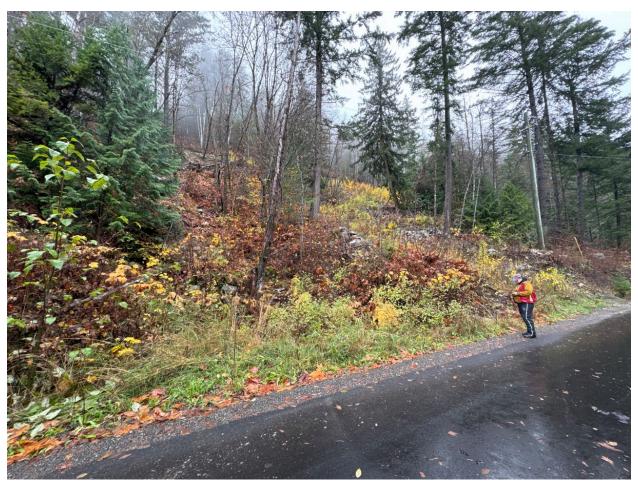
Photo D-7 Looking northwest at a debris slide area along Green Ranch Road in North Bend. Photo taken by BGC on November 13, 2024.

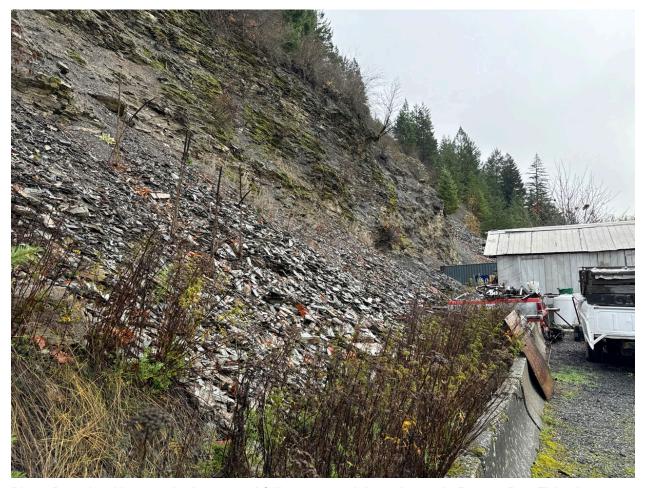
During field verification in Boston Bar and in support of understanding the large landslide complex, BGC observed active rockfall areas above several parcels that included temporary housing measures, such as a mobile home/RV park (47750 Poplar Road; PIDs 009-536-221, 009-536-264, 009-536-281, 009-501-819, 009-501-843). Based on previous reports, these parcels appear to be within an inactivate quarry. Within this quarry area, previous reports reference a debris slide or rock slide that destroyed a trailer home (Thurber, January 4, 1990), as well as a potential unreported landslide (Thurber, October 25, 1990). Photos D-8 and D-9 show rockfall observations at these parcels.

Photo D-8 Looking south along a rockfall source and deposit area in Boston Bar. This site was a historical quarry location. Photo taken by BGC on November 13, 2024.

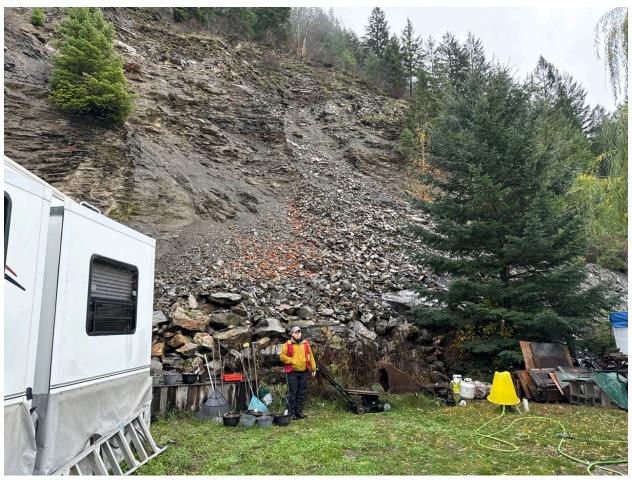
Photo D-9 Looking east at a rockfall source and deposit area in Boston Bar. This site was a historical quarry location. Photo taken by BGC on November 13, 2024.

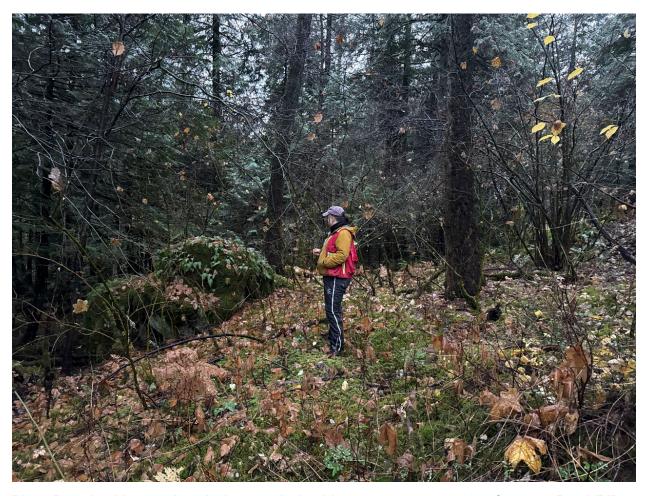
Photo D-10. Looking south at the hummocky boulders on a terrace at 38230 Spuzzum Road (PID 004-854-098). Photo taken by BGC On November 13, 2024.

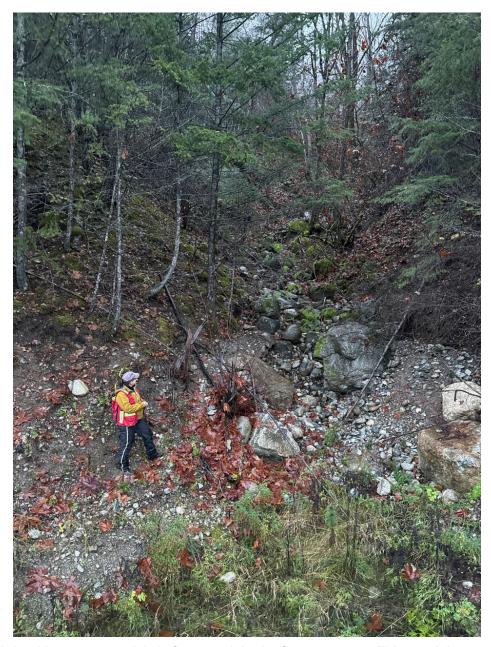
Photo D-11 Looking west at a debris flow creek in the Spuzzum area. This creek has a recorded event from the November 2021 atmospheric river. Photo taken by BGC on November 13, 2024.

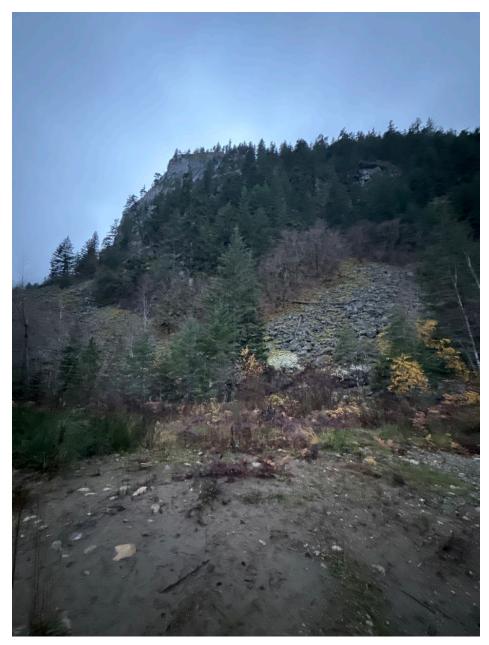
Photo D-12 Looking west at a rockfall source and deposit area south of Spuzzum. Photo taken by BGC on November 13, 2024.

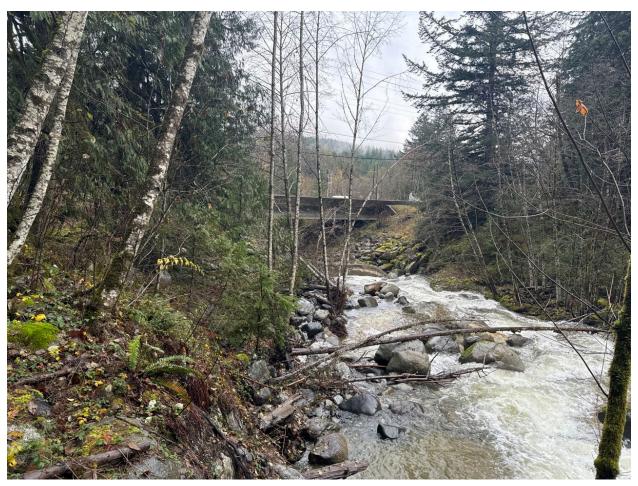
Photo D-13 Looking downstream along the left (north) bank of Gordon Creek upstream of the Highway 1 bridge crossing. Photo taken by BGC on November 14, 2024.

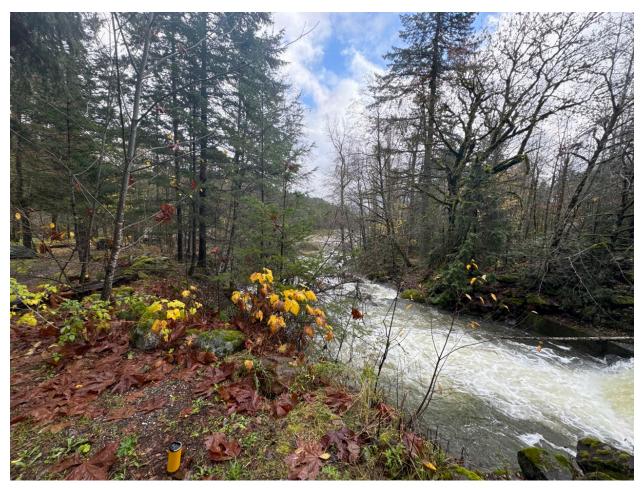
Photo D-14 Looking downstream along the left (north) bank of Gordon Creek below the Highway 1 crossing. Photo taken by BGC on November 14, 2024.

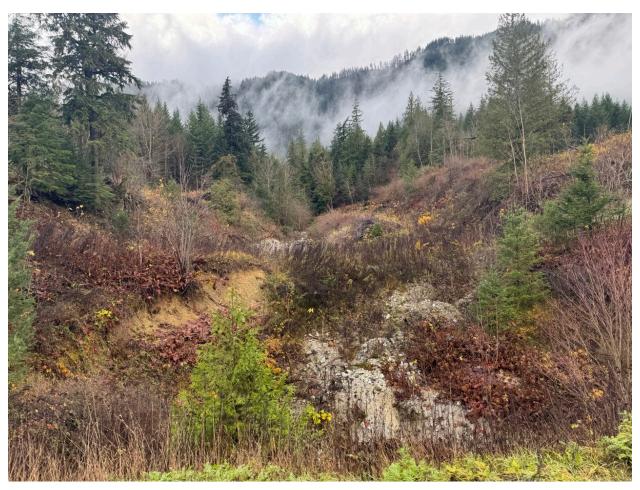
Photo D-15 Looking west and upstream at a debris flow channel north of Dogwood Valley that was active during the November 2021 atmospheric river. Photo taken by BGC on November 14, 2024.

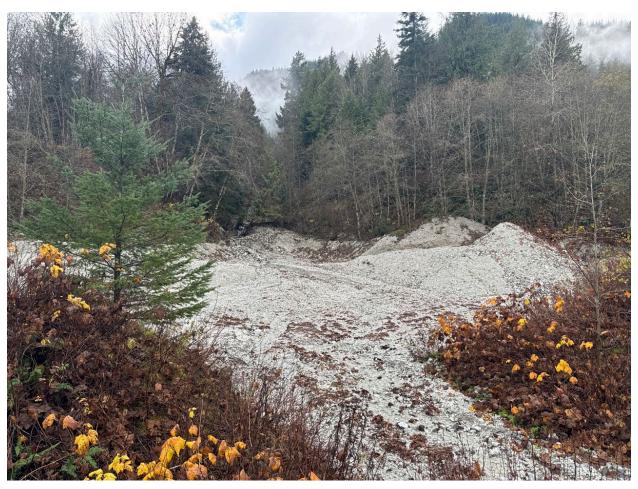
Photo D-16 Looking west and upstream at a debris flow channel north of Dogwood Valley that was active during the November 2021 atmospheric river. The deposits may have been previously cleared by an excavator. Photo taken by BGC on November 14, 2024.

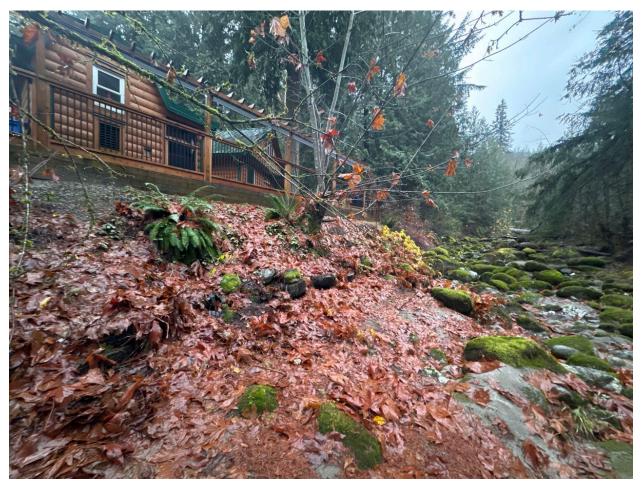
Photo D-17 Looking upstream along a side channel along the right (south) bank of Emory Creek. BGC observed tires that were embedded along the bank that may be providing bank armouring. Photo taken by BGC on November 14, 2024.

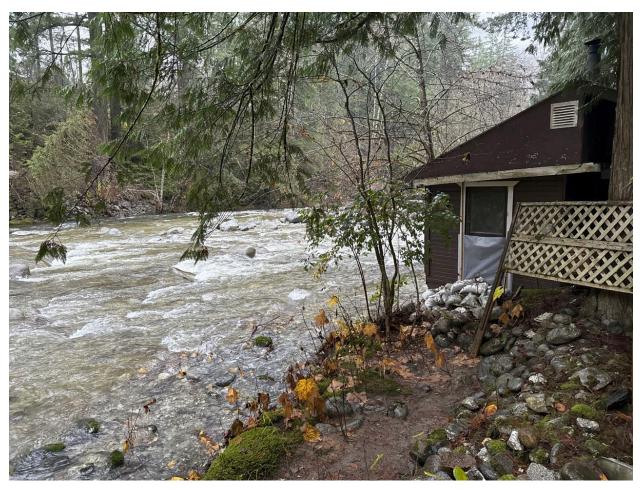
Photo D-18 Looking downstream along the right (south) bank of Emory Creek at a cabin along the active stream channel. Note the sandbags placed along the corner of the house. Photo taken by BGC on November 14, 2024.

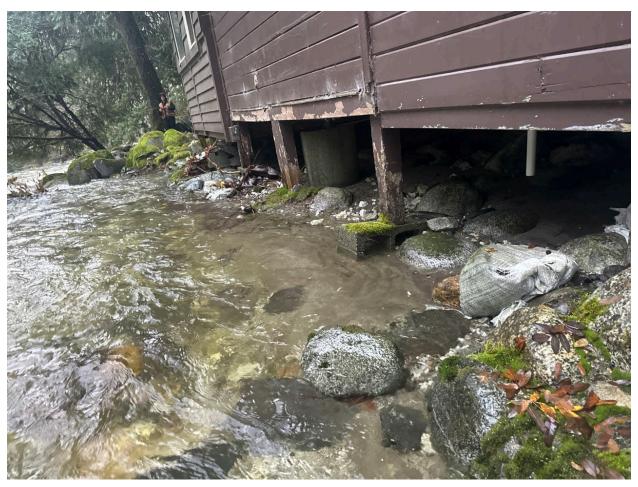
Photo D-19 Looking downstream along the right (south) bank of Emory Creek. Note the cabin footings within the creek. Photo taken by BGC on November 14, 2024.

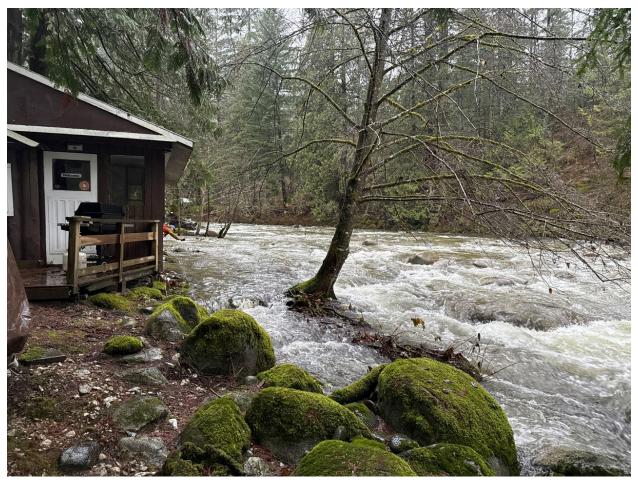
Photo D-20 Looking upstream along the left (south) bank of Emory Creek. Note the cabin along the stream channel. Photo taken by BGC on November 14, 2024.

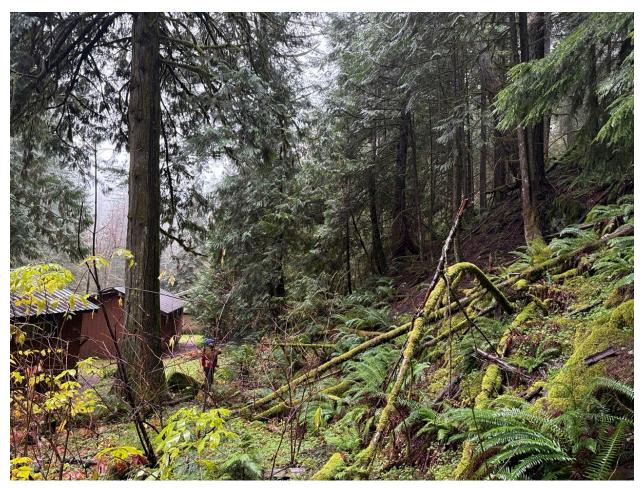
Photo D-23 Looking south along a debris slide and rockfall prone slope at Camp Squeah. Photo taken by BGC on November 14, 2024.

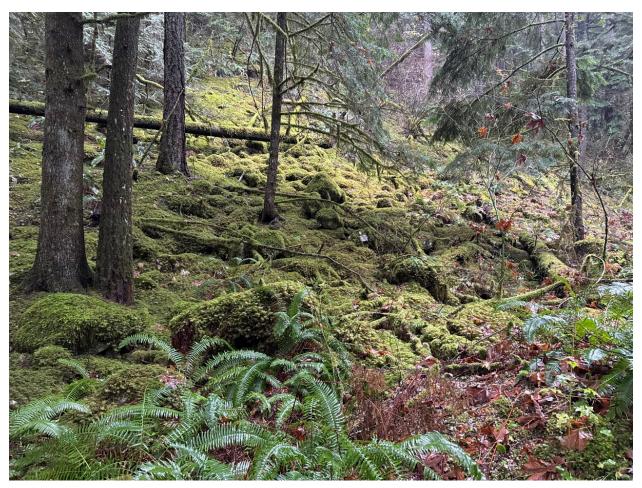
Photo D-24 Looking upslope at a rockfall runout area in Dogwood Valley. Photo taken by BGC on November 14, 2024.

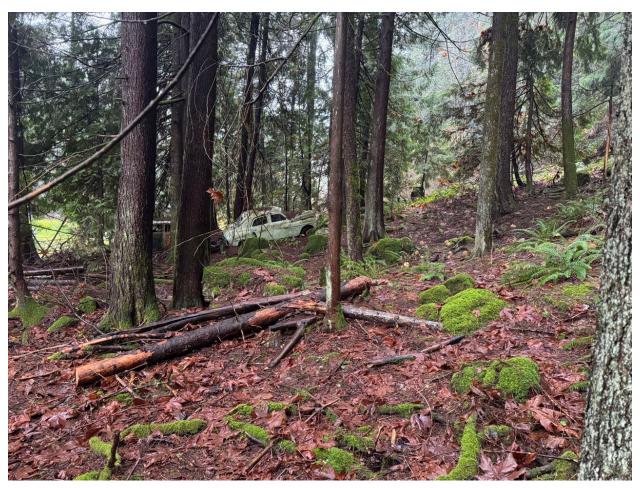
Photo D-25 Looking south along a debris slide/rockfall prone slope in Dogwood Valley. Photo taken by BGC on November 14, 2024.

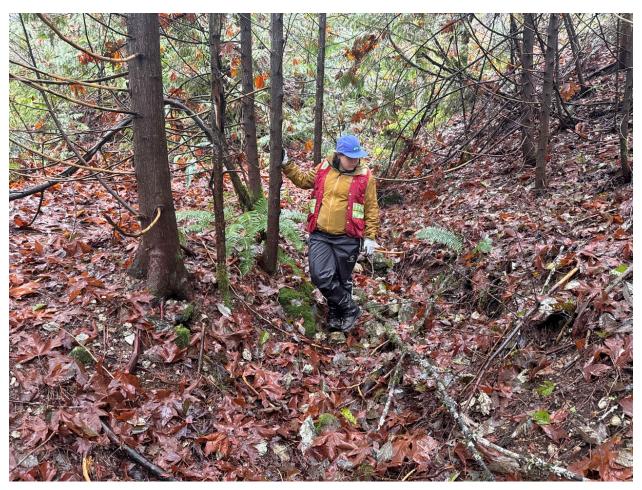
Photo D-26 Looking upstream at a debris flow channel in Dogwood Valley. BGC observed evidence of activity in this creek/fan, possibly form the November 2021 atmospheric rivers. Photo taken by BGC on November 14, 2024.

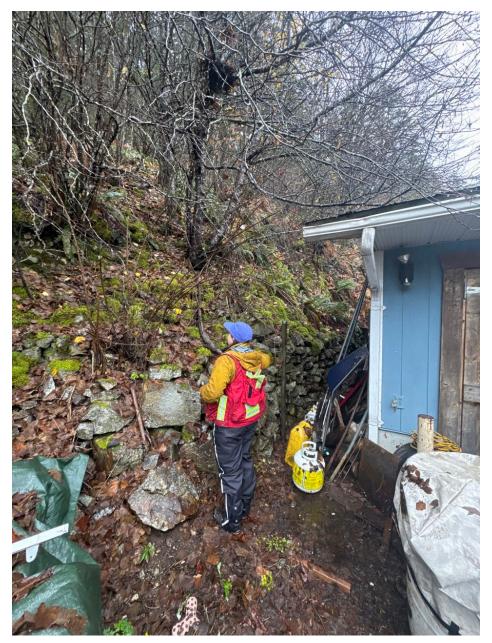
Photo D-27 Looking upslope from a home on Baker Road. Note the house is built into a slope prone to rockfall and debris slides. Photo taken by BGC on November 14, 2024.

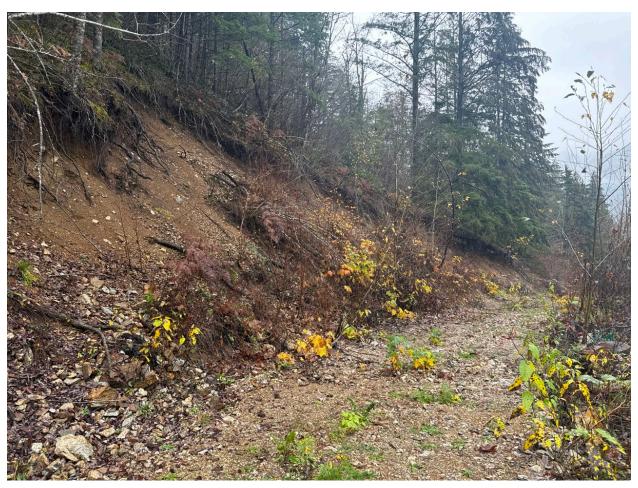
Photo D-28 Looking north at a debris slide along a roadcut and upslope of a home on Baker Road. Photo taken by BGC on November 14, 2024.

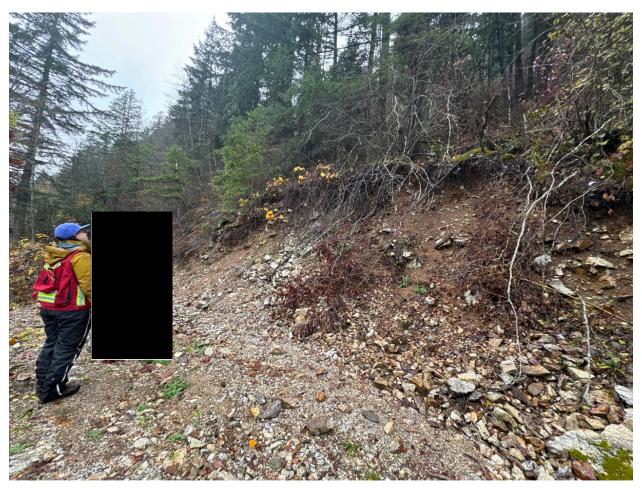
Photo D-29 Looking upslope at a debris slide along a roadcut above a house on Baker Road. Photo taken by BGC on November 14, 2024.

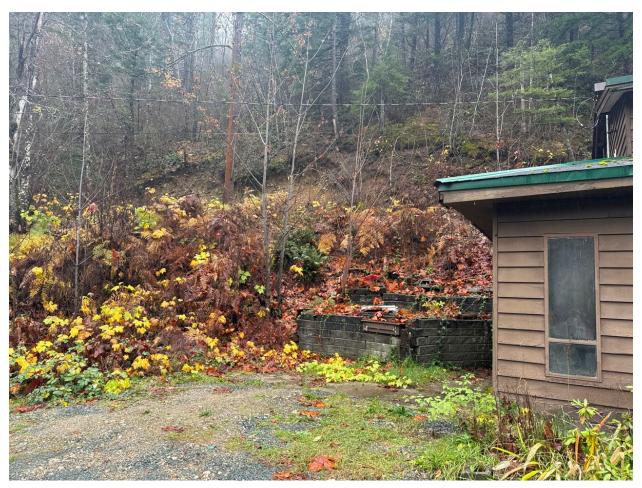
Photo D-30 Looking west at the slope above a home on Baker Road. Note the debris slides along the slope (and above a roadcut). Photo taken by BGC on November 14, 2024.

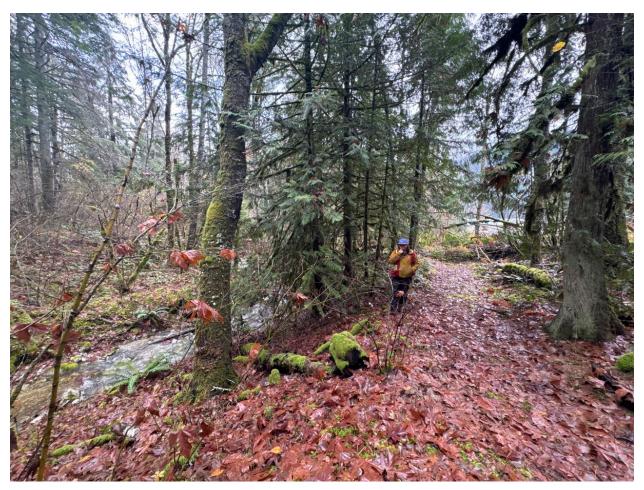
Photo D-33 Looking downstream along an unnamed creek north of Stulkawhits Creek. This creek had a debris flow event during the November 2021 atmospheric river (Hancock & Wlodarczyk, 2025). Photo taken by BGC on November 14, 2024.
