# CORPORATE REPORT

From: David Bennett, Planner II File No: 3060-20-2019-02

**Subject:** Aquadel Crossing Ltd. applied to amend an existing Development Permit (relating to form and character) to permit fencing across common strata property at the development known as Aquadel Crossing, 1885 Columbia Valley Road, Electoral Area "H".

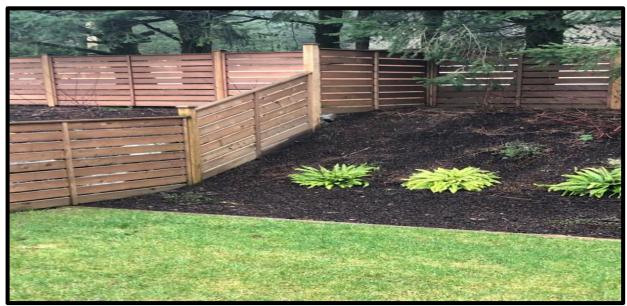
The fences and hedges shown in the images below were installed without FVRD approval and are contrary to the existing Development Permit. The developer is seeking to legalize the cross fencing and hedging by obtaining a new Development Permit from the FVRD. This Development Permit application requires a resolution by the FVRD Board.

The image above shows the design and material of fencing proposed and how the fences would cut across common strata land within the strata subdivision. The bulk mulched area with plantings is common strata property. The individual's strata lot ends where the grass ends. This common strata property acts as a buffer from neighbouring developments and it is a requirement of the zoning bylaw.

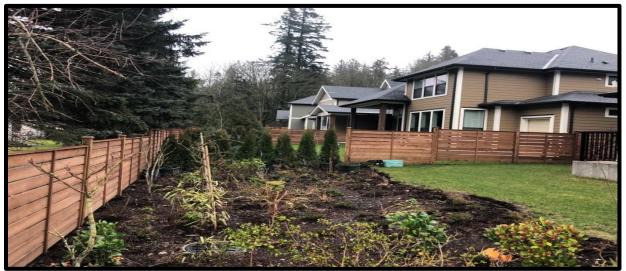
In other areas, the developer is proposing to install dense cedar hedging across the common strata areas as shown above. The bulk mulched area with plantings is common strata property and it forms the buffer between the Aquadel development and adjacent lands. The individual's strata lot ends where the grass ends.

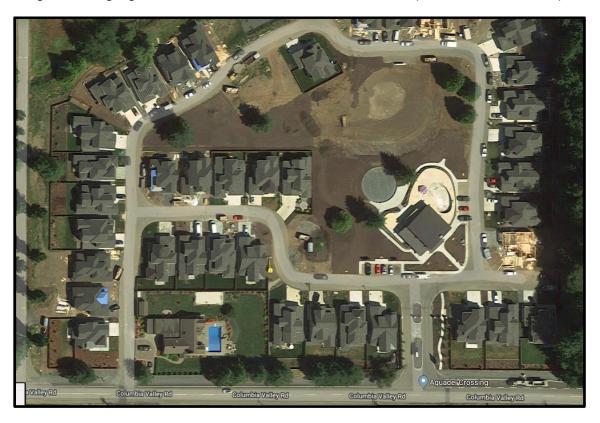
The image above is taken from Google Maps (retrieved April 26 2019) and shows the development progressing through the construction phase.

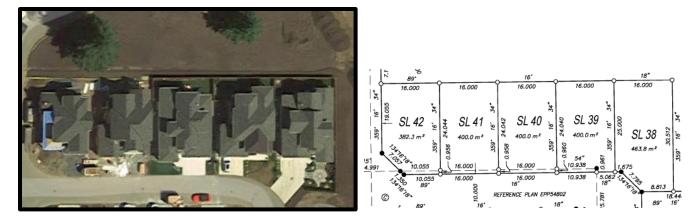
As shown in the Google Earth image above, fences installed around the perimeter of strata lots achieves the separation between individual units in the development. There is no concern with strata lot owners fencing along their own lot lines. Lots #38 to 42 are fenced along the boundary of the strata lots and do not extend the rear yards into the adjacent common strata lands. An extract of the subdivision plan is shown above.

The installation of cross fencing is also not treated the same through the development. The lots that back onto internal strata common property, like lots #38 through 42 shown above, did not construct fences into the common strata property. Only the lots adjacent to the exterior of the development are expanded into common strata property.

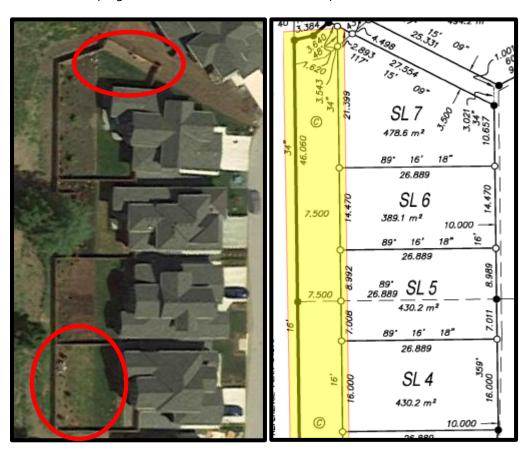
The Google Earth image below shows buffer areas are not being maintained equally. In this image, the strata lot #4 increased the lawn area into the required buffer area. Strata lot #7 has installed fences to the north bumping out into a common strata walkway.

The installation of cross fencing has already shown that the landscaping is not maintained equally throughout this development. The cross fences impede access to the common strata lands which in turn does not allow the strata to inspect and maintain the vegetation. The common strata buffer spaces need to be open in order for the strata to perform inspections to ensure maintenance is undertaken properly. To ensure uniform compliance, the maintenance of the common strata lands should be the responsibility of the strata. The images above show that the common strata buffer spaces are not being maintained the same by all lot owners.

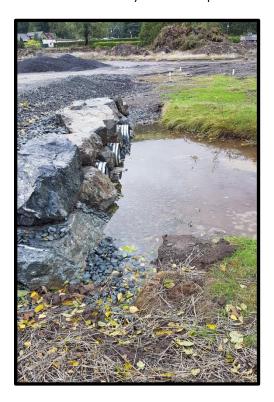
After the rezoning for this development was approved and the initial permits were issued, the project was sold to the current developer. Through the subdivision and construction process phases, the FVRD has been enforcing a number of infractions at Aquadel Crossing, which have shown a blatant disregard to FVRD permits and Provincial requirements, including fencing installed within a watercourse contrary to the FVRD Development Permit requirements and Provincial Environmental authorizations; a residential occupancy without potable water service; and lack of fencing with a filled swimming pool creating a public safety hazard as well, in the summer of 2017, the developer did not install a clear-span bridge as per the conditions of Permit 2017-01, but rather three culverts. The Province determined that the three culverts were not authorized and ordered their removal and ordered an alternative crossing design. A Box Culvert design was then submitted by the developer and accepted by the Province.

The three culverts resulted in the destabilization of the stream channel, loss of flow in Spring Creek and impacted fish passage.

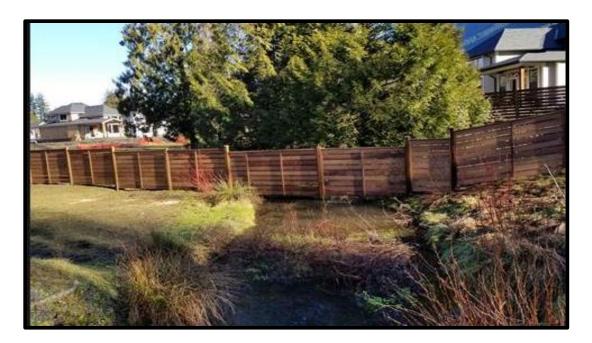
The image above shows the installation of fencing within the Spring Creek Riparian Area (March 2019).

In an email from a registered professional to the FVRD it was determined that..."the construction of the fence in its current location (See Figure 1) is inconsistent with the recommendations and/or requirements of the RAR Detailed Assessment referenced through the Development Permit...new permanent structures are not permitted in the SPEA including fencing. Fencing can be (and has been) installed along the boundary of the SPEA at the interface with the private lots (i.e., parallel to the stream)....the section of fence that crosses the stream as constructed will need to be removed (email dated March 22, 2019).

- 1) Removal of all fencing material installed across the common strata buffer areas.
- 2) Removal of cedars installed to create a hedge line across the common strata buffer areas.
- 3) Removal of the fencing from within the protected Riparian Area and certification of compliance from the registered professional biologist.
- 4) Inspection of the buffer areas by a qualified professional to determine compliance with the original development permit.
- 5) After completion of all phases of the subdivision and confirmation that all of the buffer areas are in compliance with the conditions of the original development permit, security deposits may be returned. There will be no partial refund of security until all phases are completed.
- 6) Individual strata lot owners may install fences around the perimeter of their strata lots, but not on common strata property.
