**Subject: Chilliwack River Erosion Setback Line Update – Slesse Park Area**

## Technical Memorandum

**RE:** **CHILLIWACK RIVER SLESSE PARK**  
**Erosion Setback Line Update**  
**Our File 2080.040-300**

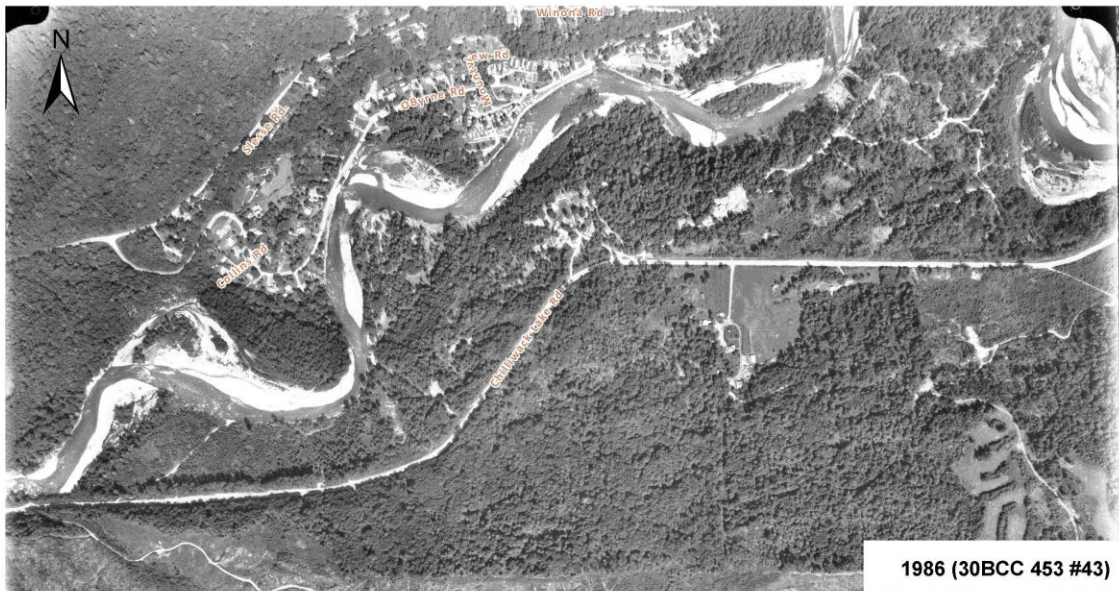
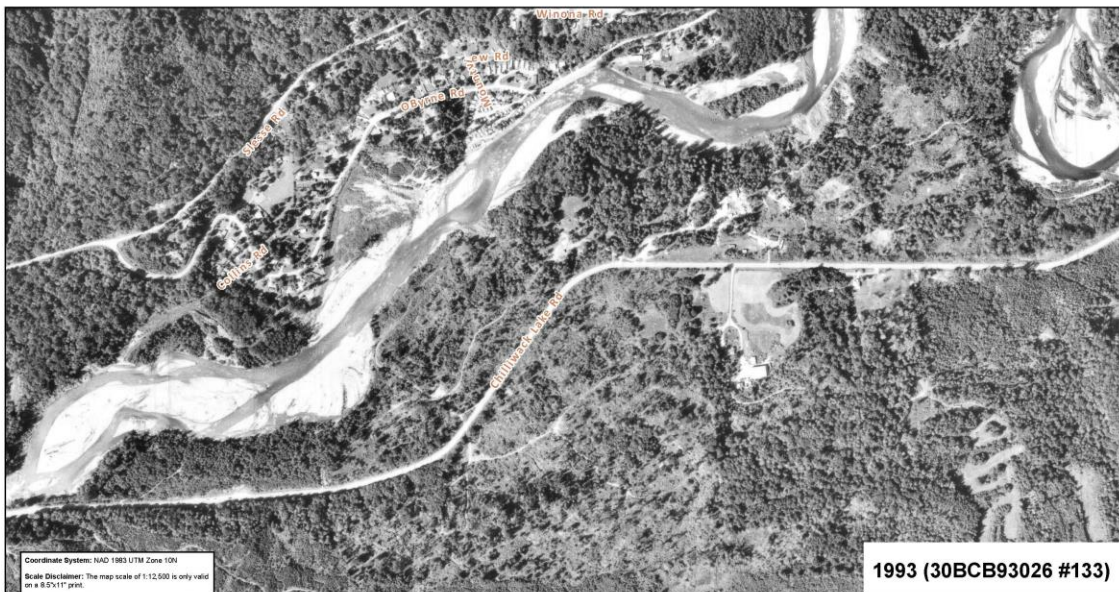
Figure 3 illustrates the dynamic nature of the Chilliwack River and the potential for change within the study reach in a single, large flood event. In addition, the air photo review indicates that there are old

channels in now-vegetated areas that could become activated in a flood (these are also visible in the LiDAR topography).

Slesse Park: 1986 vs 1993  
Georeferenced Air Photos

As indicated in Table 1, the largest morphologic change captured in the historical air photo record occurred in the 1990s: Hay & Co. et al. (1992) indicate that this change occurred during the November 1990 flood. Figure 3 shows a comparison of the Slesse Park reach from before (1986) and after (1993) the November 1990 event. As shown, there was a notable change in alignment (rather than progressive erosion at the outside of existing bends), as part of which two meander bends were cut off, resulting in a much straighter channel alignment.

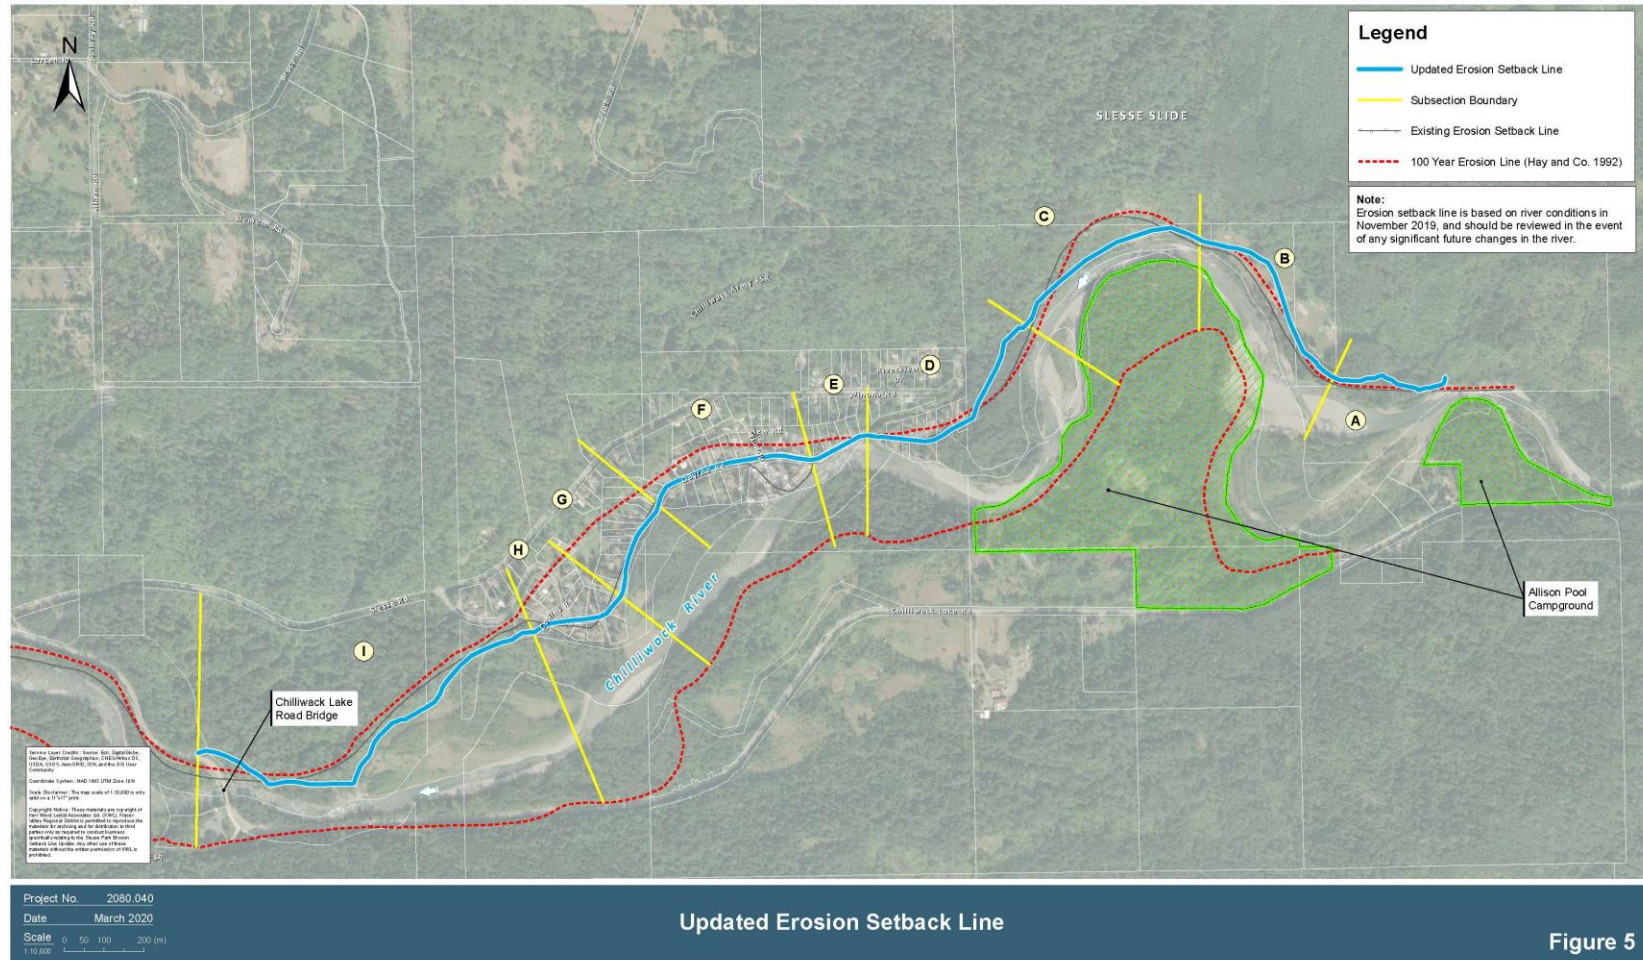
The updated erosion setback line for Slesse Park is presented in Figure 5.

In general, the location of the updated line does not differ greatly from the previous erosion setback line established by Hay & Co et al. (1992). Given the observed ability of Chilliwack River to dramatically change its alignment within a single large flood event, the erosion setback line must necessarily consider the potential for avulsion into older channels (including the reactivation of vegetated floodplain). As noted in Table 2, in a few locations the updated erosion setback line is now on the landside of the 100-year erosion limit line.

Table 2 describes features identified within the study reach that were considered in establishing the updated erosion setback line. Within this table, the study reach has been broken into sub-sections (identified by letters); these breaks and sub-section identifiers are also shown on Figure 5.
