RE: Chehalis FSR Assessment – 0 - 11.5 km

As requested by Mr. David Rogalsky of Graestone Ready Mix Ltd. (GRM), Onsite Engineering Ltd. (OEL) has completed a field review of the Chehalis FSR from its junction with the Morris Valley Road to approximately 11.5 km and the road junction at an existing gravel pit. This report was prepared to provide GRM with a summary of the field review completed on June 2, 2020. Michael Foster, P.Eng representing OEL completed the field assessment. The road was accessed via 4x4 vehicle, and weather conditions were overcast and cool.

1 Chehalis FSR Assessment

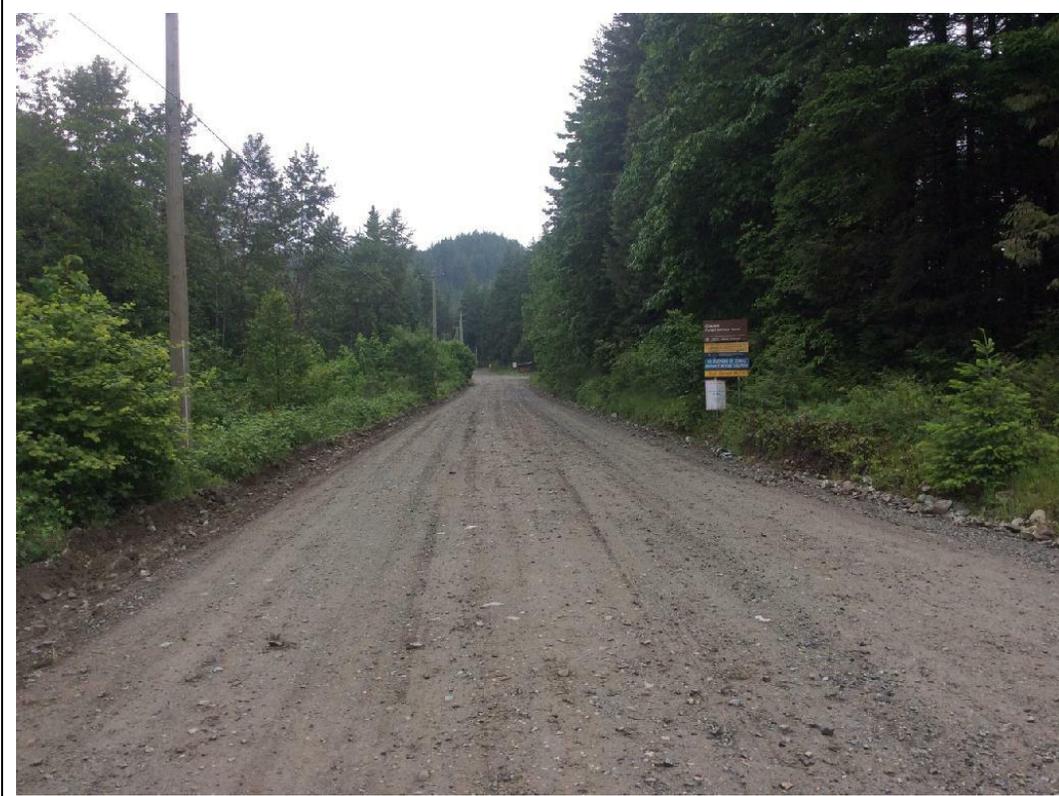
Photo 1
Junction
with Morris
Valley
Road at 4-
Way Stop
Sign

Road Station	Current Conditions	Recommended Work
0 km	Existing junction with Morris Valley Road, start of full two lane road	Recommend to install 60 km/hr speed limit sign (typical FSR speed limit)

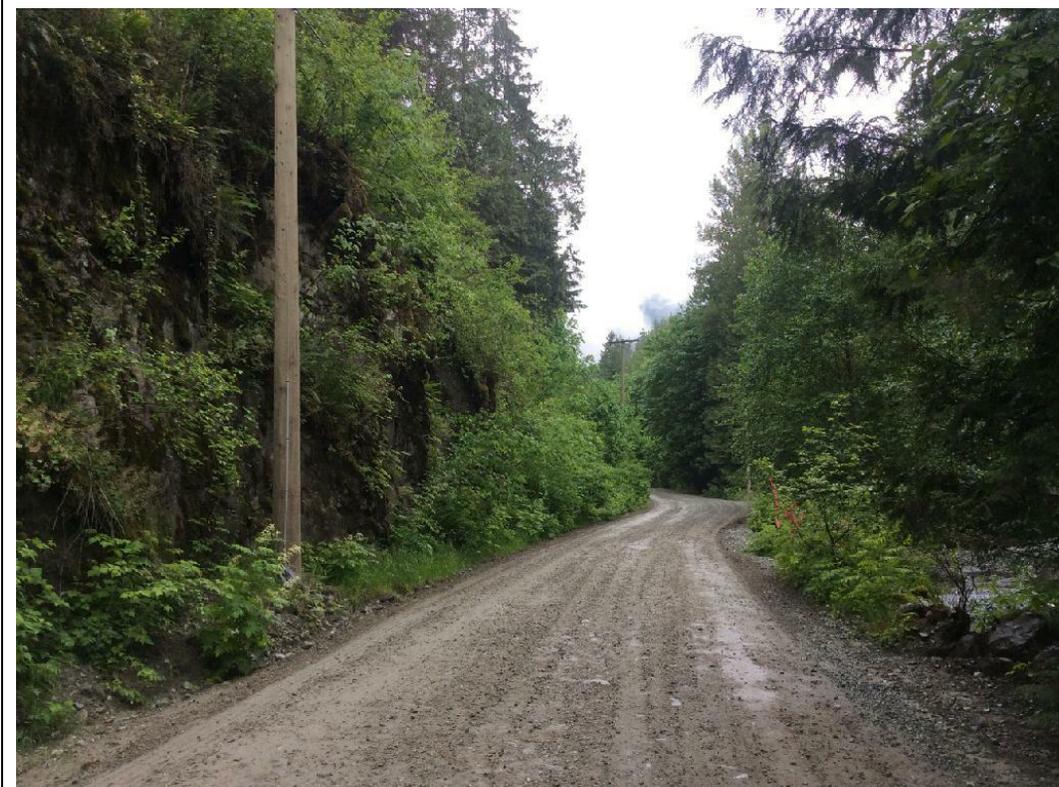
0.6 km	Road narrows to a single lane road due to bedrock on uphill side and stream on downhill side, large existing pullout on the town side available	Brush out sight lines and clean ditches

Photo 2
Narrow
road
section at
0.6 km.

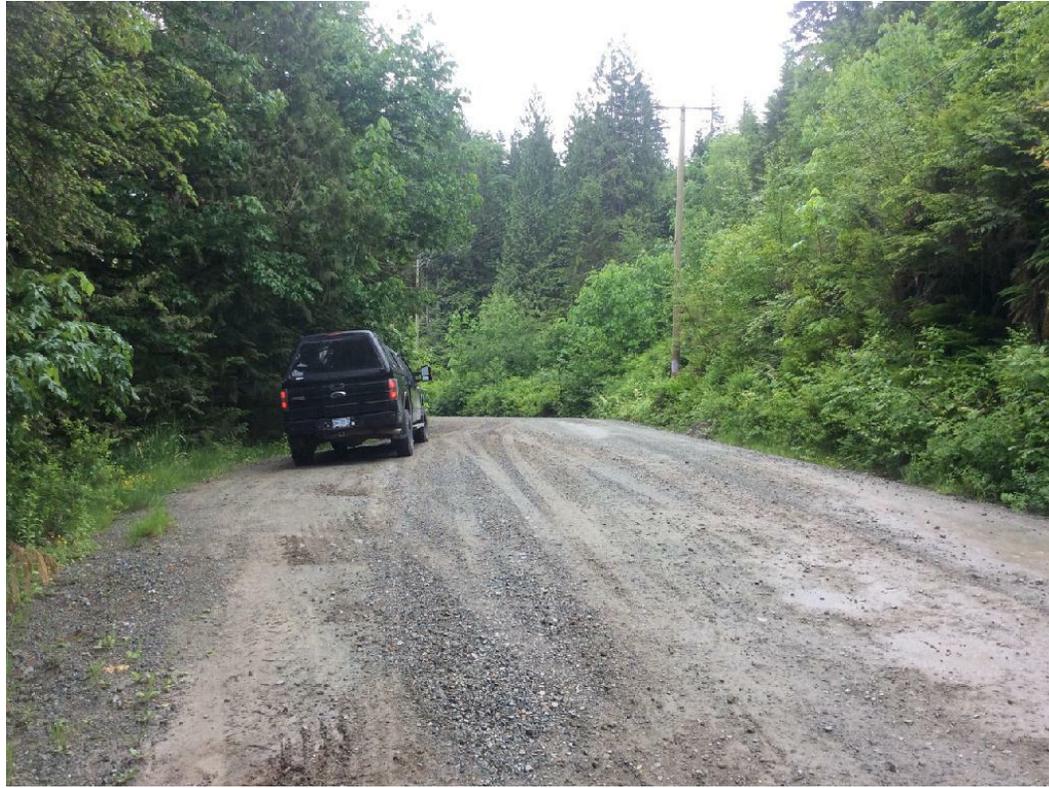
0.8 km	Existing pullout available	Brush out sight lines and clean ditches
1.1 km	Existing pullout available, road is over 10m wide	Brush out sight lines and clean ditches

Photo 3
0.8 km
Chehalis
FSR, typical
pullout

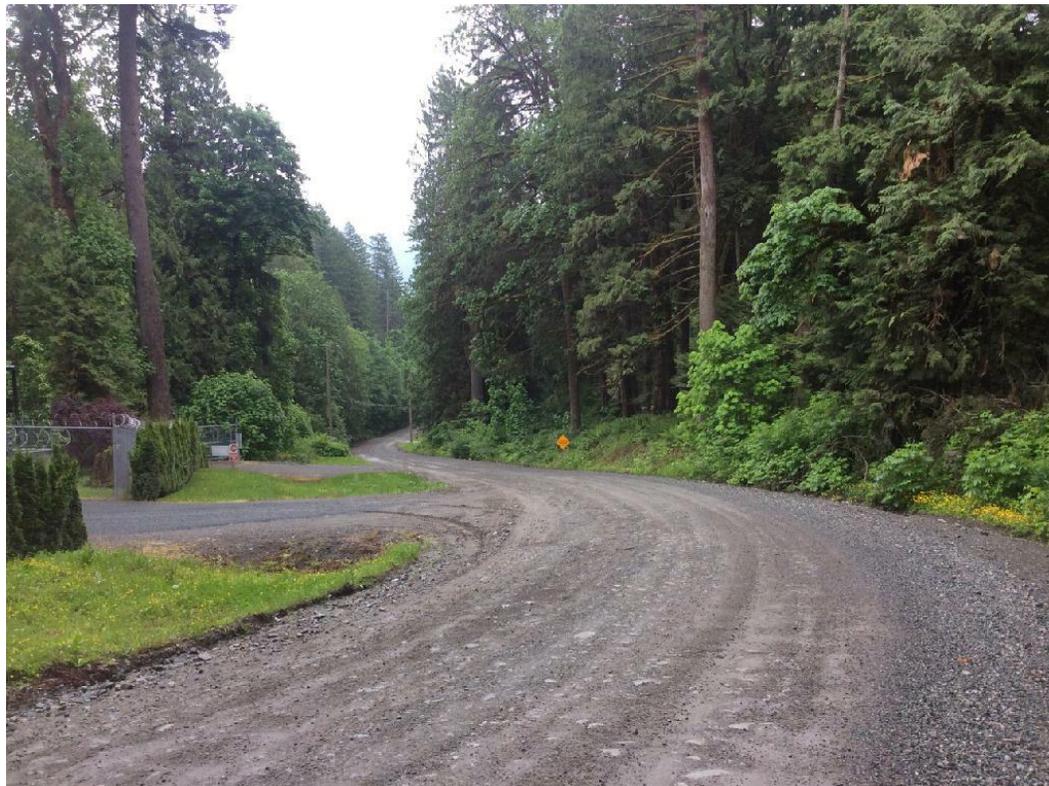
Photo 4
1.5 km
Chehalis
FSR, road
section
with
washboard
surface

1.5 km	Road surface has excessive washboard due to rough surface over a 150 m long section	Consider widening out the corner to improve sightlines. Place and compact 1' lift of 3" minus CBC and a 6" thick layer of HFSA to improve road surfacing and grade.

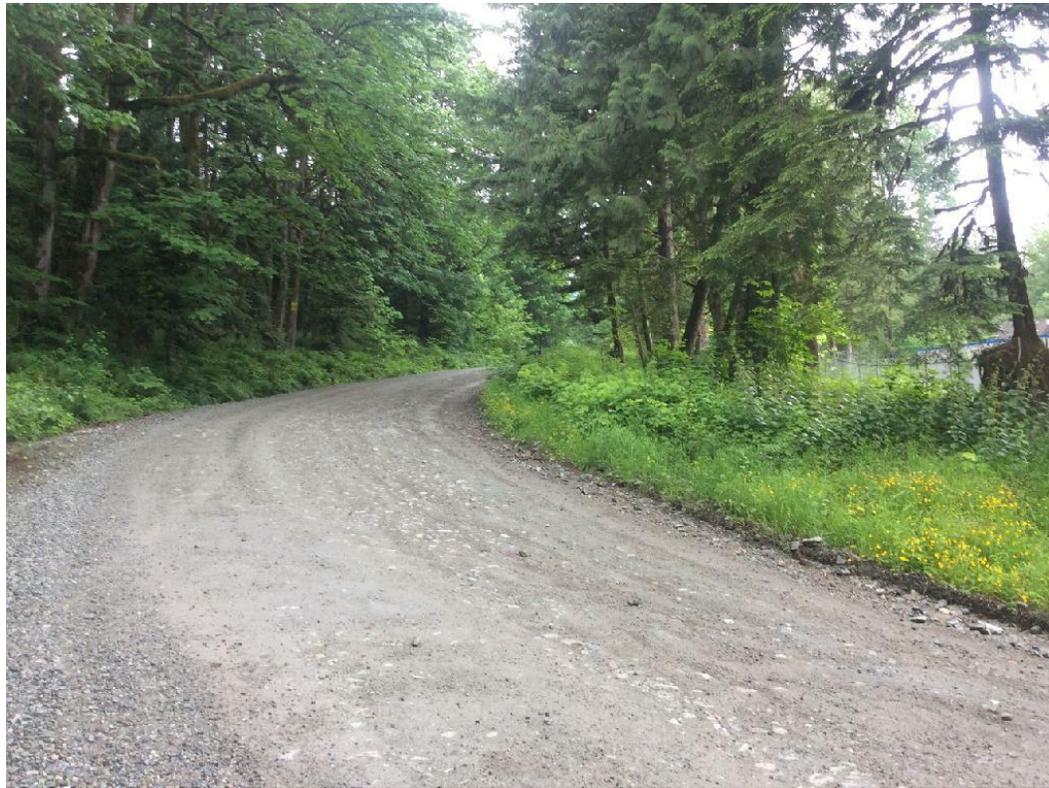
Photo 5
1.5 km
Chehalis
FSR, road
section
with
washboard
surface

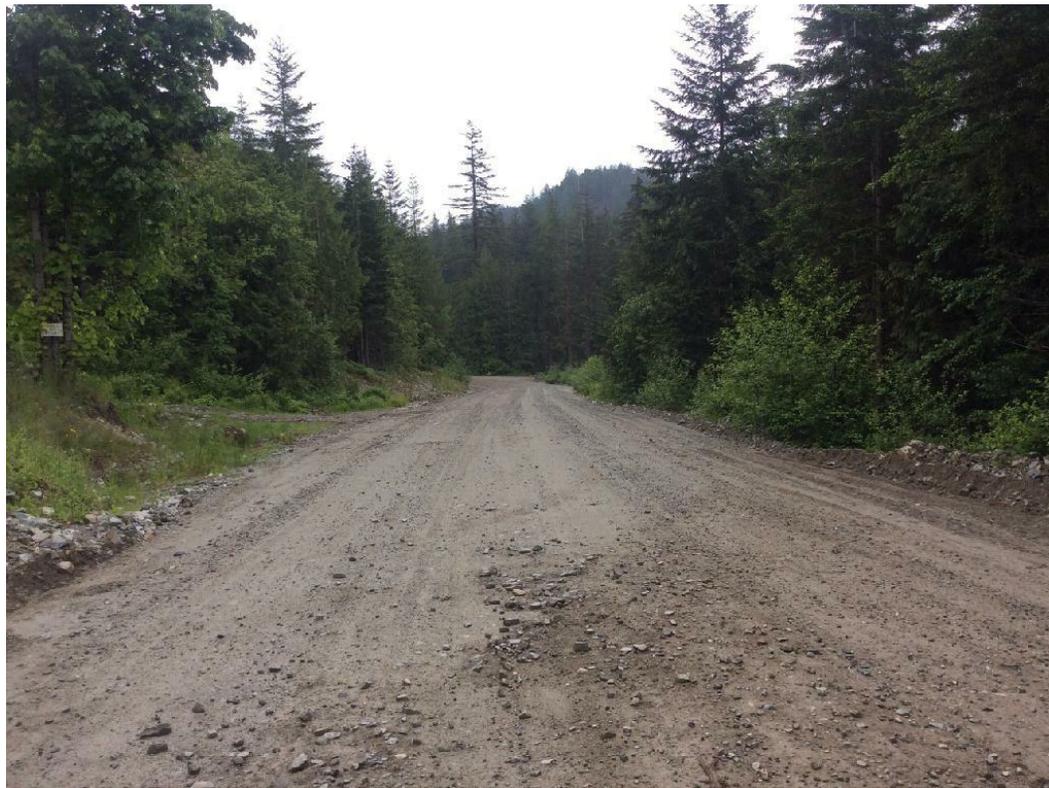
Photo 6
2.4 km
Chehalis
FSR, view
towards
campsite

2.4 km	10m wide road on approach to campsite	Consider posting reduced speed limit sign (30 km/hr) through Elbow Lake road section due to heavy public use of the lake and pullouts along the lake. Post 60 km/hr sign for traffic heading down.

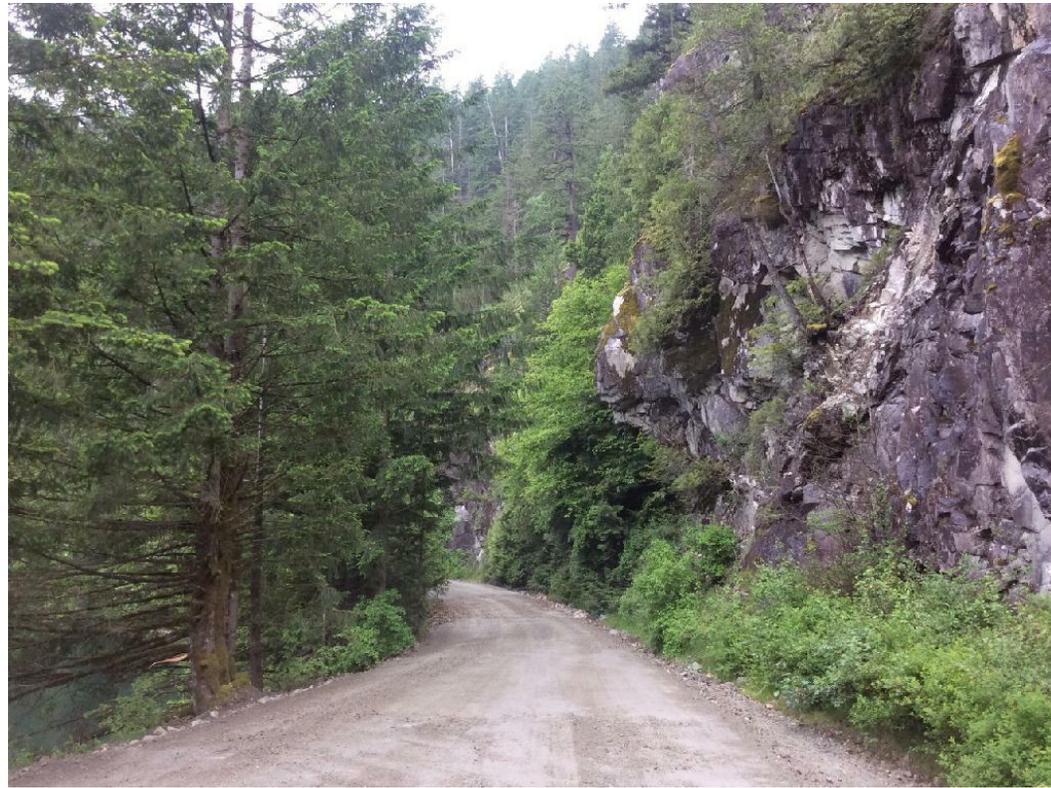
Photo 7
~3.4 km
Chehalis
FSR,
narrow
road
section
with rock
bluffs
above

3.2 km	Existing road is 11-12 m wide	Brush out sight lines and clean ditches
3.4 km to 3.9 km	Existing road is 6-7 m wide, rock bluffs above	Brush out sight lines, road is generally considered single lane, existing pullouts available but likely to have public vehicles parked during summer months, and clean ditches

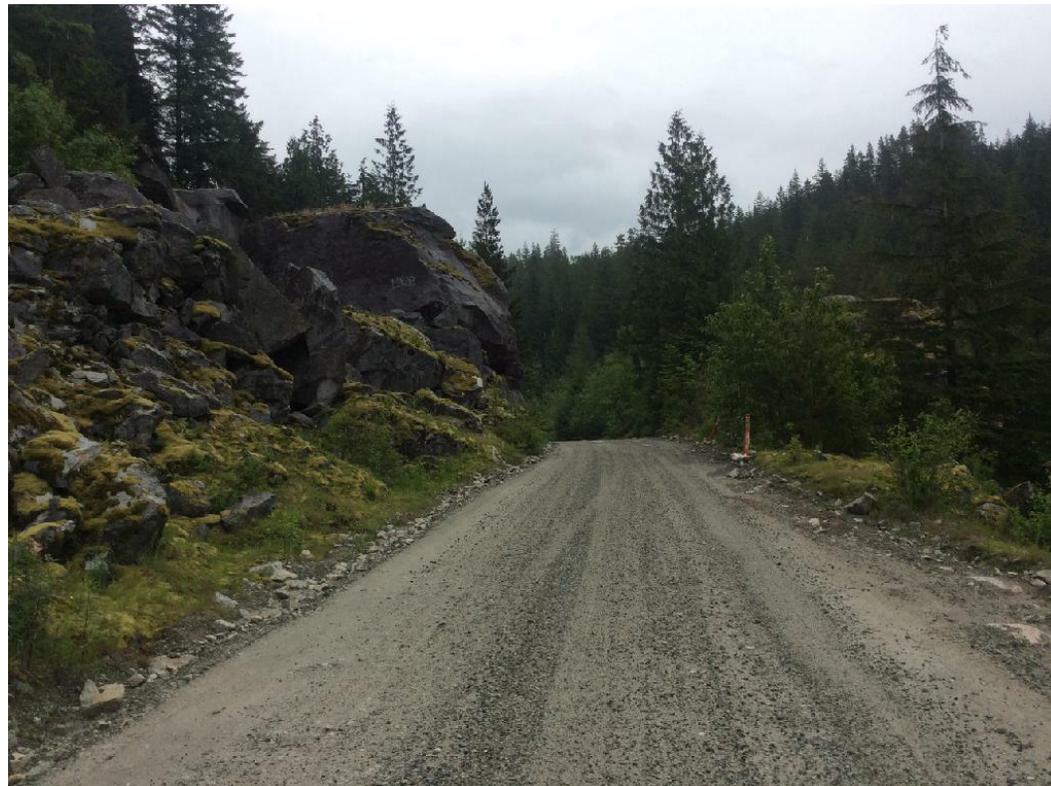
Photo 8
~3.9 km
Chehalis
FSR,
narrow
road
section
with talus
rock slope
above

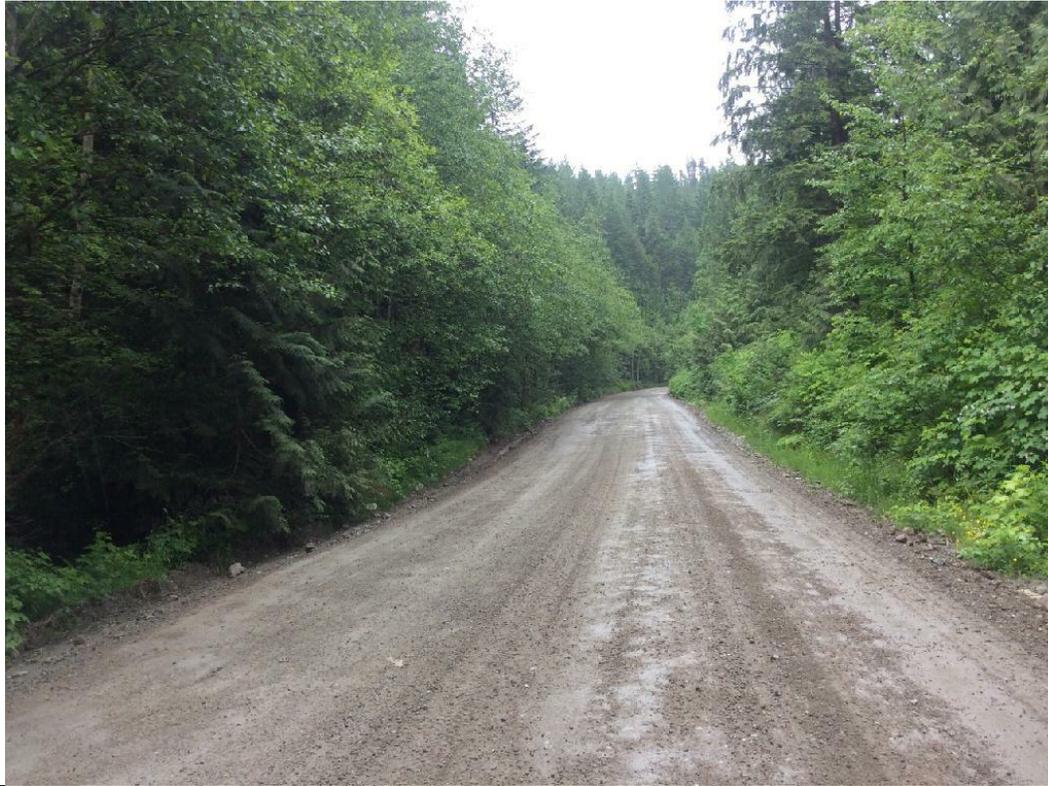
4.5 to 6 km	7-8 m wide road, not quite full two lane road width with no existing pullouts except at road junctions at 4.9, 5, 5.7, and 5.9 km. 5 km is the junction to a Correctional Service Canada facility.	Will need to review junctions for length of truck and pup to determine if they can work. Brush out sight lines and clean ditches.

Photo 9
4.4 km
Chehalis
FSR, typical
7-8 m road
width

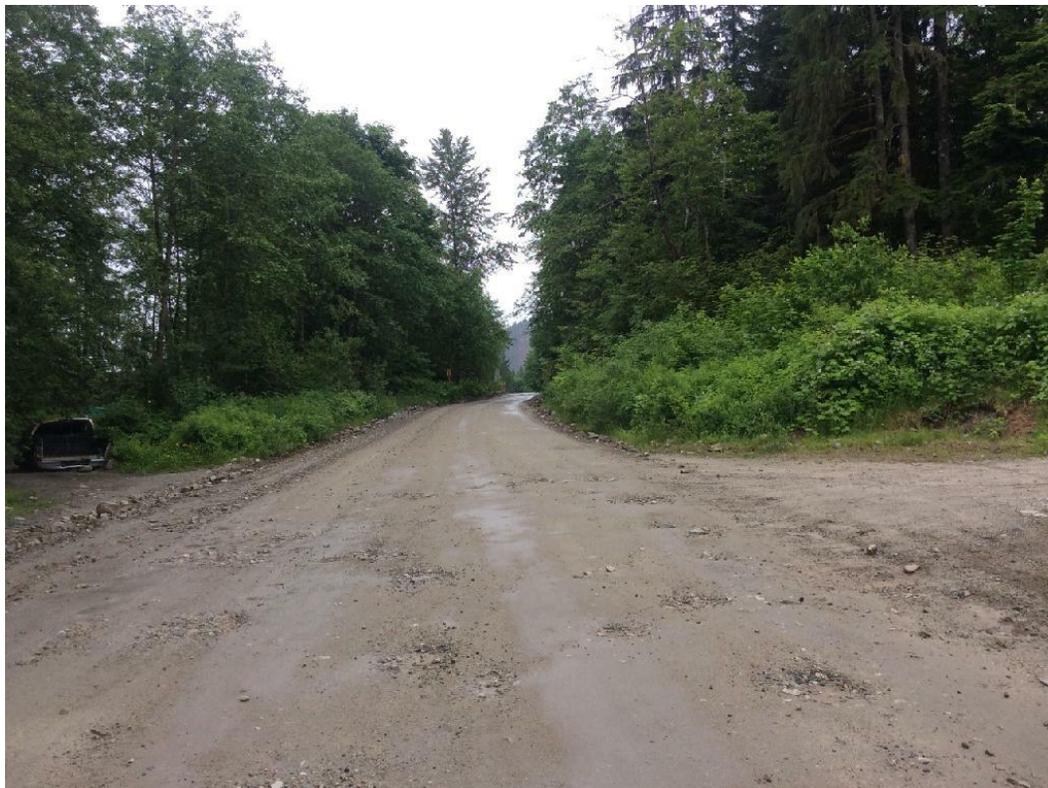
Photo 10
5.8 km
Chehalis
FSR, wide
road with
existing
pullouts /
junctions

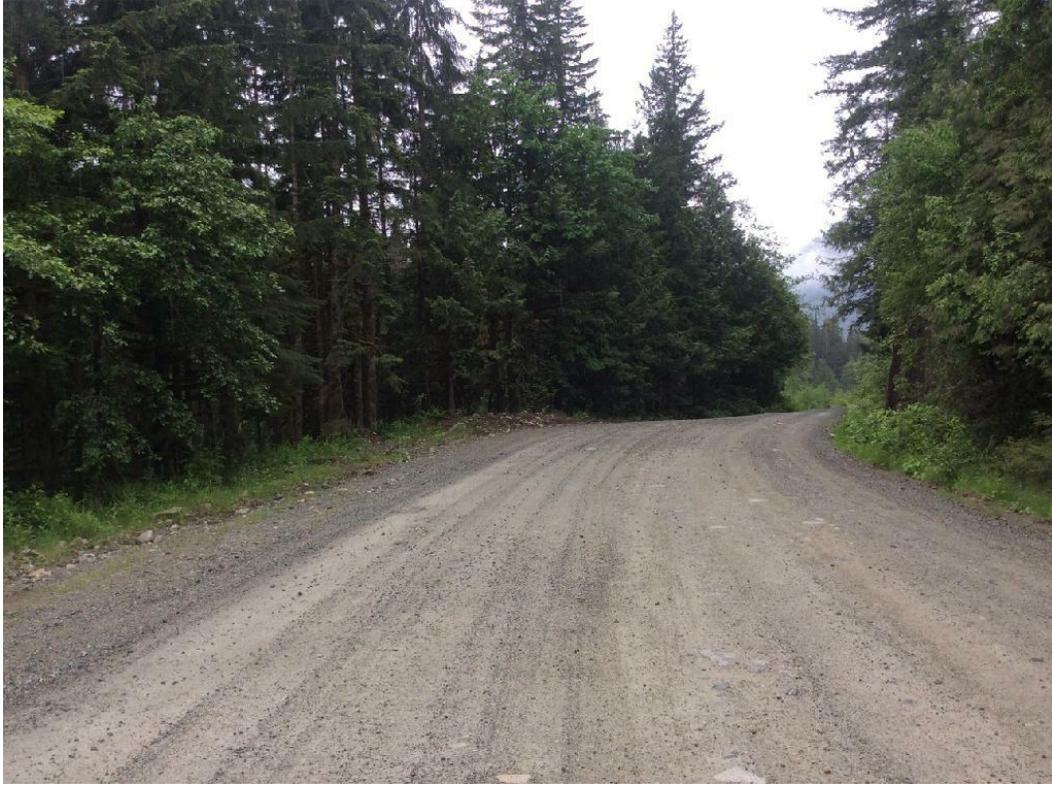
5.8 km	Existing bridge CK-2020, currently load rated to L-165 or 150 tonnes. Structure has no vehicle tracking concerns.	Abutments are old log cribs with untreated timbers, MOF will likely require this entire structure to be replaced within 2 years with a longer bridge
6 to 7 km	Typically 7-8 m road width with a 12 m wide road width at 6.9 km	Brush out sight lines and clean ditches

<p>Photo 11 6.9 km Chehalis FSR, ~15 m wide road for 50 m length</p>
	<p>Photo 12 7.4 km Chehalis FSR, narrow road section in thru cut</p>

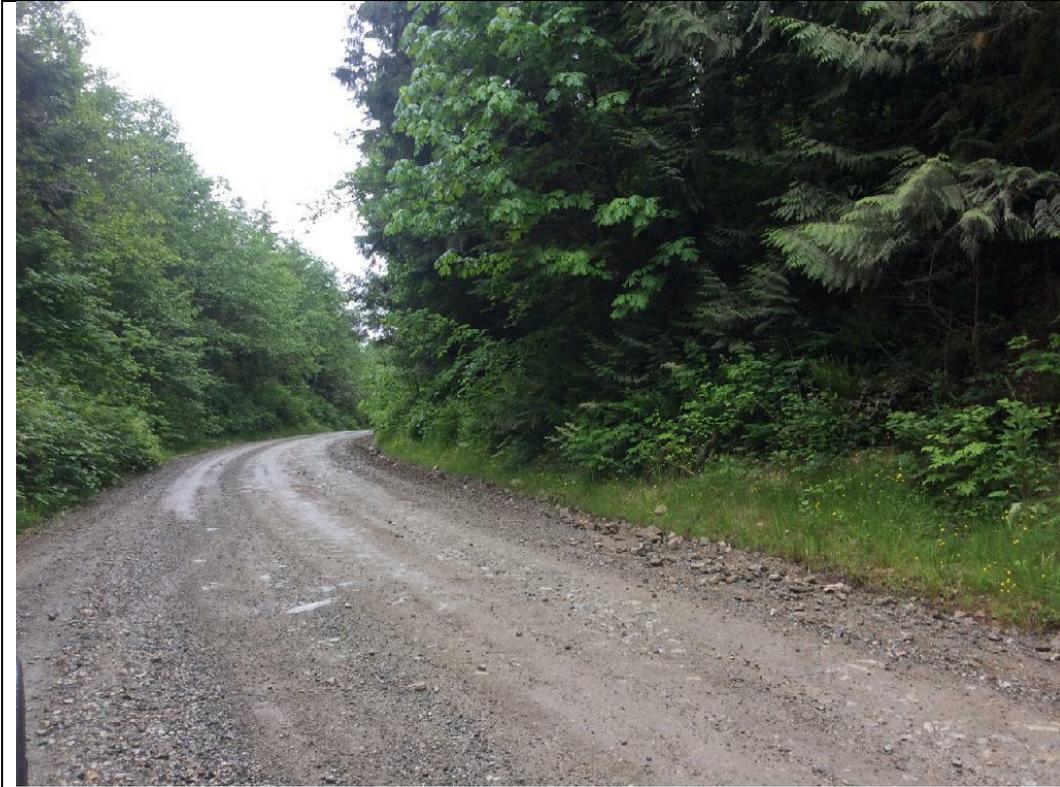
7.4 km	Narrow road section for 100 m length in a thru cut.	Long term road use with increased traffic would require widening this road section,
7.9 km	Existing pullout available	Brush out sight lines and clean ditches
8 to 10 km	Road is typically 7 to 8 m wide with pullouts at 8.4, 8.6, 8.8, 9.0, and 9.8 km.	Brush out sight lines and clean ditches

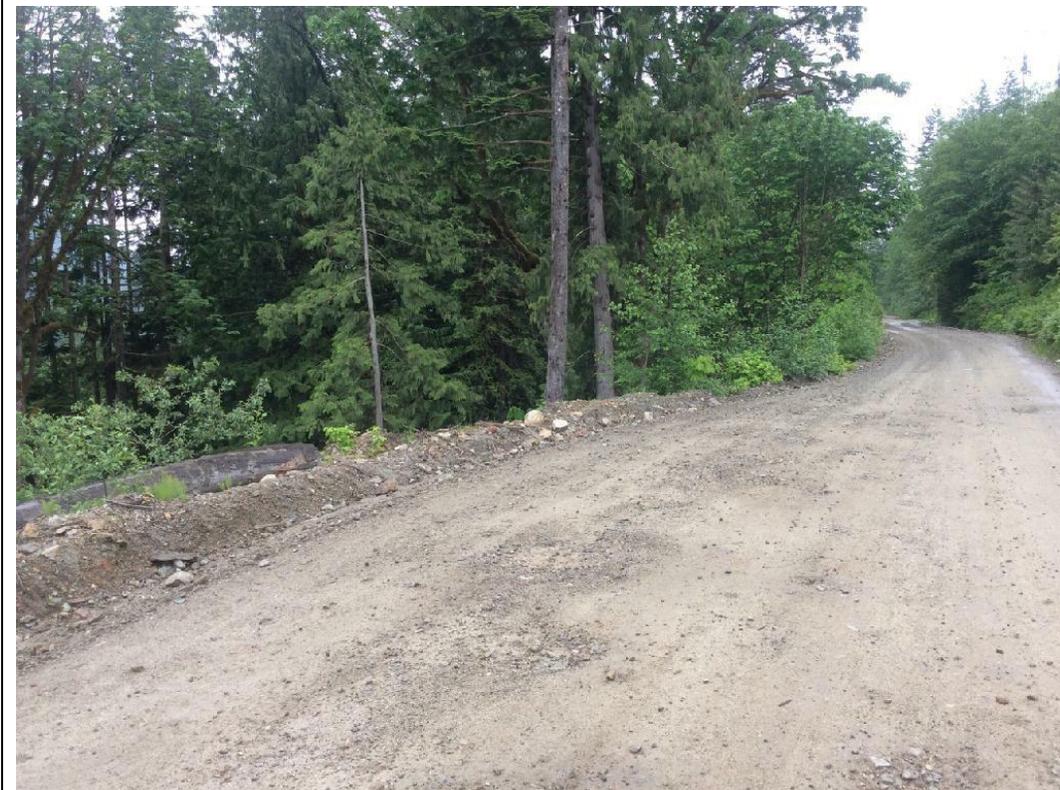
Photo 13
8.6 km
Chehalis
FSR, typical
pullout

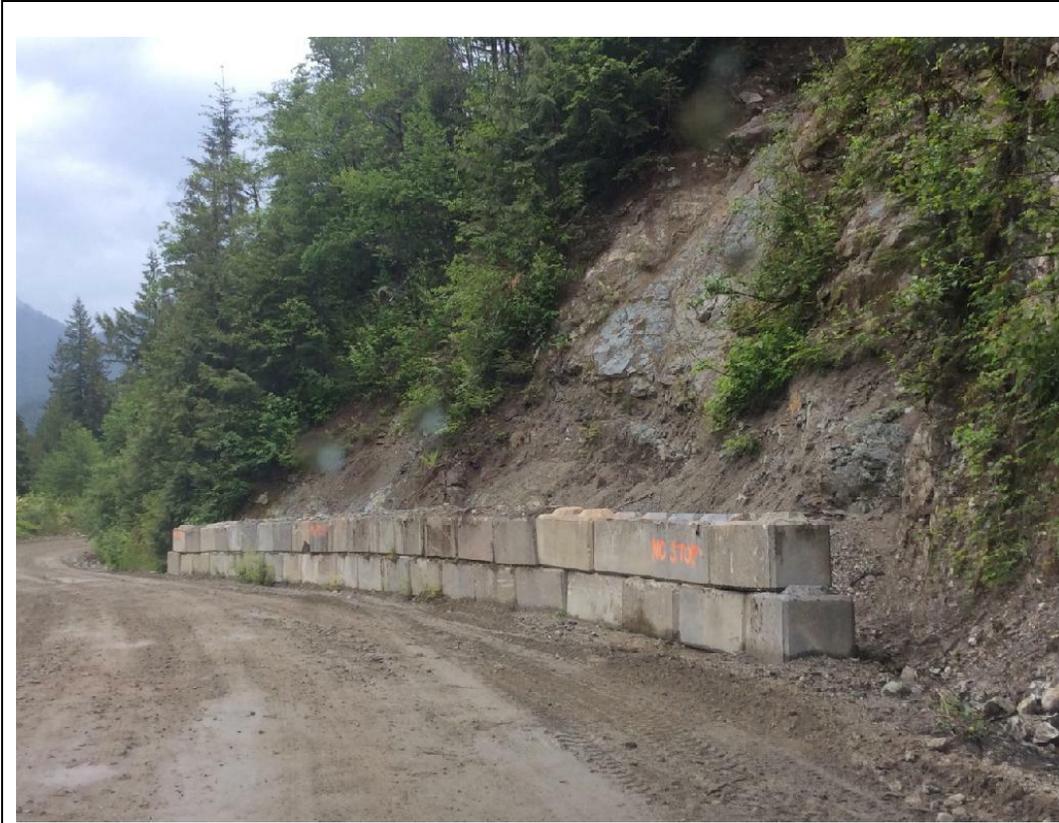
10.1 km	Existing lock block retaining wall along uphill road edge to capture raveling material.	Brush out sight lines and clean ditches
10.2 km	Existing bridge CK-2021, currently load rated to L-150 to 136 tonnes. Structure is in a tight corner but current logging truck traffic can track adequately.	Brush out sight lines, ensure bridge ahead signs are posted on each approach, and clean ditches. Due to the tight curves on approach to the bridge and limited sight lines this road section should be posted to 30 km/hr.

Photo 14
10.1 km
Chehalis
FSR, rock
fall
catchment
retaining
wall

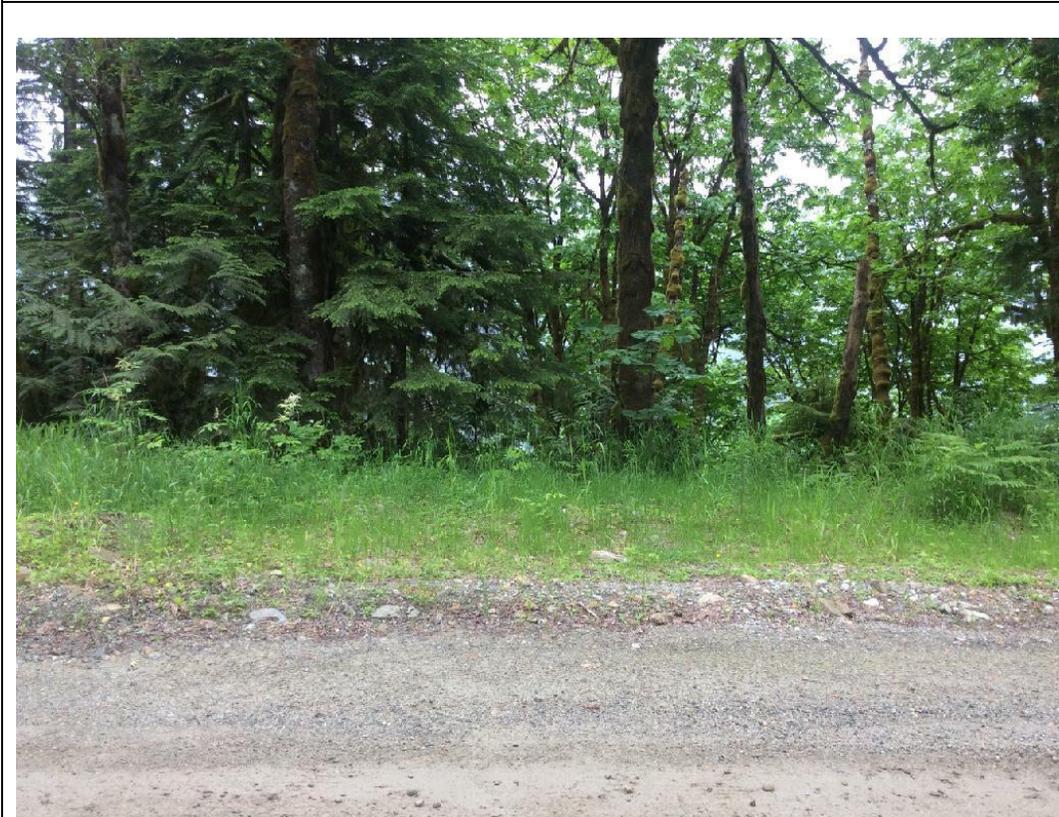
Photo 15
10.6 km
Chehalis
FSR
Existing
area that
could be
widened to
create new
pullout.
Also
available at
10.4 and
10.9 km

10.5, 10.7, 10.9 km	Existing undersized pullouts	Minor construction work to widen pullout for dump truck and trailer. Brush out sight lines and clean ditches.

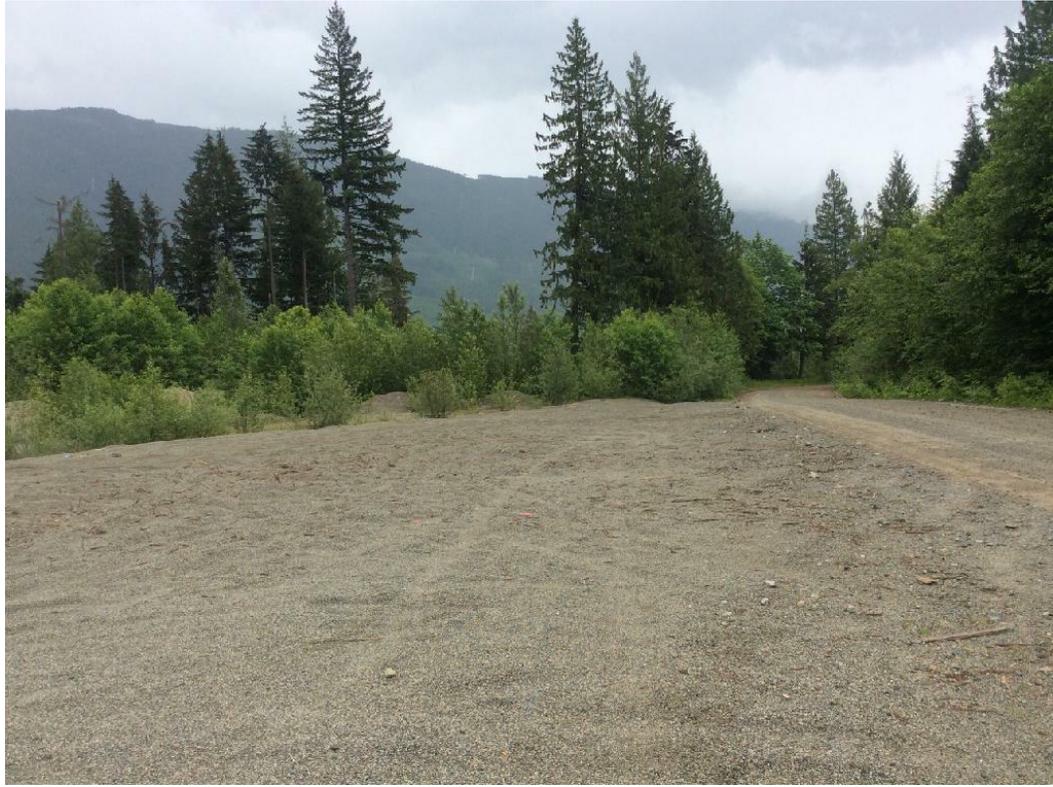
<p>Photo 16 11.3 km Chehalis FSR Existing area that could be widened to create new pullout. Also available at 10.4 and 10.9 km</p>
	<p>Photo 17 11.5 km Chehalis FSR, view up towards existing gate</p>

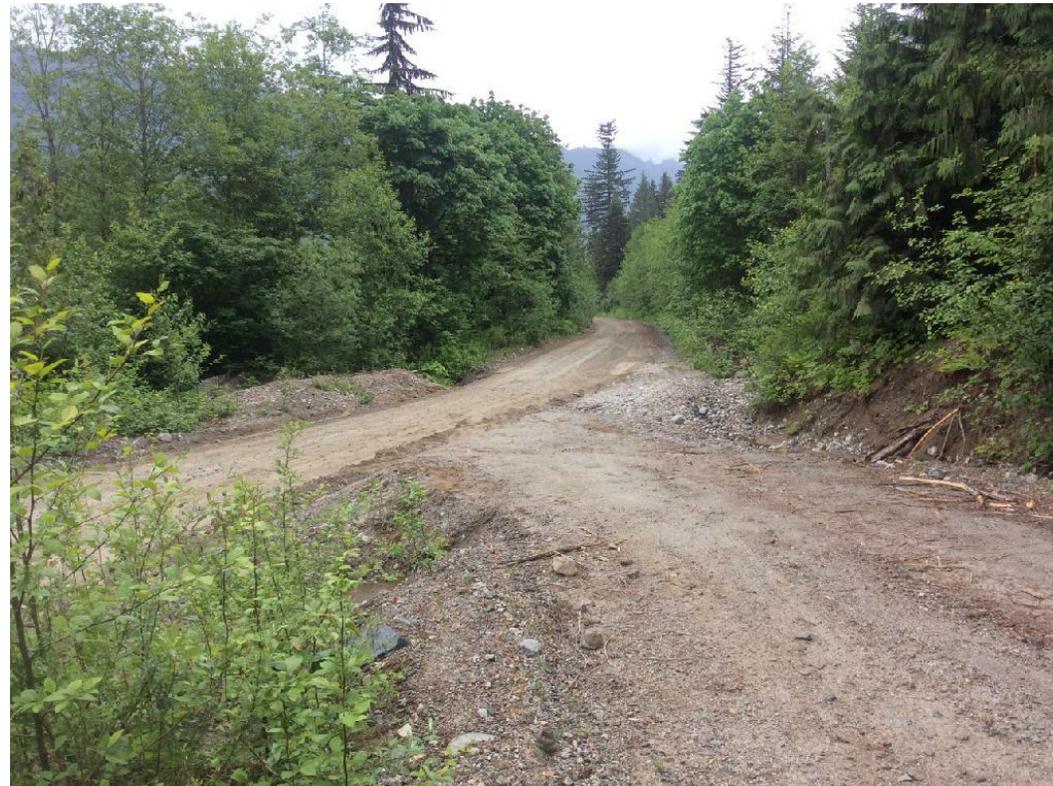
Photo 18
11.5 km
Chehalis
FSR, view
from
existing
gate
towards
FSR

Road Station	Current Conditions	Recommended Work
11.45 km	Old wood stave culvert	Still functional but consideration should be given to replacing with corrugated steel pipe
11.5 km	Existing junction to gravel pit. Junction is gated.	<p>Post road junction warning sign on woods approach on Chehalis FSR to notify users in the change in road activity from the gravel pit.</p> <p>Ensure an R-1 stop sign is posted on the gravel pit road on approach to the FSR.</p>
