REQUEST FOR SITE-SPECIFIC EXEMPTION

GEO-HAZARD ASSESSMENT

Title 17.0333 Geo-hazard Assessment 30420 Trans-Canada Highway, Yale BC Date November 14, 2017

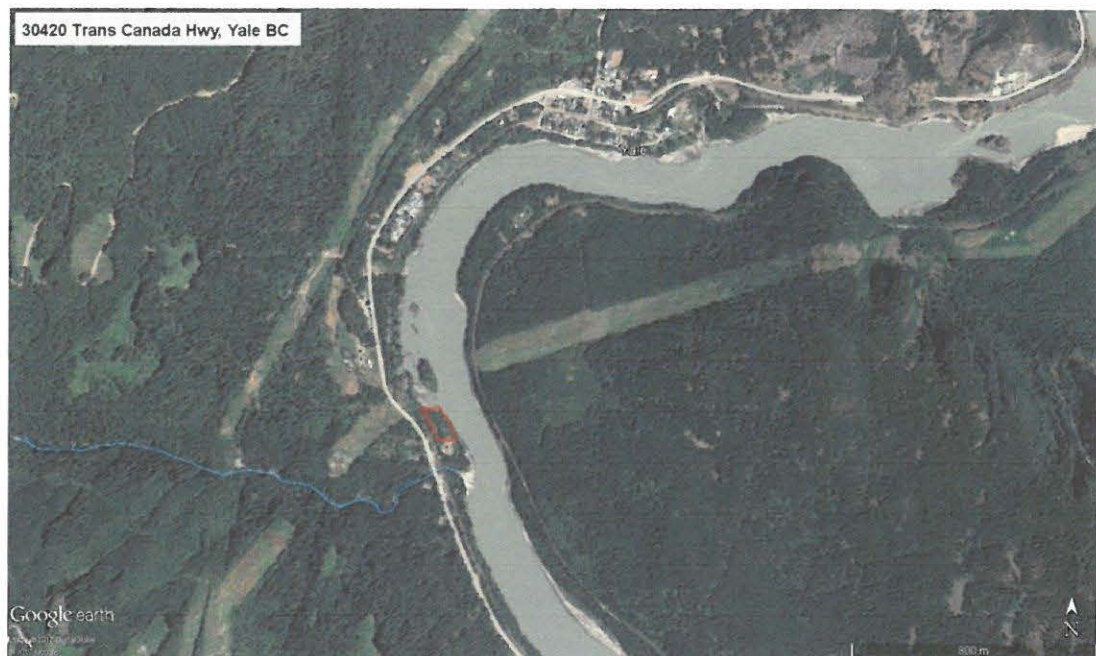
FIGURE 1: OVERVIEW OF YALE REGION. PROPERTY OUTLINED IN RED, GORDON CREEK IN BLUE. FROM GOOGLE EARTH PRO.

The subject Property is situated along the western shore of the Fraser River, approximately 1.5 km southwest of Yale town centre (Figure 1). Yale is the southern extent of the Fraser Canyon, a gorge cut by the Fraser River through the Coast Mountains, which widens to approximately 1 km south of Yale. Gordon Creek runs west to east into the Fraser River, approximately 140 m south of the property. The bedrock geology of the area has been mapped as Cretaceous to Tertiary, which locally consists of metamorphic rock. The bedrock underlying the subject property is mapped as the Custer Gneiss⁷, a granitic gneiss with abundant pegmatite dikes, schist and amphibolite. No bedrock was exposed on site, however, this is consistent with the local geotechnical reports. The Hope Fault runs north-northeast approximately 900 m west of the property, and is believed to be inactive.

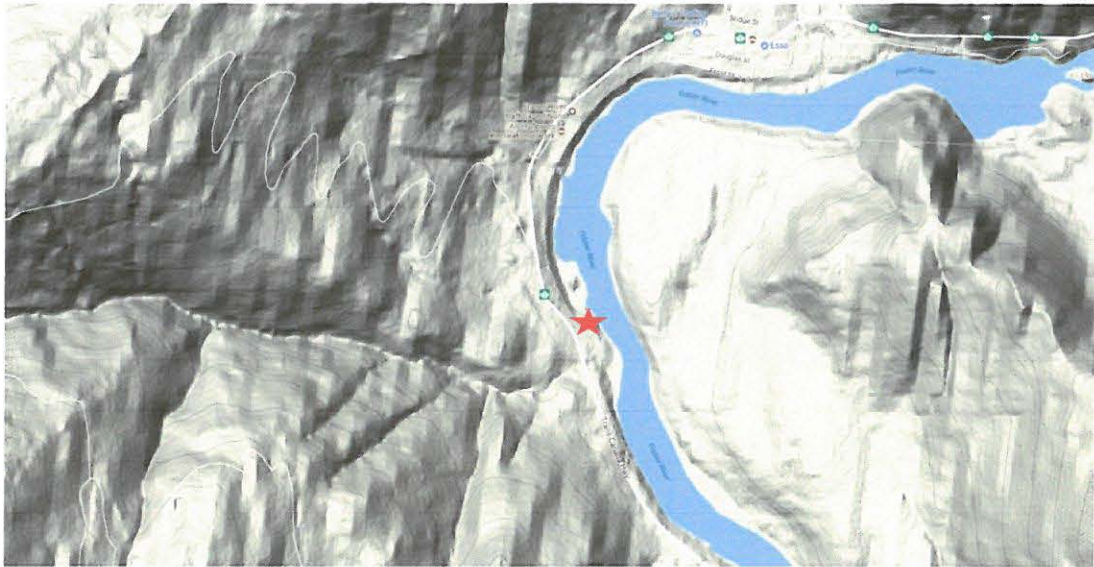
FIGURE 2: TOPOGRAPHIC TERRAIN OF AREA, RED STAR IS PROPERTY. FROM GOOGLE MAPS TERRAIN VIEW.

The property ranges in elevation between approximately 42.63 and 62.67 m.a.s.l..

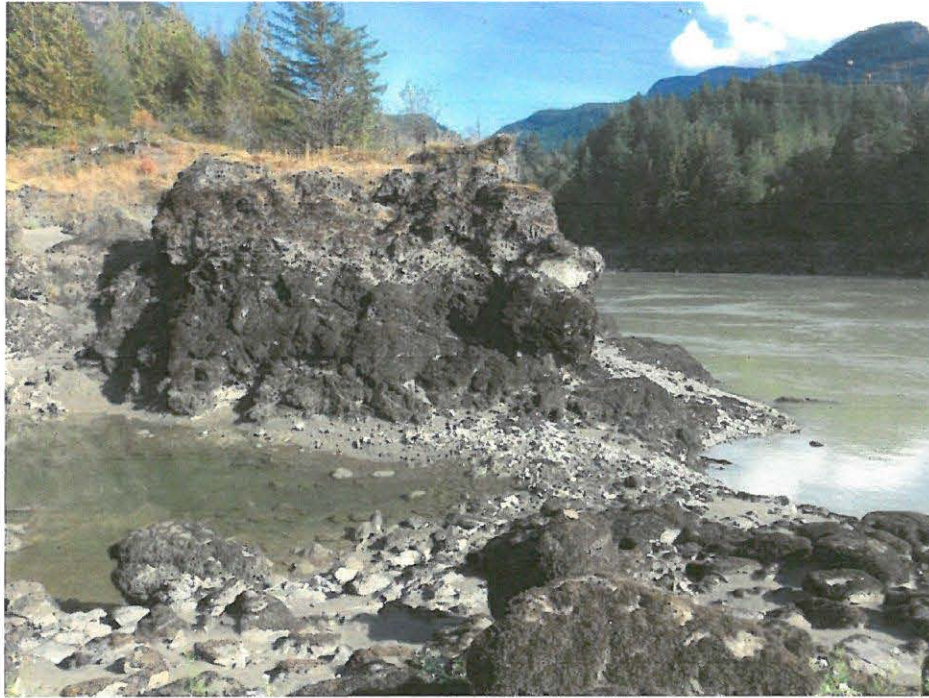
The northern property boundary is just outside of the transmission line corridor, faces a backchannel of the Fraser River. Air photos show this backchannel does fill completely during high water events.

PHOTO 1: BACK CHANNEL FOR THE FRASER RIVER, NOT FULL AT TIME OF PHOTO, ALONG THE NORTHERN PROPERTY BOUNDARY.

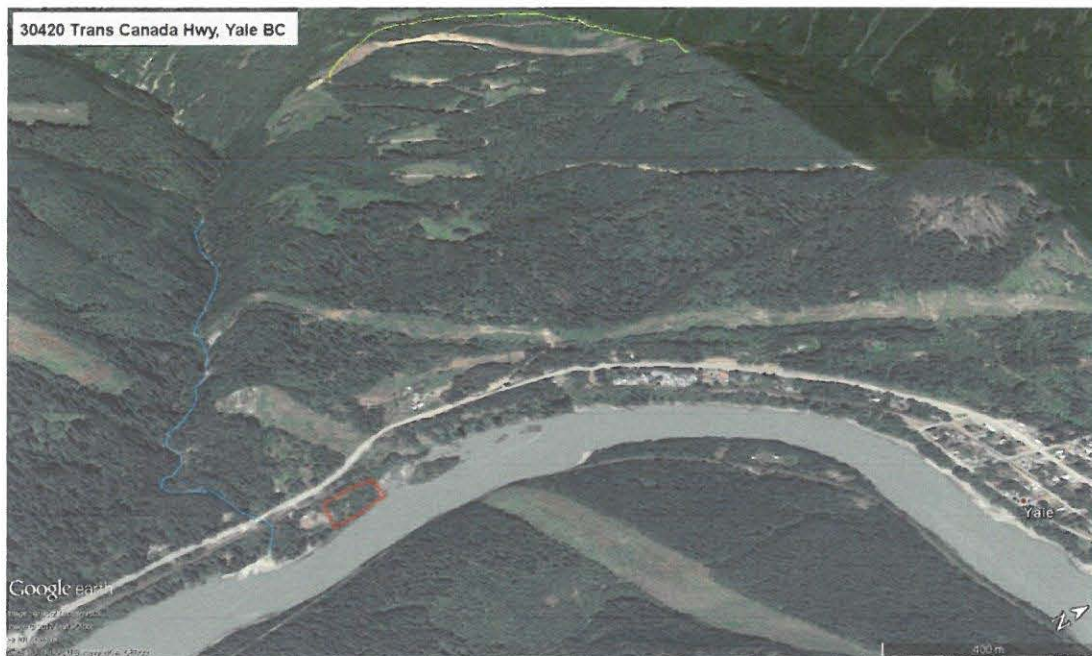
The Graveyard Creek Landslide is located to the northwest of the property. It is on the east flank of the Gordon- Yale Creek divide and is moderately steep and underlain by schist and granodiorite. The slope is approximately 2.2 km wide has 900 m of vertical relief. The site has been described as an ancient post-glacial landslide where the southern half may have failed catastrophically blocking the Fraser River. Numerous field reconnaissance investigations by other parties have traversed the site and determined that the landslide consists of fragmental bedrock debris. No landslide deposit has been found below 110 elevation, and could indicate that the debris either did not travel farther than that location or the toe has been removed by Fraser River erosion. We estimate the annual probability of reactivation of failure as 1:1,000 to 1:10,000.

FIGURE 4: PERSPECTIVE VIEW OF AREA; YELLOW LINE IS APPROXIMATE LOCATION OF THE GRAVEYARD CREEK LANDSLIDE HEAD SCARP. FROM GOOGLE EARTH PRO.

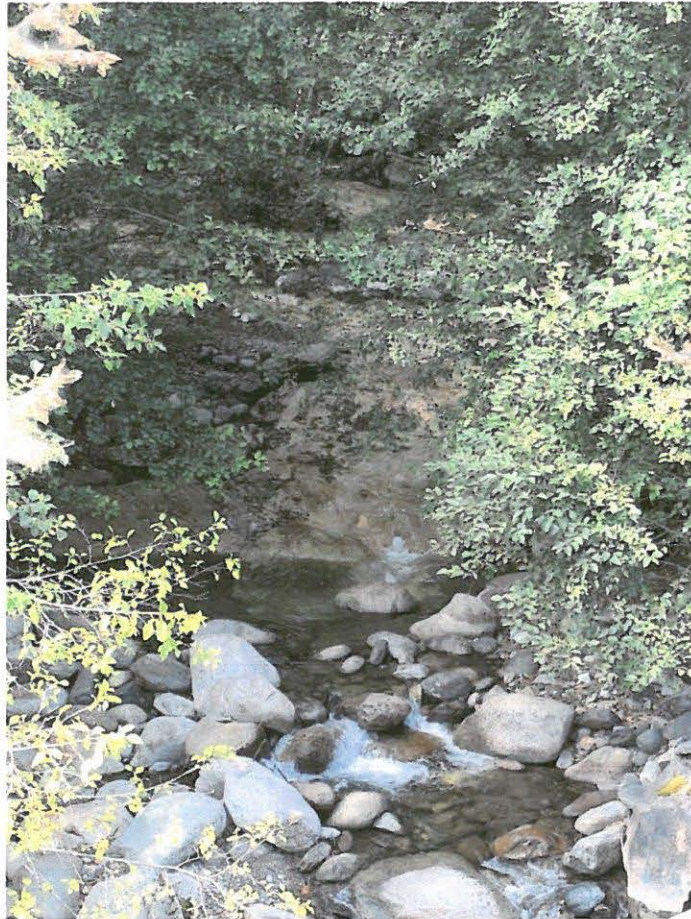
Through field and air photo analysis, there appears to be no possibility for avulsion to affect the subject property. There has been no major change in the alluvial fan location since 1928, it remains approximately 150 m south of the property. However, the large discharge event in 1949 appears to have cleared vegetation along the alluvial fan's edges, but did not extend to the property. Approximate minimum distance from property is 100 m. If material blocks the channel downstream of the railway bridge, the flow of the channel will most likely be diverted to the southeast due to the topography, and not towards the subject property. Any debris flow event large enough to impact the subject property would not be able to pass under the first bridge at the highway.

PHOTO 3: GORDON CREEK, LOOKING UPSTREAM, CUTS THROUGH BEDROCK BEFORE ENTERING CHANNELIZED PORTION.

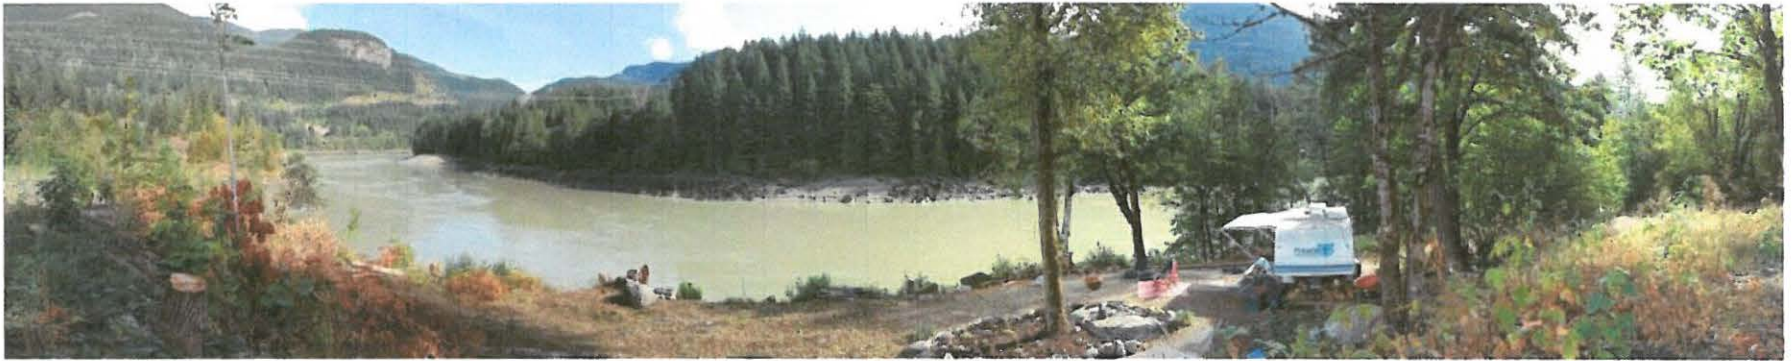
PHOTO 4: VIEW OF FRASER RIVER FROM TERRACE 2, FACING EAST.

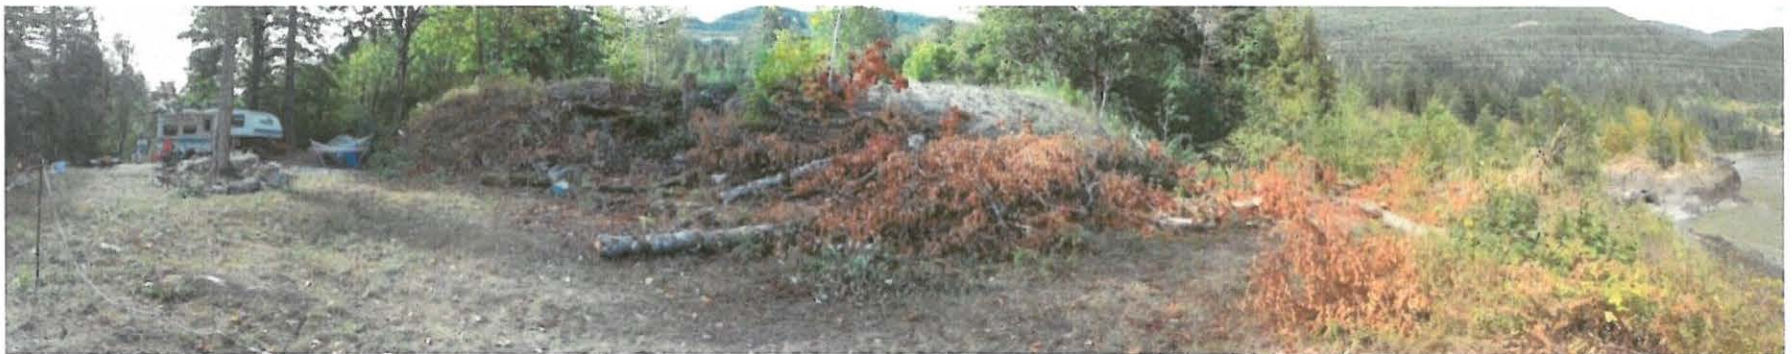
PHOTO 5: VIEW FROM TERRACE 1 UP TO TERRACE 2, FACING WEST. SLOPE IN FOREFRONT IS SLOPE 2.

1. Parts of the property are subject to localized landslip and inundation by flooding. We recommend the following for the main residential structure:
 - We estimate an annual probability of localized landslip to be 1:200 to 1:10,000 and recommend a 10 m setback from the crest of Slope 2.

Localized Landslip	1:500 to 1:10,000	Approval, but with siting requirements to avoid the hazard, or with requirements for protective works to mitigate the hazard	Due to the steepness of Slope 2 we recommend a 10 m setback from the crest of the slope for all habitable buildings. This setback falls within the recommended 45 m setback from Fraser River.
Rock Fall	<1:1,000	Approval without conditions relating to hazards	
Catastrophic Landslide	1:1,000 to 1:10,000	Approval without conditions relating to hazards
