Agricultural Land Capability Assessment – 13028 Stave Lake Road, Fraser Valley Regional District, BC

Prepared for: Rick Mathers

April 19, 2024

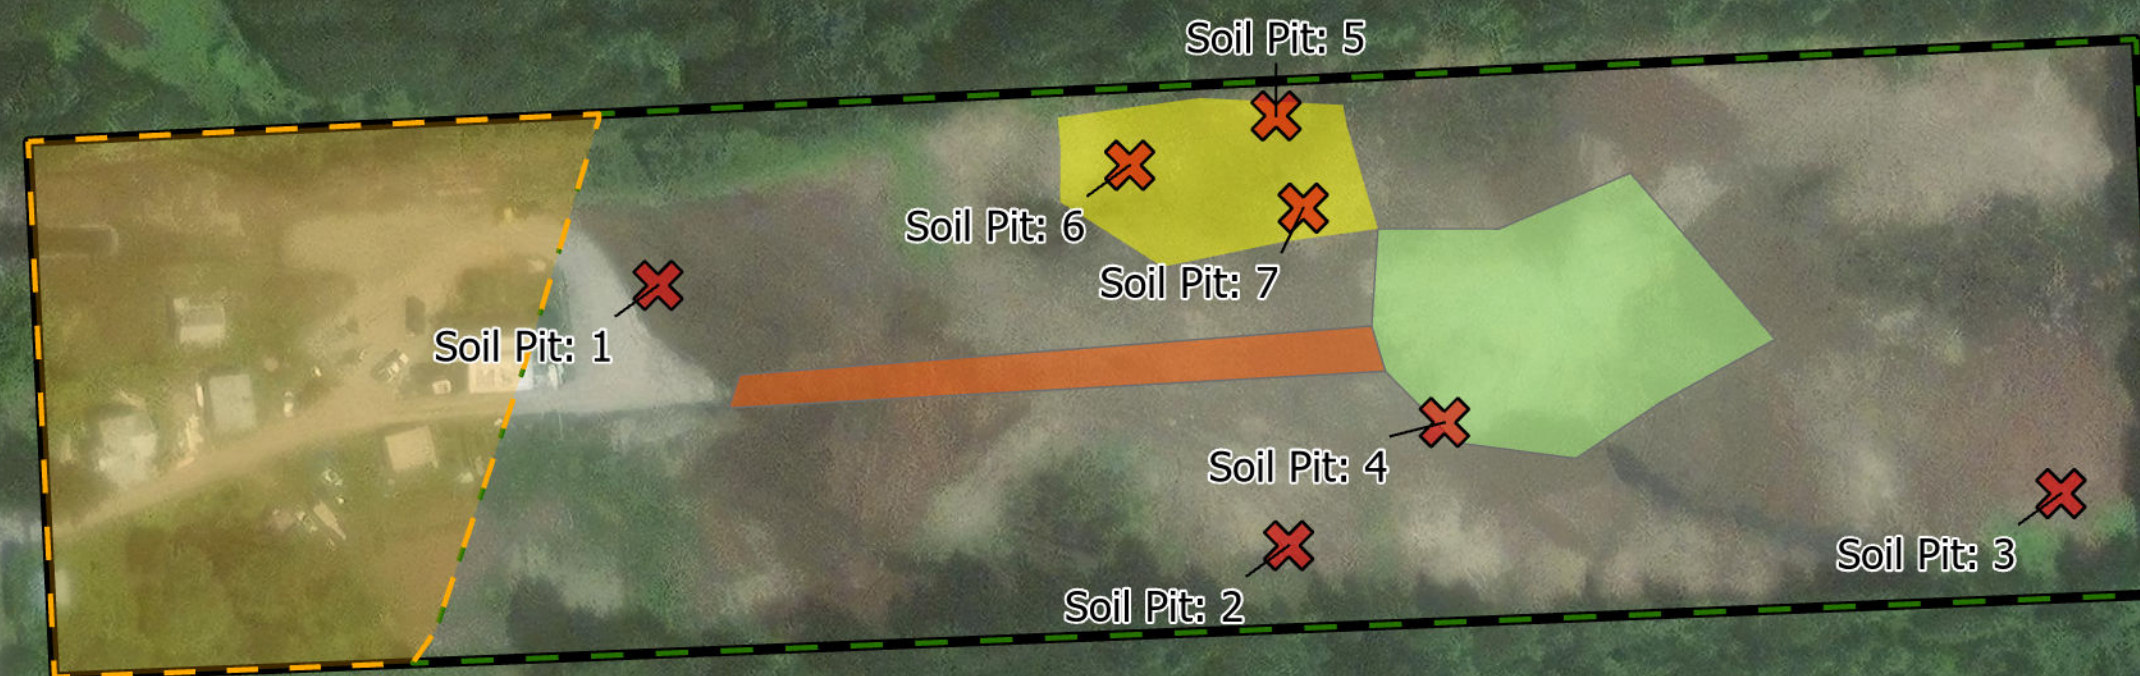
13028 Stave Lake Road - Areas of Imported Fill

A temporary road using crushed rock, approximately 7m wide, from Stave Lake Road heading east toward the east end of the Property. Near the east end of the Property a temporary turnaround had been constructed using crushed rock and was connected to the access road. In addition to the gravel road, fill had been deposited on the north side of the temporary access road near the center of the Property. Prior to laying crushed rock or depositing fill, it appeared that topsoil had been stripped and stockpiled on site in anticipation of replacement after temporary access and turnaround removal. Based on a conversation with the excavator operator, the location of the turnaround exists was a high point of the property. McTavish observed that the property sloped downward to the north, east, and south of this high point. Operators had done some minor grading of the area where this high point existed, to produce a level turnaround. According to personnel on site, the landowner intends to build a new sheep barn on the imported fill.

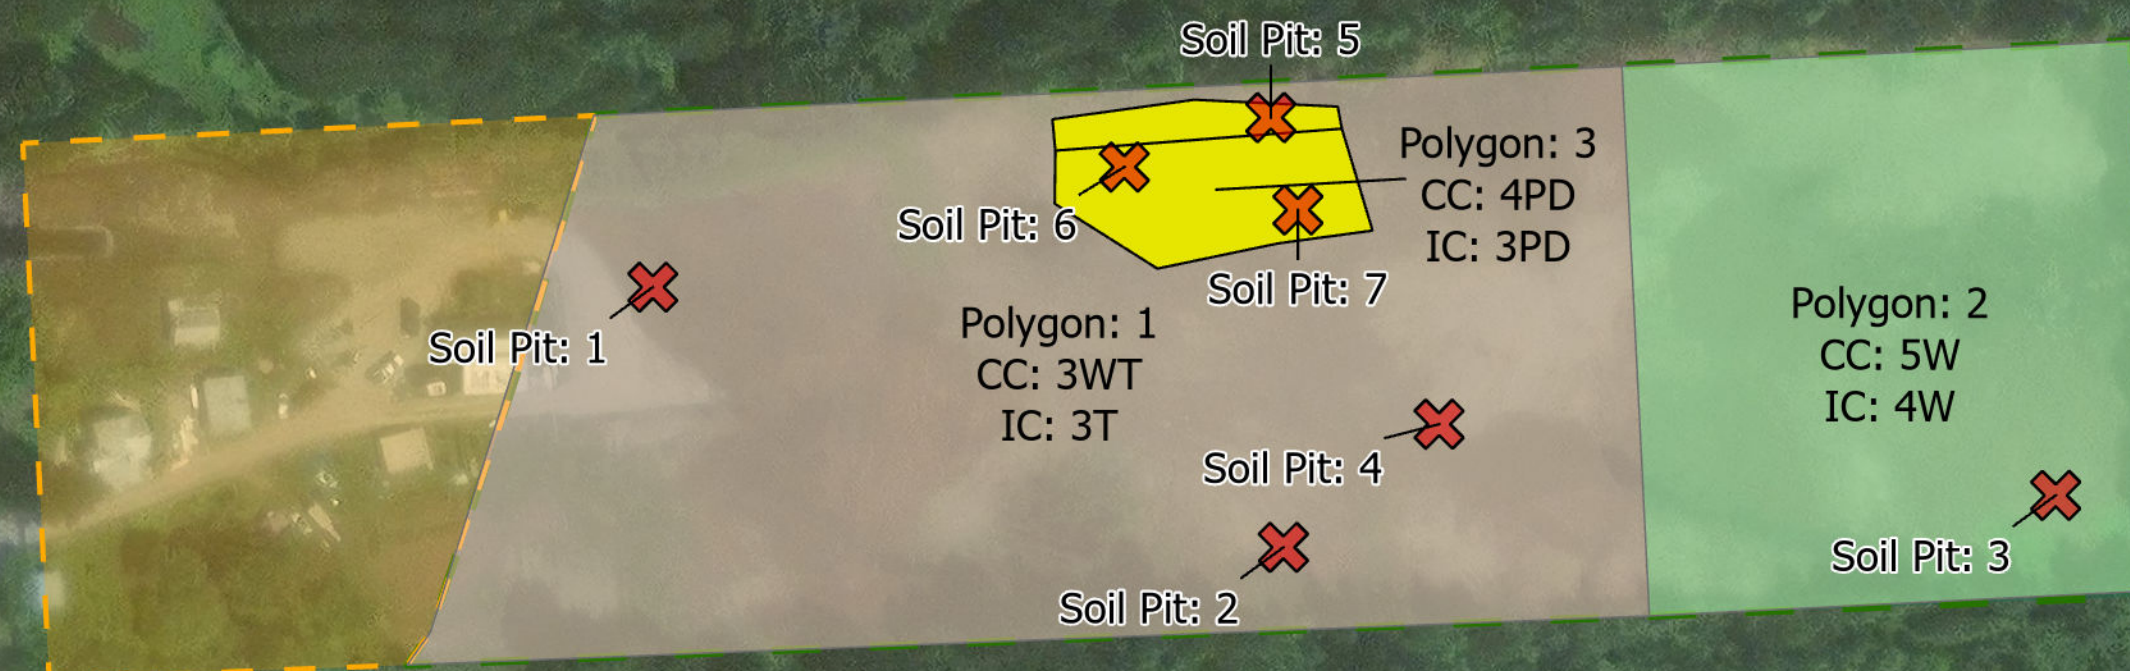
13028 Stave Lake Road - Field Assessed Agricultural Capability Ratings

capabilities summarized in Table 4. In total, four LCA Polygons have been delineated for the Property (Appendix I), with three being assigned an unimproved and improved LCA rating (Table 5).

For Polygon 1 (undisturbed soils) the LCA is revised to a capability rating of 3WT. This agrees with the provincially mapped soils except for the mapped undesirable soil structure limitation. There wasn't evidence of this limitation in the soil pits excavated in this polygon. The excess water (W) limitation can be improved to a class 2W through water management practices including surface and subsurface drainage and appropriate tillage. The topography (T) limitation is not considered practical to improve. As a result, the improved rating for this polygon is 3T.

For Polygon 2 (low lying undisturbed soils) the LCA is revised to a capability rating of 5W. This agrees with the provincially mapped ratings (see table 4.) The excess water (W) limitation is improvable to class 4 W through water management practices including surface and subsurface drainage and appropriate tillage. As a result, the improved rating for this polygon is 4W.

For Polygon 3 (fill area) the LCA is revised to a capability rating of 4PD. Both limitations are a result of the importation and packing of fill material and are not seen in undisturbed soils elsewhere on site. The undesirable soil structure and/or low perviousness (D) limitation is improvable through additions of organic matter and deep tillage to break-up root restricting layers. Stoniness (P) is improvable by removing cobbles and stones, either manually or by mechanical means. Coarse gravels are not considered practical to remove, and this limitation remains after improvement. As a result, the improved rating for this polygon is 3PD.

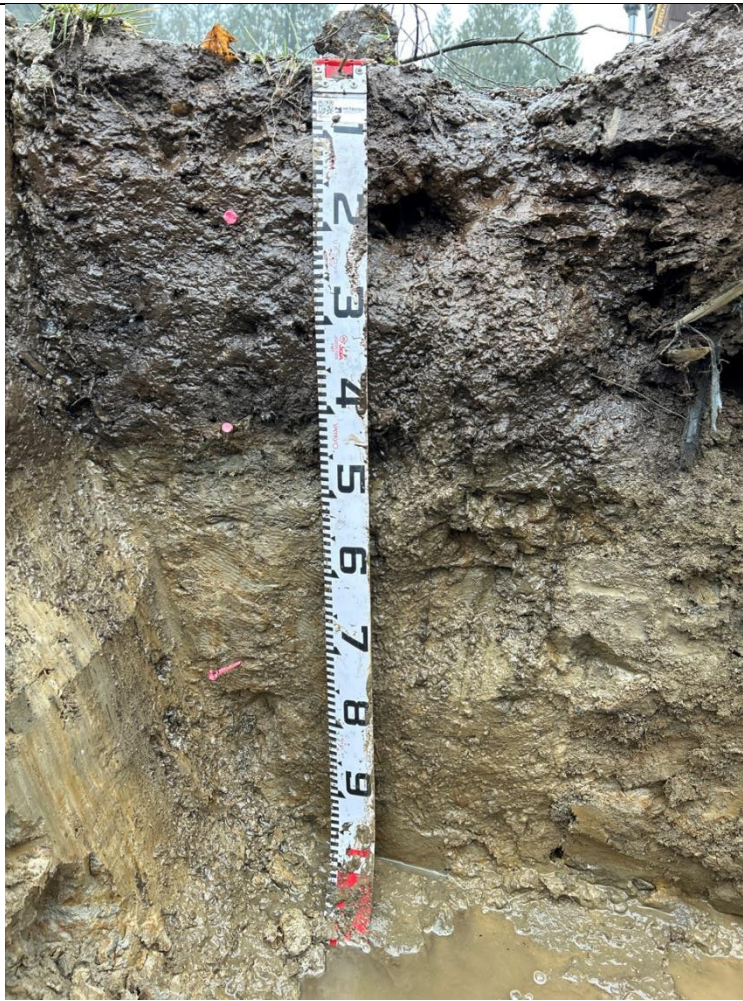
Test Pit 1

Comments: native soil with topsoil stripped

Horizon	Depth (cm)	Texture	Coarse Fragment %	Coarse fragment notes	Structure	Consistence	Colour	Mottles
Bf	0-19	Silt loam	30	Gravel dominant	M ABK	Moist; firm	10YR 3/4	No
Bfh	19-43	Silt loam	25	Gravel dominant	M ABK	Moist; friable	10YR 2/2	No
Cg	43-76	Sandy loam	5	Fine gravel	M SBK	Moist; friable	10YR 5/4	Medium; common; 10YR 5/4
Cg2	76-110	Loamy sand	5	Fine gravel	C ABK	Moist; very friable	2.5Y 6/2	Medium; many; 10YR 5/4

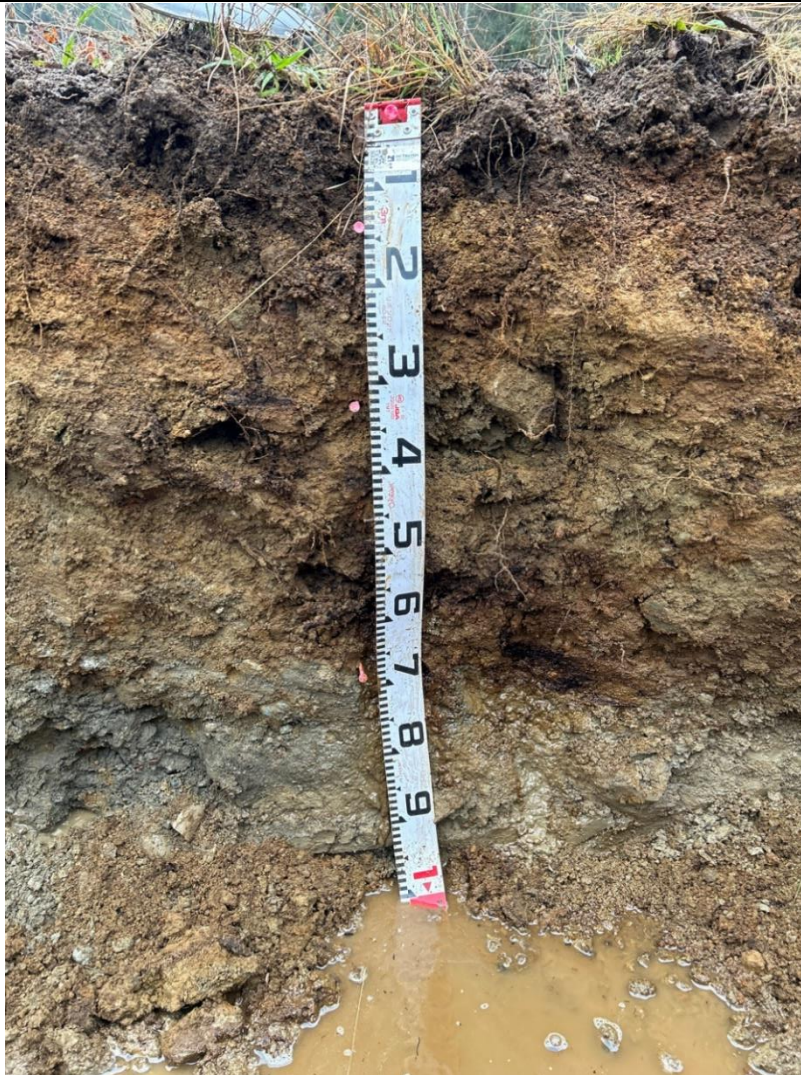
Test Pit 2

Comments: Native soil

Horizon	Depth (cm)	Texture	Coarse Fragment %	Coarse fragment notes	Structure	Consistence	Colour	Mottles
Ah	0-14	Silt loam	10	Fine gravel	Granular	Moist; friable	10YR 2/2	No
Bf	14-32	Silt loam	15	Fine gravel	F SBK	Moist; friable	7.5YR 4/4	No
Bm	32-69	Loam	20	Gravels	M SBK	Moist; friable	2.5Y 5/3	No
C	69-101	Loamy sand	10	Fine gravel	C ABK	Moist; firm	2.5Y 5/1	No

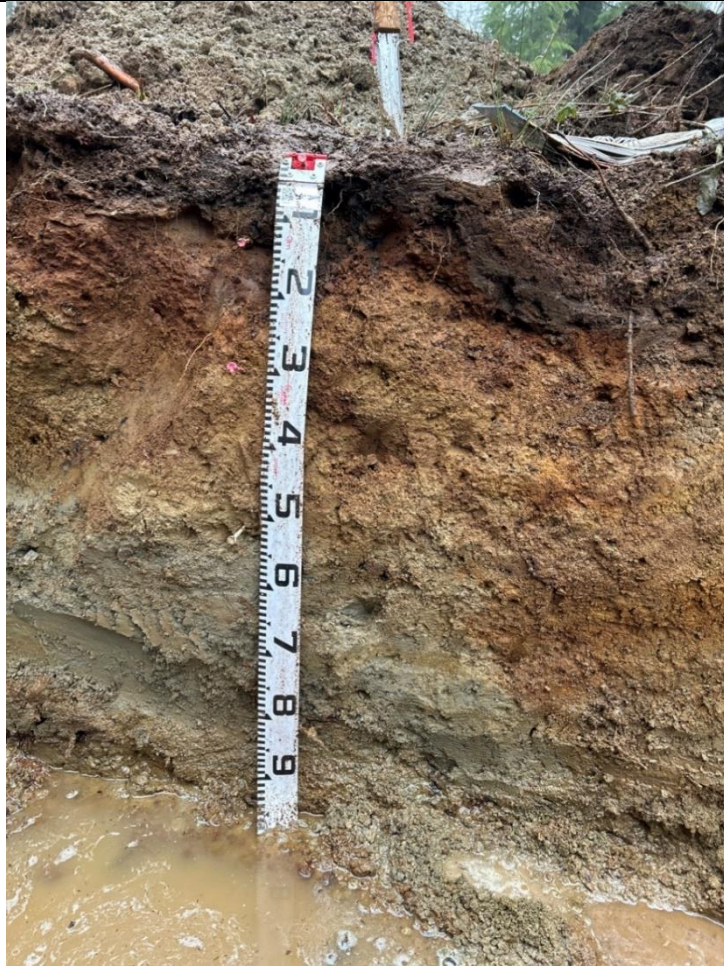
Test Pit 3

Comments: Native soil

Horizon	Depth (cm)	Texture	Coarse Fragment %	Coarse fragment notes	Structure	Consistence	Colour	Mottles
Ah	0-11	Silt Loam	5	Gravels	Medium Granular	Moist; friable	10YR 3/2	No
Bf	11-29	Silt loam	10	Fine gravels	M SBK	Moist; firm	7.5YR 3/4	No
Bm	29-52	Sandy loam	10	Gravels	C SBK	Moist; firm	2.5Y 5/3	No
Cg	52-100+	Sandy loam	0		M ABK	Moist; firm	2.5Y 5/1	Fine; few; 10YR 4/4

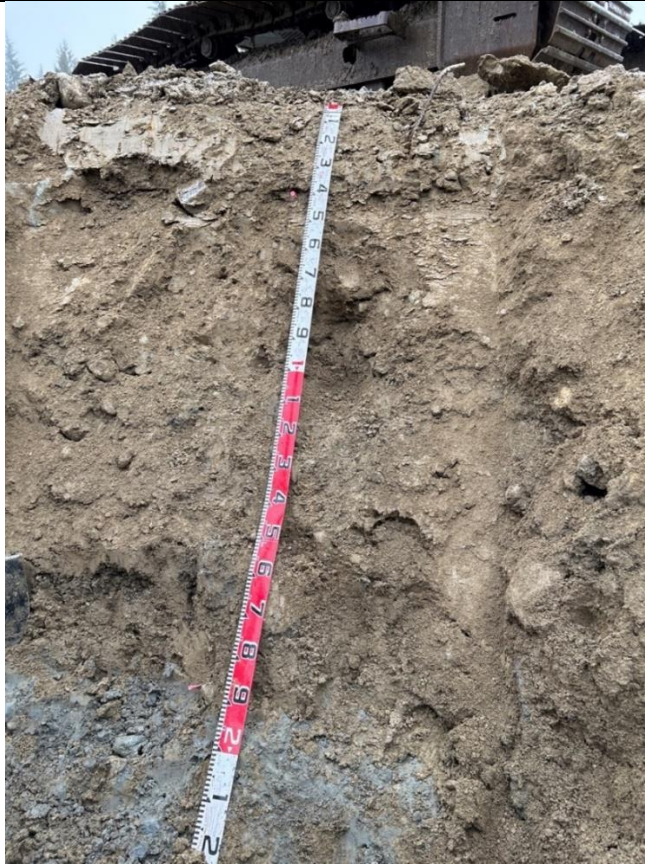
Test Pit 4

Comments: Fill. Road base used for truck turn around. Admixed native soil and imported high coarse materials down to 190 cm.

Horizon	Depth (cm)	Texture	Coarse Fragment %	Coarse fragment notes	Structure	Consistence	Colour	Mottles
Fill 1	0-40	Silt loam	60	Mostly gravel. Some cobble.	M SBK	Moist; friable	2.5Y 6/3	
Fill 2	40-190	Sandy loam	45	Mostly gravel. Some cobble.	M SBK	Moist; firm	2.5Y 5/3	
Cg	190-220+	Sandy loam	10	Gravels	C ABK	Moist; firm	5Y 5/1

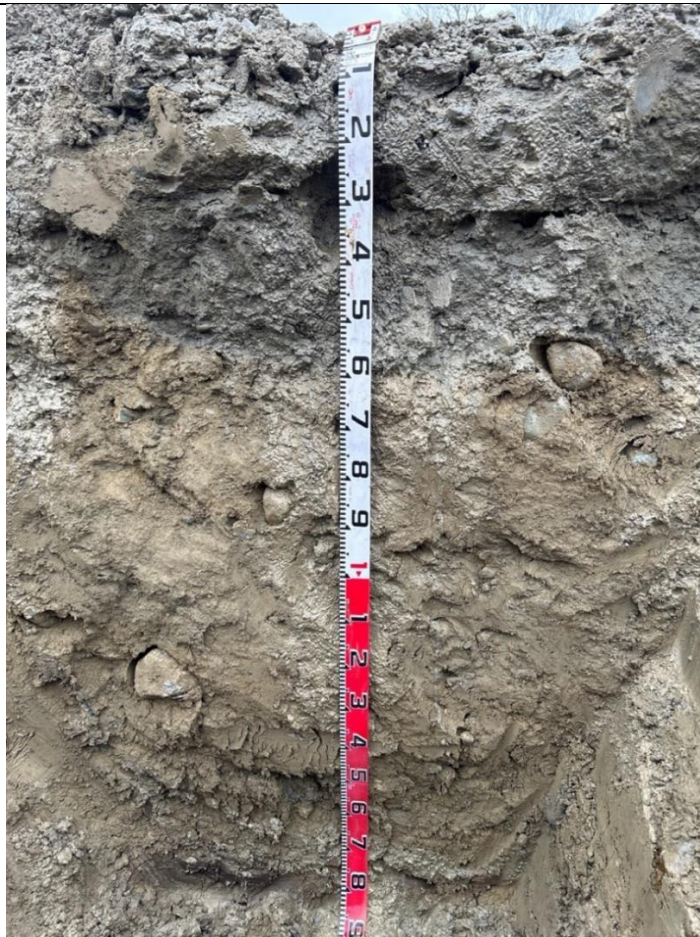
Test Pit 5

Horizon	Depth (cm)	Texture	Coarse Fragment %	Coarse fragment notes	Structure	Consistence	Colour	Mottles
Fill 1	0-55	Loam	75	Mixed gravels	C SBK	Wet; slightly sticky	2.5Y 4/1	
Fill 2	55-81	Sandy loam	20	Gravel and cobble	M SBK	Moist; firm	2.5Y 5/3	
Fill 3	81-180	Sandy loam	15	Gravel and cobble	M SBK	Moist; firm	10YR 5/1	Medium; common; 10YR 5/1
Bfh	180-190+	Silt loam	5	Gravels	M SBK	Wet; slightly sticky	10YR 2/2

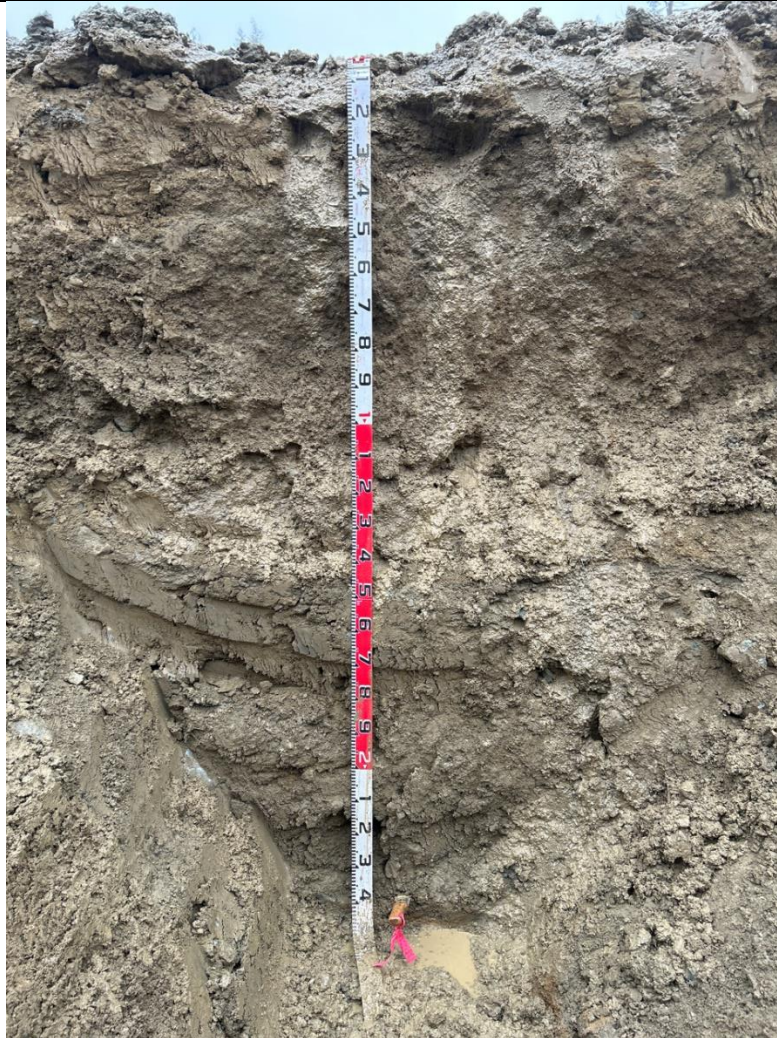
Test Pit 6

Soil name: N/A
Soil classification: FILL
Rooting depth: N/A
Water table: 250 cm
Drainage class: moderately well
Parent material: N/A
Comments:

Horizon	Depth (cm)	Texture	Coarse Fragment %	Coarse fragment notes	Structure	Consistence	Colour	Mottles
Fill	0-241	Loam	50	Gravel through boulders	C SBK	Moist; firm	2.5T 5/3	No
Cg	241-250+	Silt loam	5		M ABK	Moist; firm	2.5Y 5/1	Fine; common; 10YR 4/3

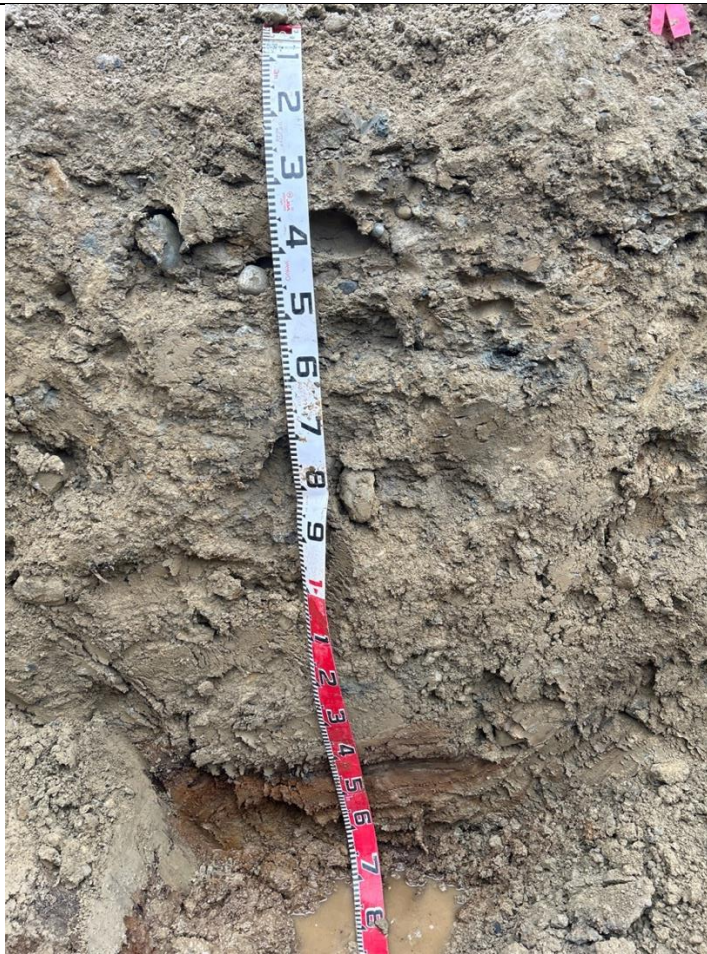
Test Pit 7

Comments: Fill to 141 cm and then bf to 169 cm. Top 50cm heavily packed. Woody debris from logging activity found at fill/native soil barrier.

Horizon	Depth (cm)	Texture	Coarse Fragment %	Coarse fragment notes	Structure	Consistence	Colour	Mottles
Fill	0-141	Loam	50	Mostly gravel and cobble. Occasional stones & boulders	C SBK	Moist; firm	2.5Y 5/3	No
Bfh	141-170+	Silt loam	5	Gravels	M SBK	Wet; non- sticky	7.5YR 4/4	No

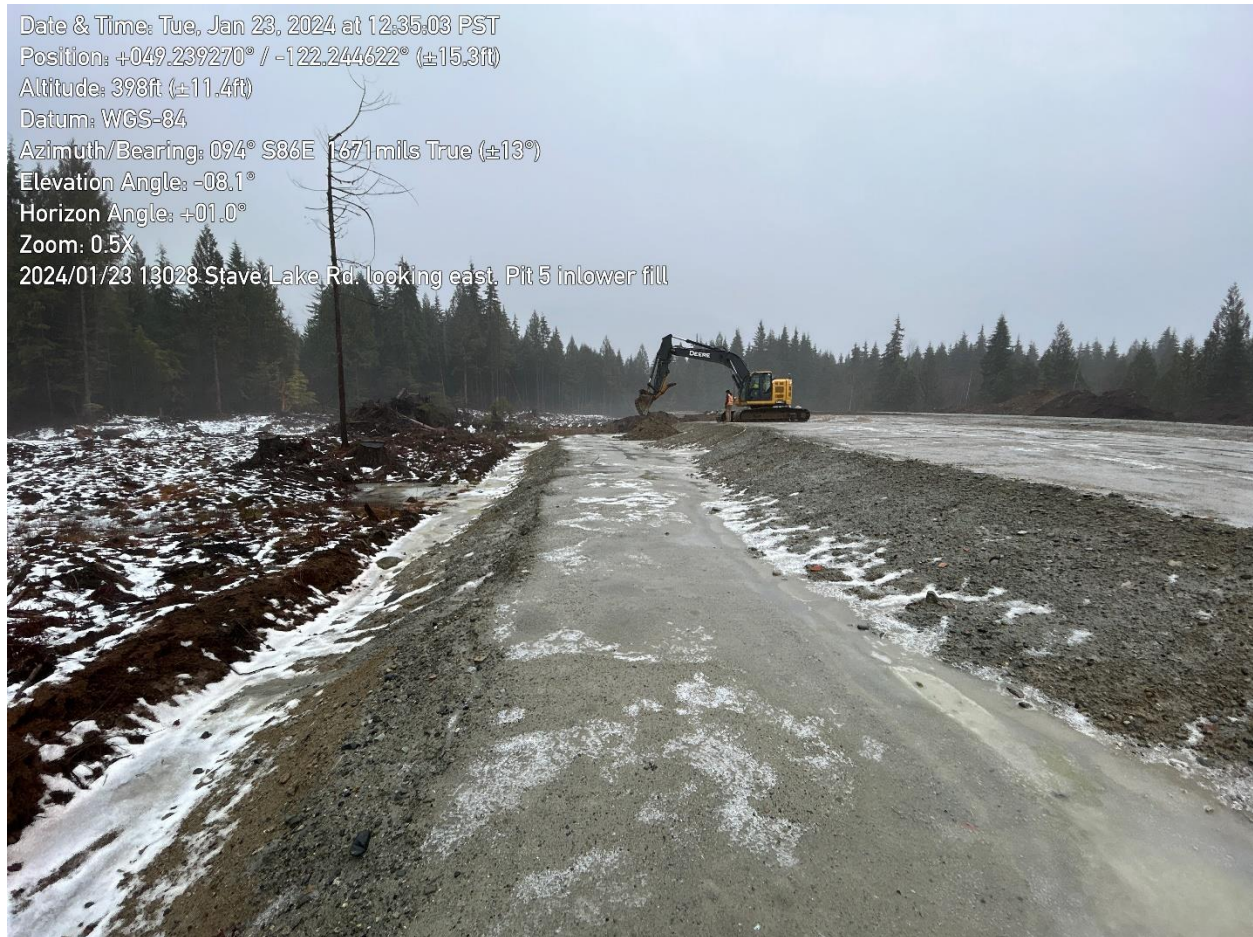
FIGURE 1 LOWER BENCH OF IMPORTED FILL LOOKING TOWARD PIT 5

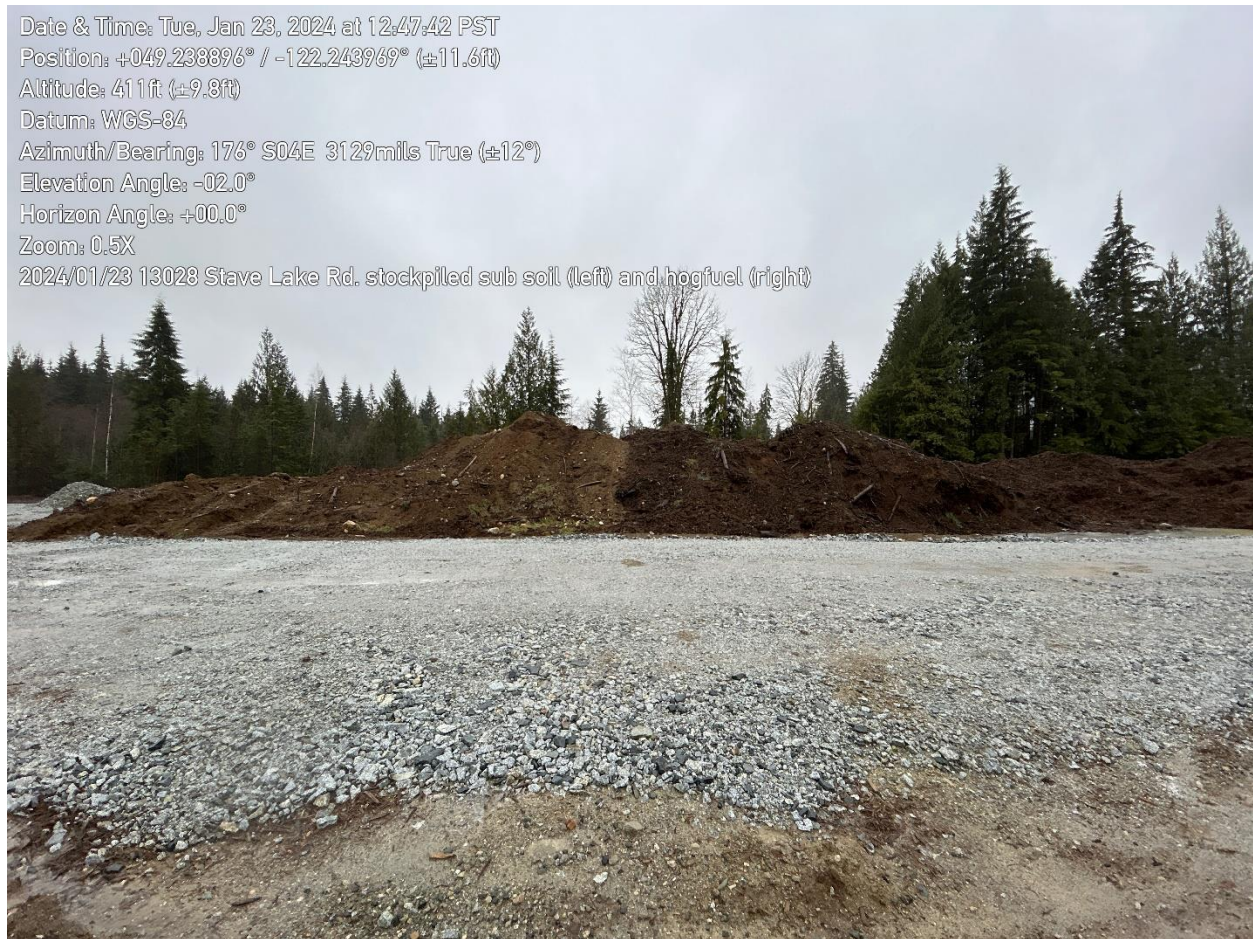
Topsoil was stripped prior to McTavish consultants being on site and was stockpiled adjacent to the temporary road. No buried topsoil was found in any of the fill; however, it is not possible to determine whether or not all topsoil was properly stripped and salvaged. According to the landowner, topsoil will be replaced across the property once the temporary road and turnaround are removed. Some garbage was found within the fill (e.g., plastic PVC pipe), but the amount was minimal.

FIGURE 2 TOPSOIL PILED ADJACENT TO TEMPORARY ROAD

- Replacement of stripped topsoil and the addition of soil amendments to improve topsoil structure and depth.
- Subsoiling or deep tillage to improve the compaction and undesirable soil structure (D), particularly in the fill and at the fill topsoil interface.
- Rock picking of the upper 50 cm of the fill material to reduce the excess stoniness limitation (P)

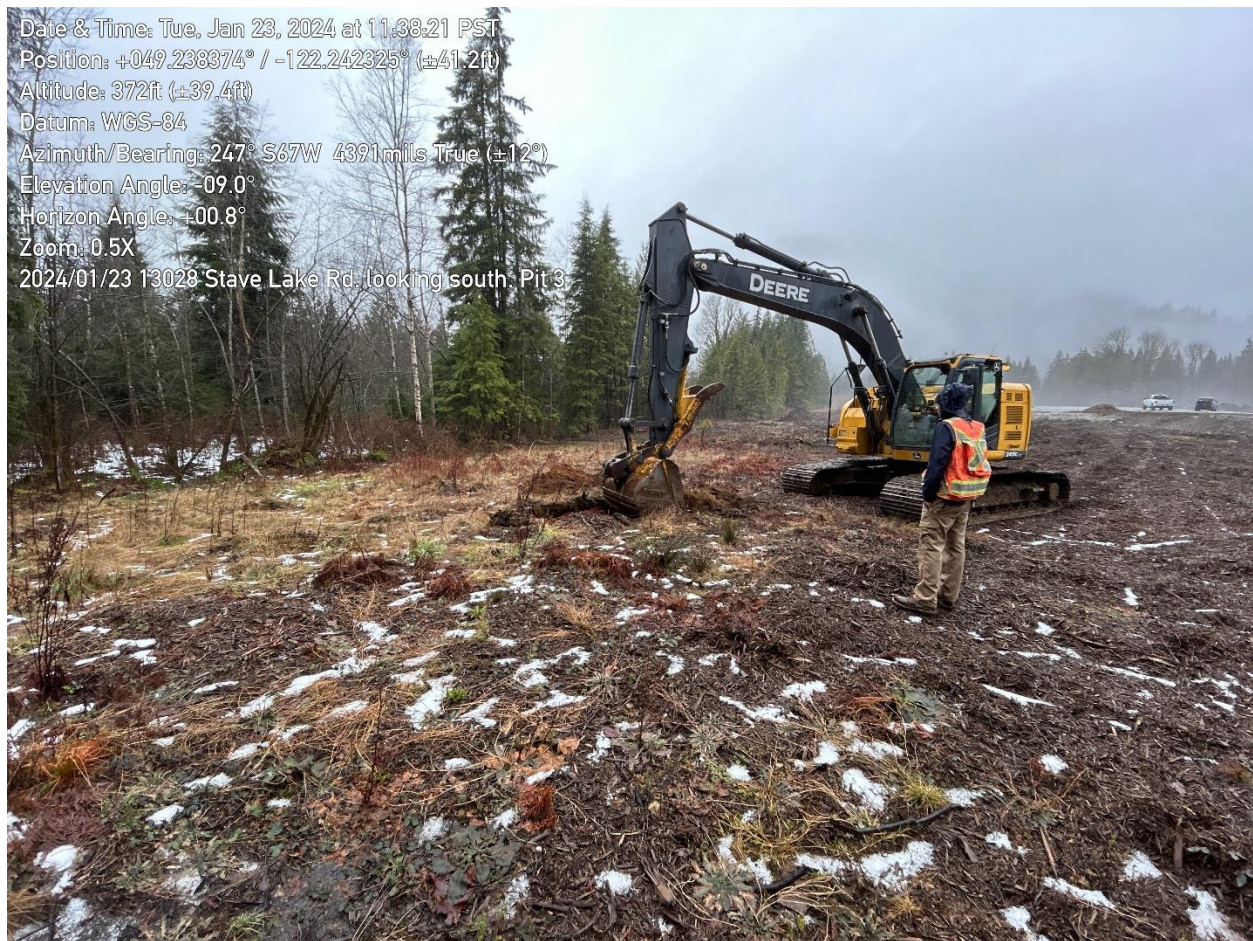
FIGURE 3 PIT 3 IN NATIVE SOIL

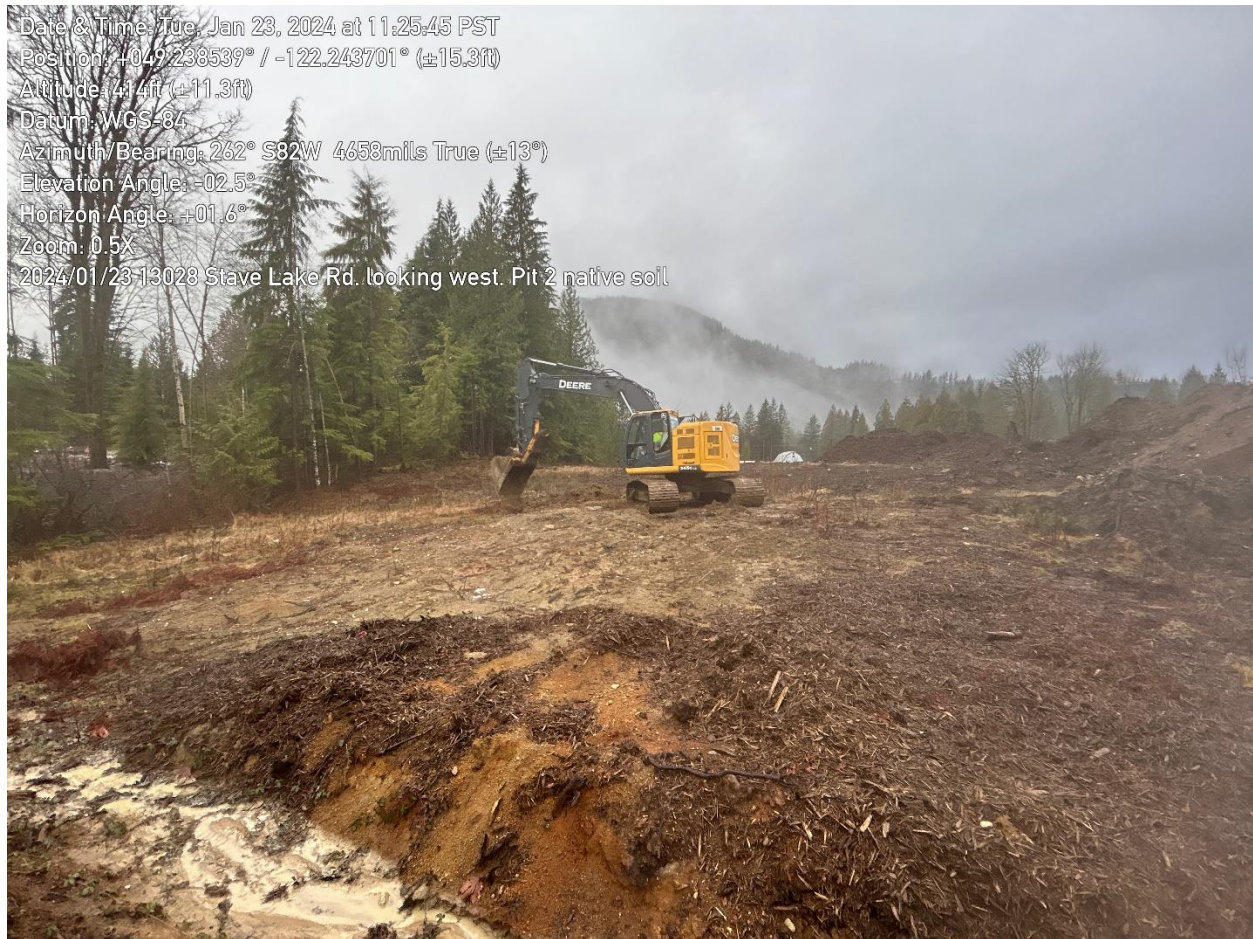
FIGURE 4 PIT 2 IN NATIVE SOIL

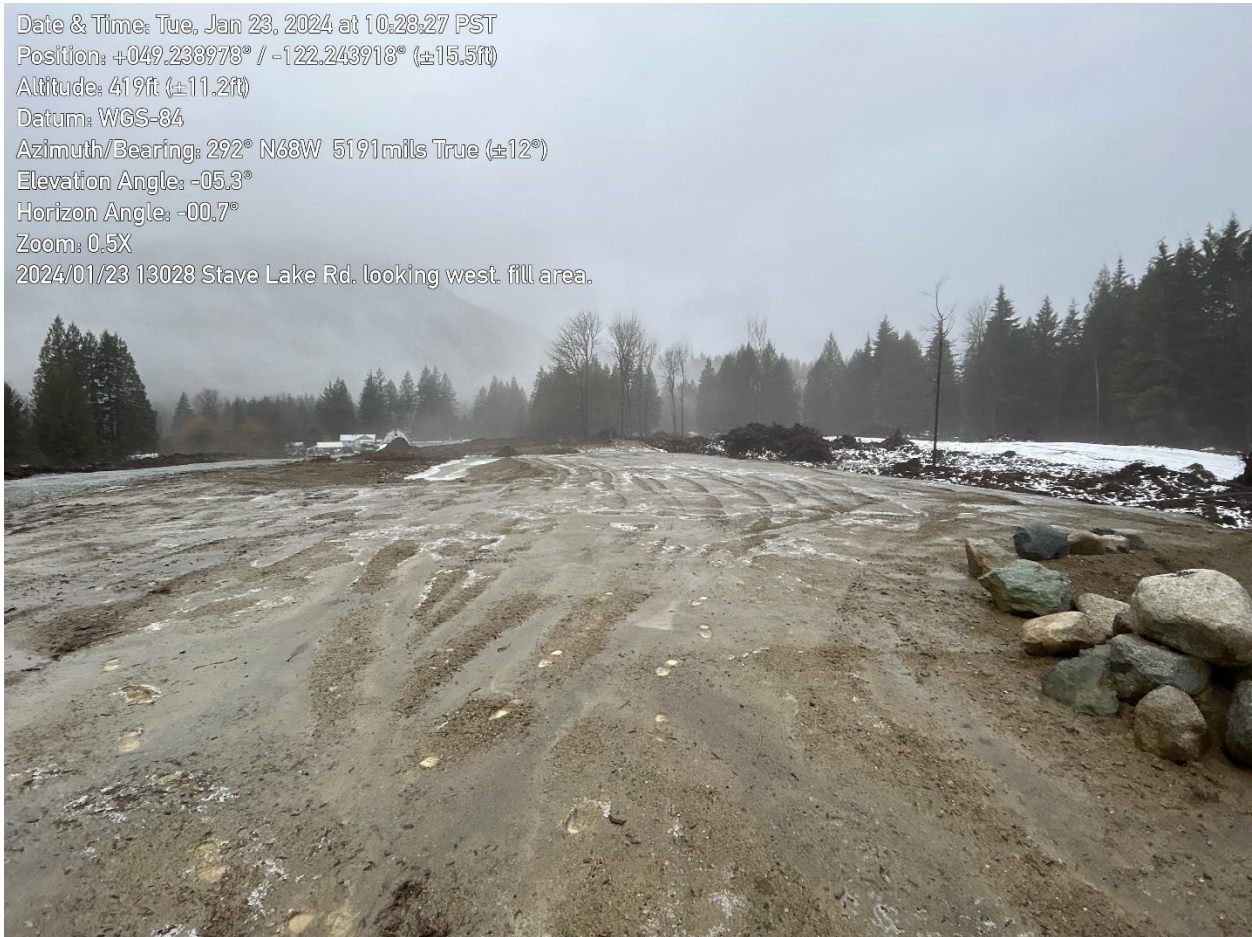
FIGURE 5 IMPORTED FILL (CENTER RIGHT) FROM THE TURNAROUND LOOKING WEST

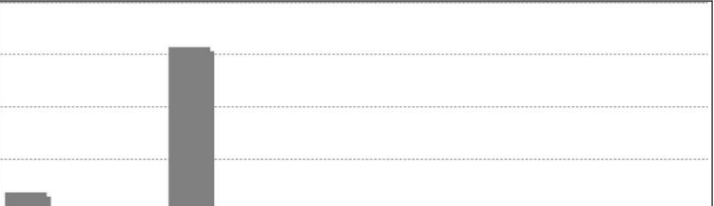
Nutrient analysis (ppm)														Soil Quality			
Depth	N*	P	K	S**	Ca	Mg	Fe	Cu	Zn	B	Mn	Cl	Na	pH	EC(dS/m)	OM(%)	Lot Ref #
0" - 36"	2			18										7.7	0.28		21730
Excess

Alkaline	Extreme	High	
Optimum														Neutral	Very High	Normal	
Marginal														Acidic	High	Low	
Deficient														Very Acidic	Good	Very Low	
Total lbs/acre	29			217	Texture <u>Sandy Loam</u> Hand Texture <u>n/a</u>						BS <u>n/a</u> CEC <u>n/a</u>						
					Sand 57.6 % Silt 31.0 % Clay 10.8 %						Ca <u>n/a</u> Mg <u>n/a</u> Na <u>n/a</u> K <u>n/a</u>						
Estimated lbs/acre	29			211	Ammonium <u>n/a</u>						TEC <u>n/a</u>						
					Lime <u>n/a</u> Buffer pH <u>n/a</u> K/Mg Ratio <u>n/a</u>

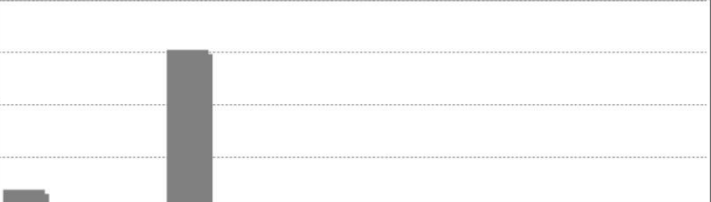
Nutrient analysis (ppm)														Soil Quality			
Depth	N*	P	K	S**	Ca	Mg	Fe	Cu	Zn	B	Mn	Cl	Na	pH	EC(dS/m)	OM(%)	Lot Ref #
0" - 36"	3			11										7.2	0.2		21731
Excess

Alkaline	Extreme	High	
Optimum														Neutral	Very High	Normal	
Marginal														Acidic	High	Low	
Deficient														Very Acidic	Good	Very Low	
Total lbs/acre	31			130	Texture <u>Sandy Loam</u> Hand Texture <u>n/a</u>						BS n/a CEC n/a						
					Sand 53.0 %	Silt 32.0 %	Clay 15.5 %	Ca n/a Mg n/a Na n/a K n/a									
Estimated lbs/acre	30			126	Ammonium n/a						TEC n/a						
					Lime n/a Buffer pH n/a						K/Mg Ratio n/a
