# REPORT

## NOI: Dale Road Placement of Fill Agrologist Report & Reclamation Plan

OCTOBER 2024

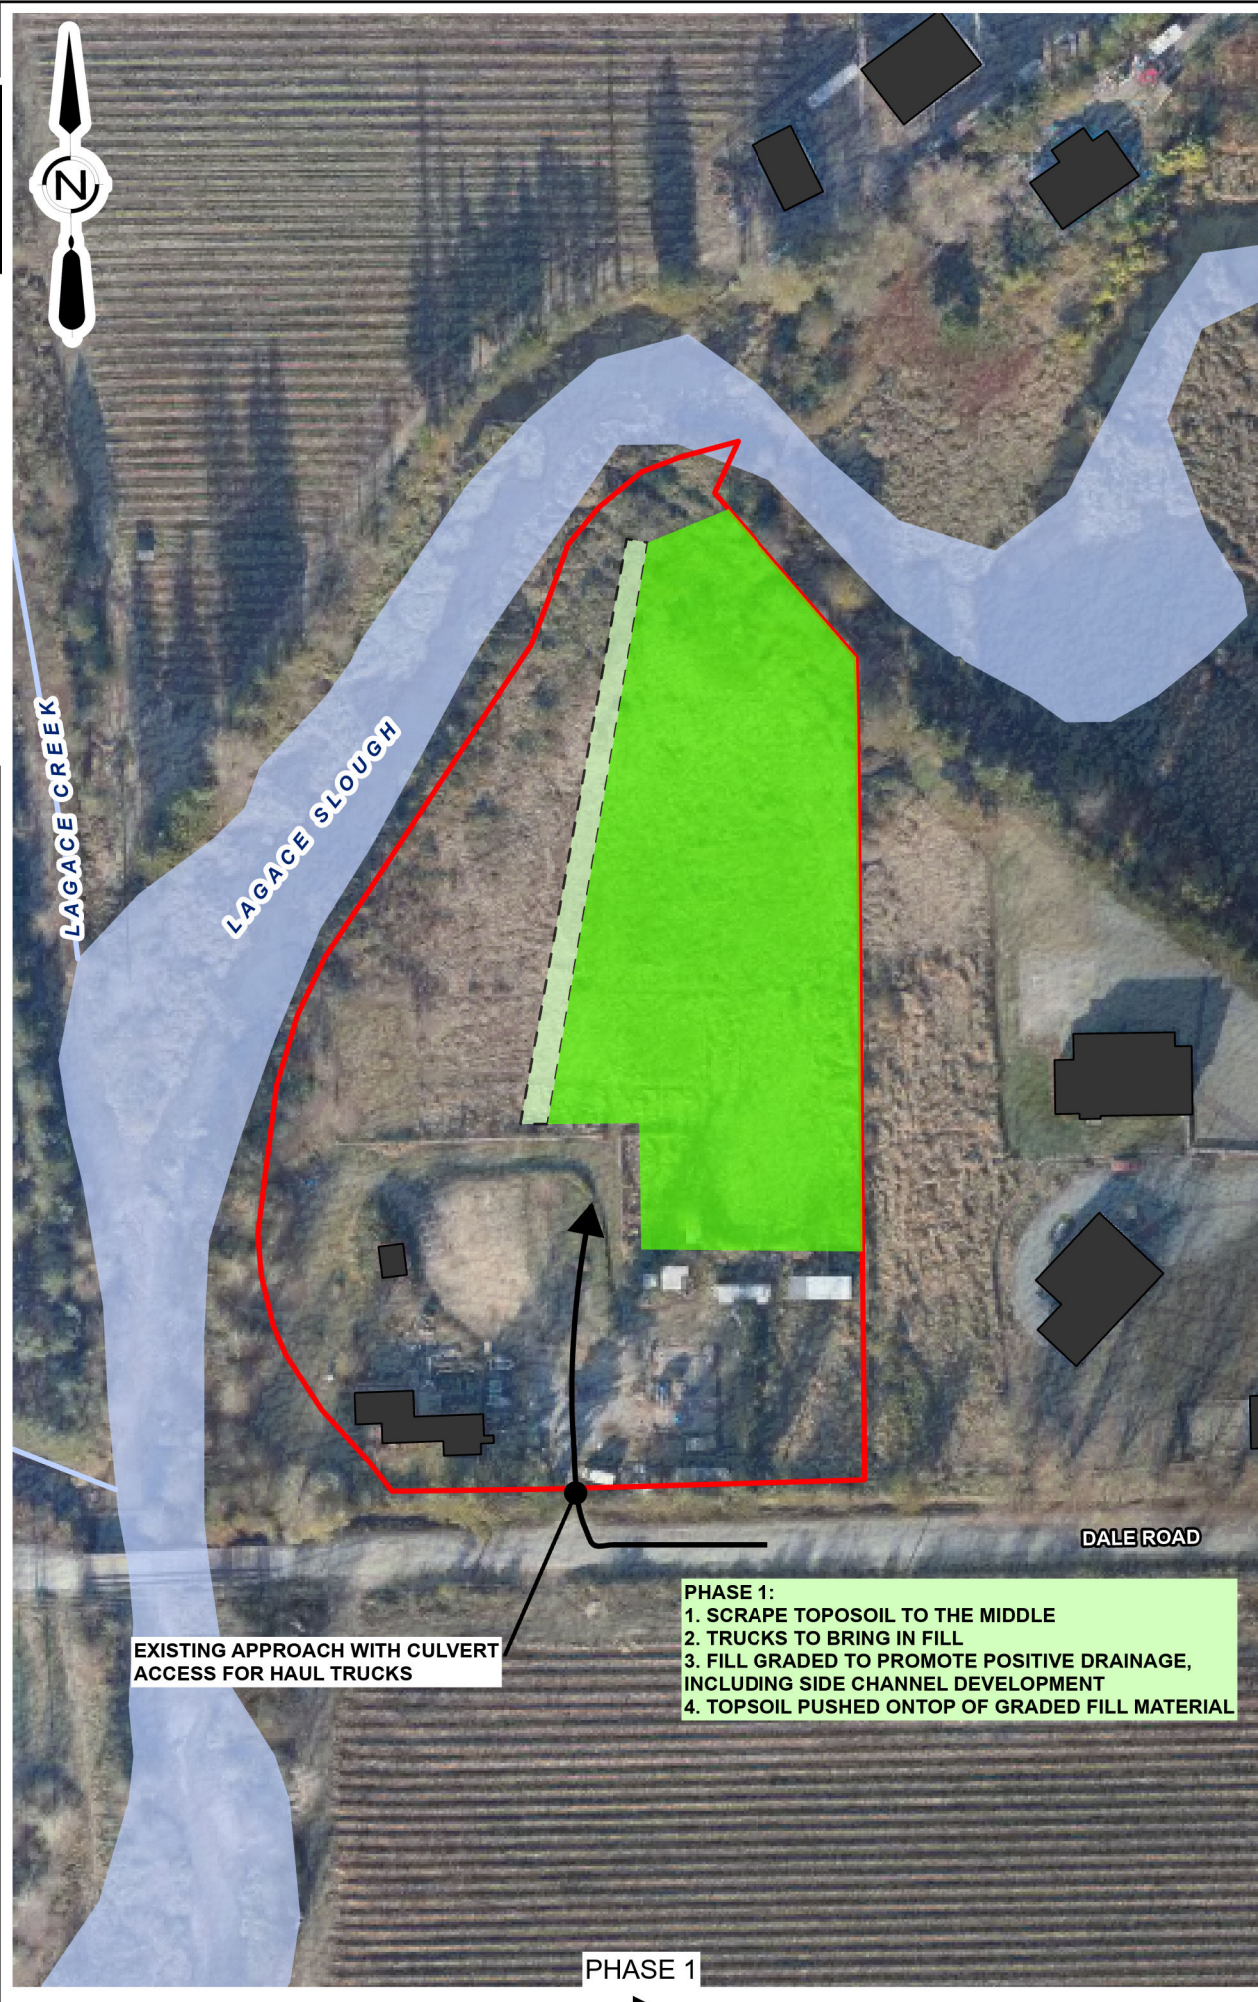
FIGURE 3-1

The regraded land will generally slope from east to west, towards the creek, but also slope away from the centre of the site to the north and south, to encourage drainage in every direction towards the perimeter swales. A grade break along the centreline will separate gradual hillslopes of between 0.7 to 0.8% in the east, from between 0.5 to 0.6% in the west. The centreline will have a slightly steeper hillslope of 1.5% to the north and 2.3% to the south. The perimeter swales will tie into existing elevations along the edge of the development, with a 1m wide channel bed, encouraging positive drainage from the site to flow towards the Lagace Slough. There will be shrubby vegetation maintained around the perimeter of the fill area to allow for natural attenuation of any excess surface flow, as the trees are becoming established. Figure 3-2 shows the proposed cross-section of the fill placement.

35225 DALE ROAD  
SITE PLAN

Access for fill import will be brought in through the gates off Dale Road (Figure 3-1). Fill placement will begin upon approval of the NOI and placement would be expected to be finished in 1 year. Depending on approval date, the proponent would like to start importing fill in spring 2025, and then being planting trees as soon as possible after the fill is placed and topsoil restored. Mr. Hancock plans to irrigate the trees using available water sources, which will initially be with trucking in water. For the long term, water for irrigation is dependant on upgrading his current domestic water use license.

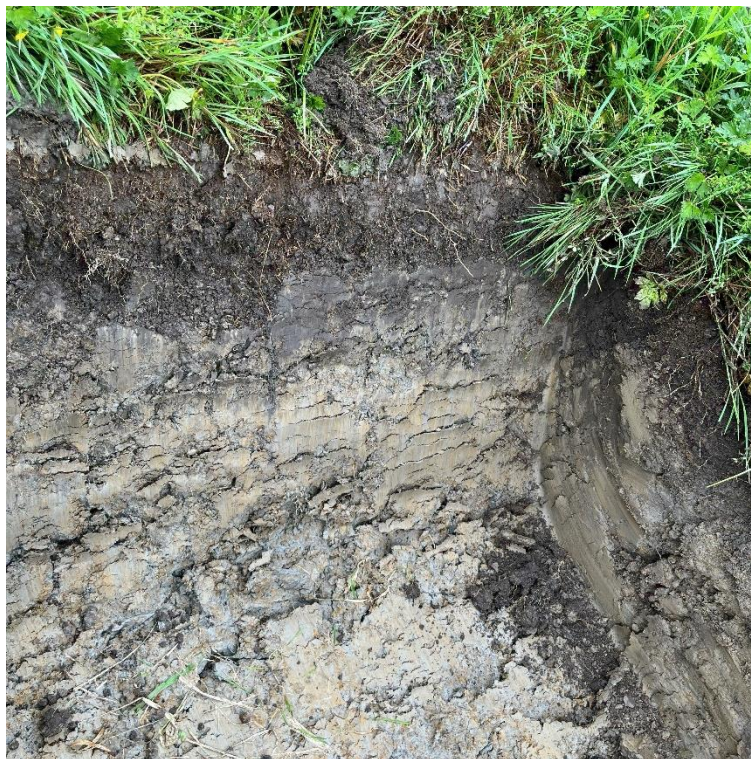
Photo A-1 Mottling present in subsoil

Our observations of the soils in the two test pits, were similar to mapping with slight variations. The soil was textured as a silty loam to silty clay with some mottling present in the B horizon (Photo 1 in Appendix-A). The agricultural capability was assessed as 3W with the primary limitation occurring from excess water where there is up to 20 cm during the winter and early spring. Standing water is also present after high intensity rainfall events. Results from the test pits are provided in Table 5-1. Photos of each pit are provided in Appendix A (Photo 2 & 3).

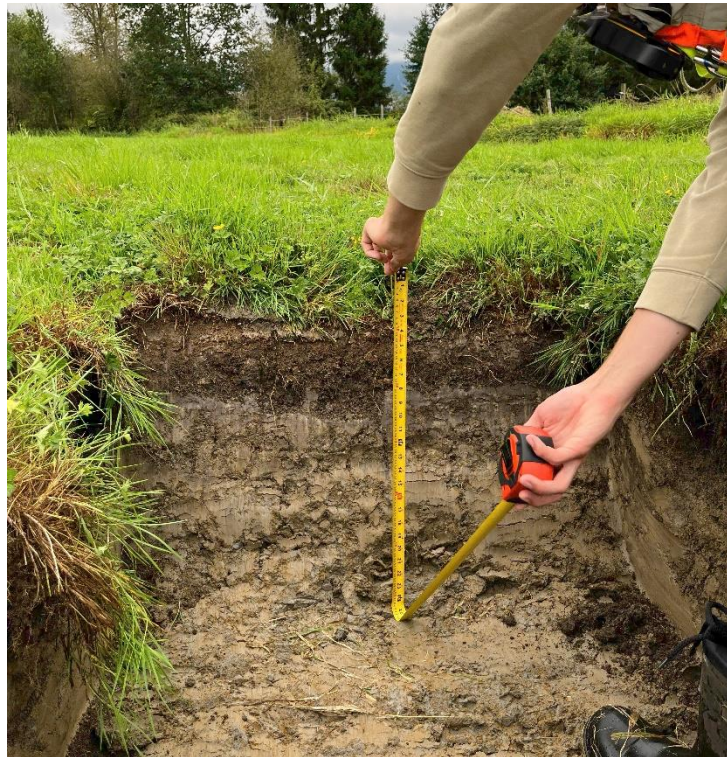
Photo A-2 Test Pit #1

A Horizon	B Horizon
Horizon depth (cm bgl)	20	20 to 40 cm
Texture	Silt Loam	Silty Clay
Structure	Moderate	Strong
Consistence	Sticky	Very Sticky
Coarse Fragment	None	None
Presence and depth of mottles	No	20 cm +
Drainage Class	Poor	Poor
Rooting depth/root restricting layer	No	Compact clay could restrict root depth
Agricultural Capability	3W

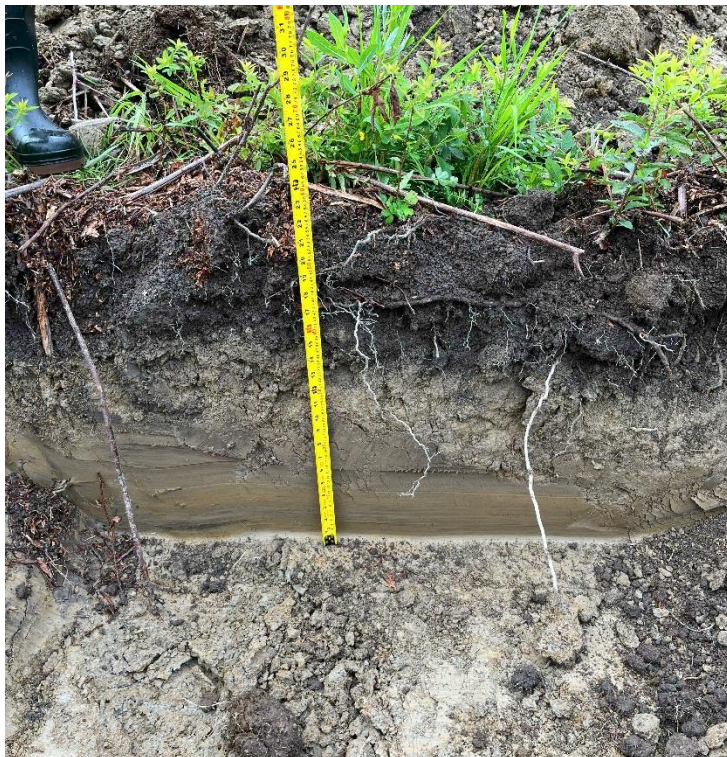
Photo A-3 Test Pit #2

A Horizon	B Horizon
Horizon depth (cm bgl)	20	20 to 40 cm
Texture	Silty Clay	Silty Clay
Structure	Moderate	Strong
Consistence	Sticky	Very Sticky
Coarse Fragment	None	None
Presence and depth of mottles	No	20 cm +
Drainage Class	Poor	Poor
Rooting depth/root restricting layer	No	Compact clay could restrict root depth
Agricultural Capability	3W
