FRASER VALLEY REGIONAL DISTRICT DEVELOPMENT PERMIT

Permit No.	2025-02	Folio No.	775.02616.000
Issued to:	Wladyslaw Wojcik		
Applicant:	Jamie Stirling, P.Geo. (Stirling Geoscience Ltd.)		
Site Address:	38482 Bell Road, Area G

**38482 Bell Road, Deroche, BC – Flood Hazard Assessment and Development Permit Application,
dated April 16, 2025, prepared by Jamie Stirling, P. Geo. of Stirling Geoscience Ltd.**

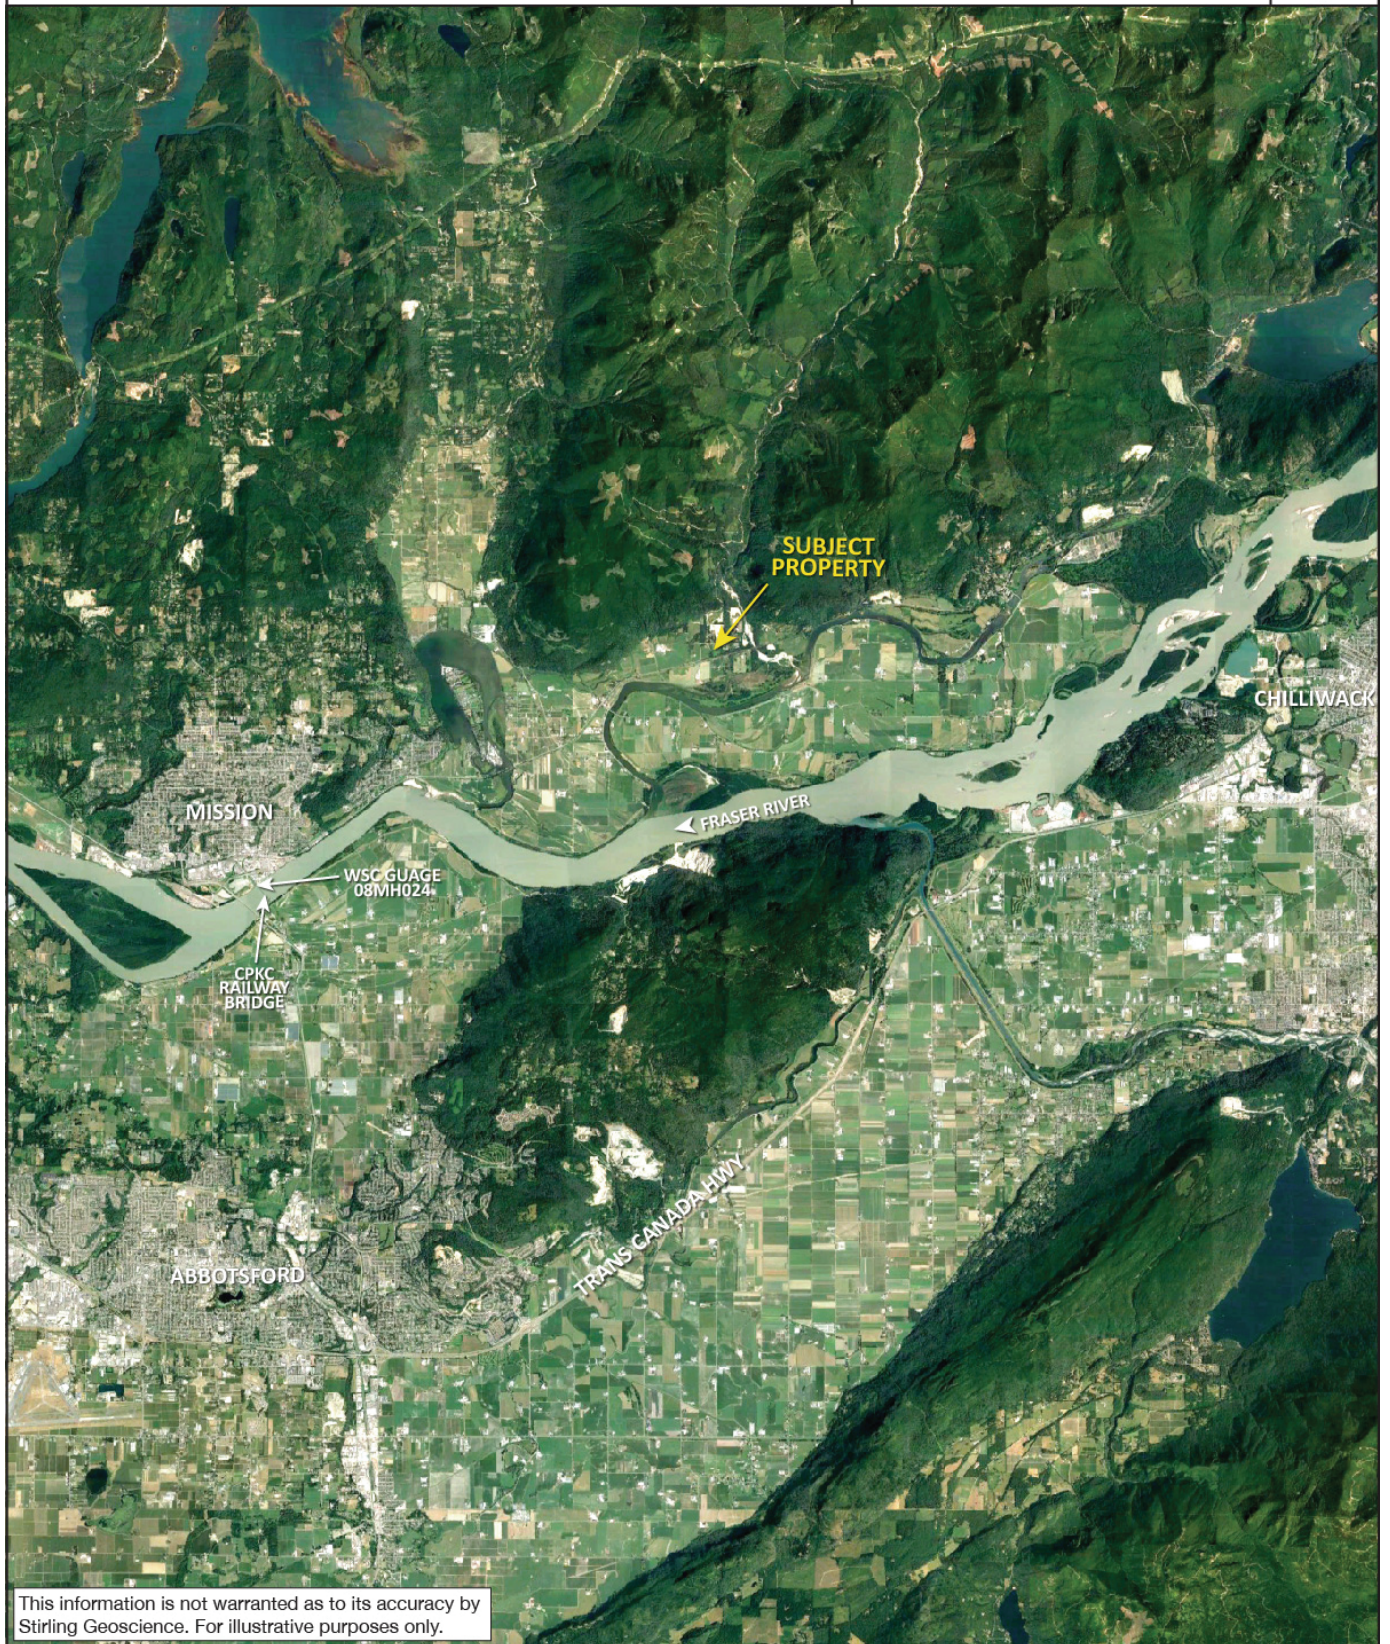
Figure 1: Subject Property and the Fraser Valley (Basemap source: Google Earth, July 29, 2022).

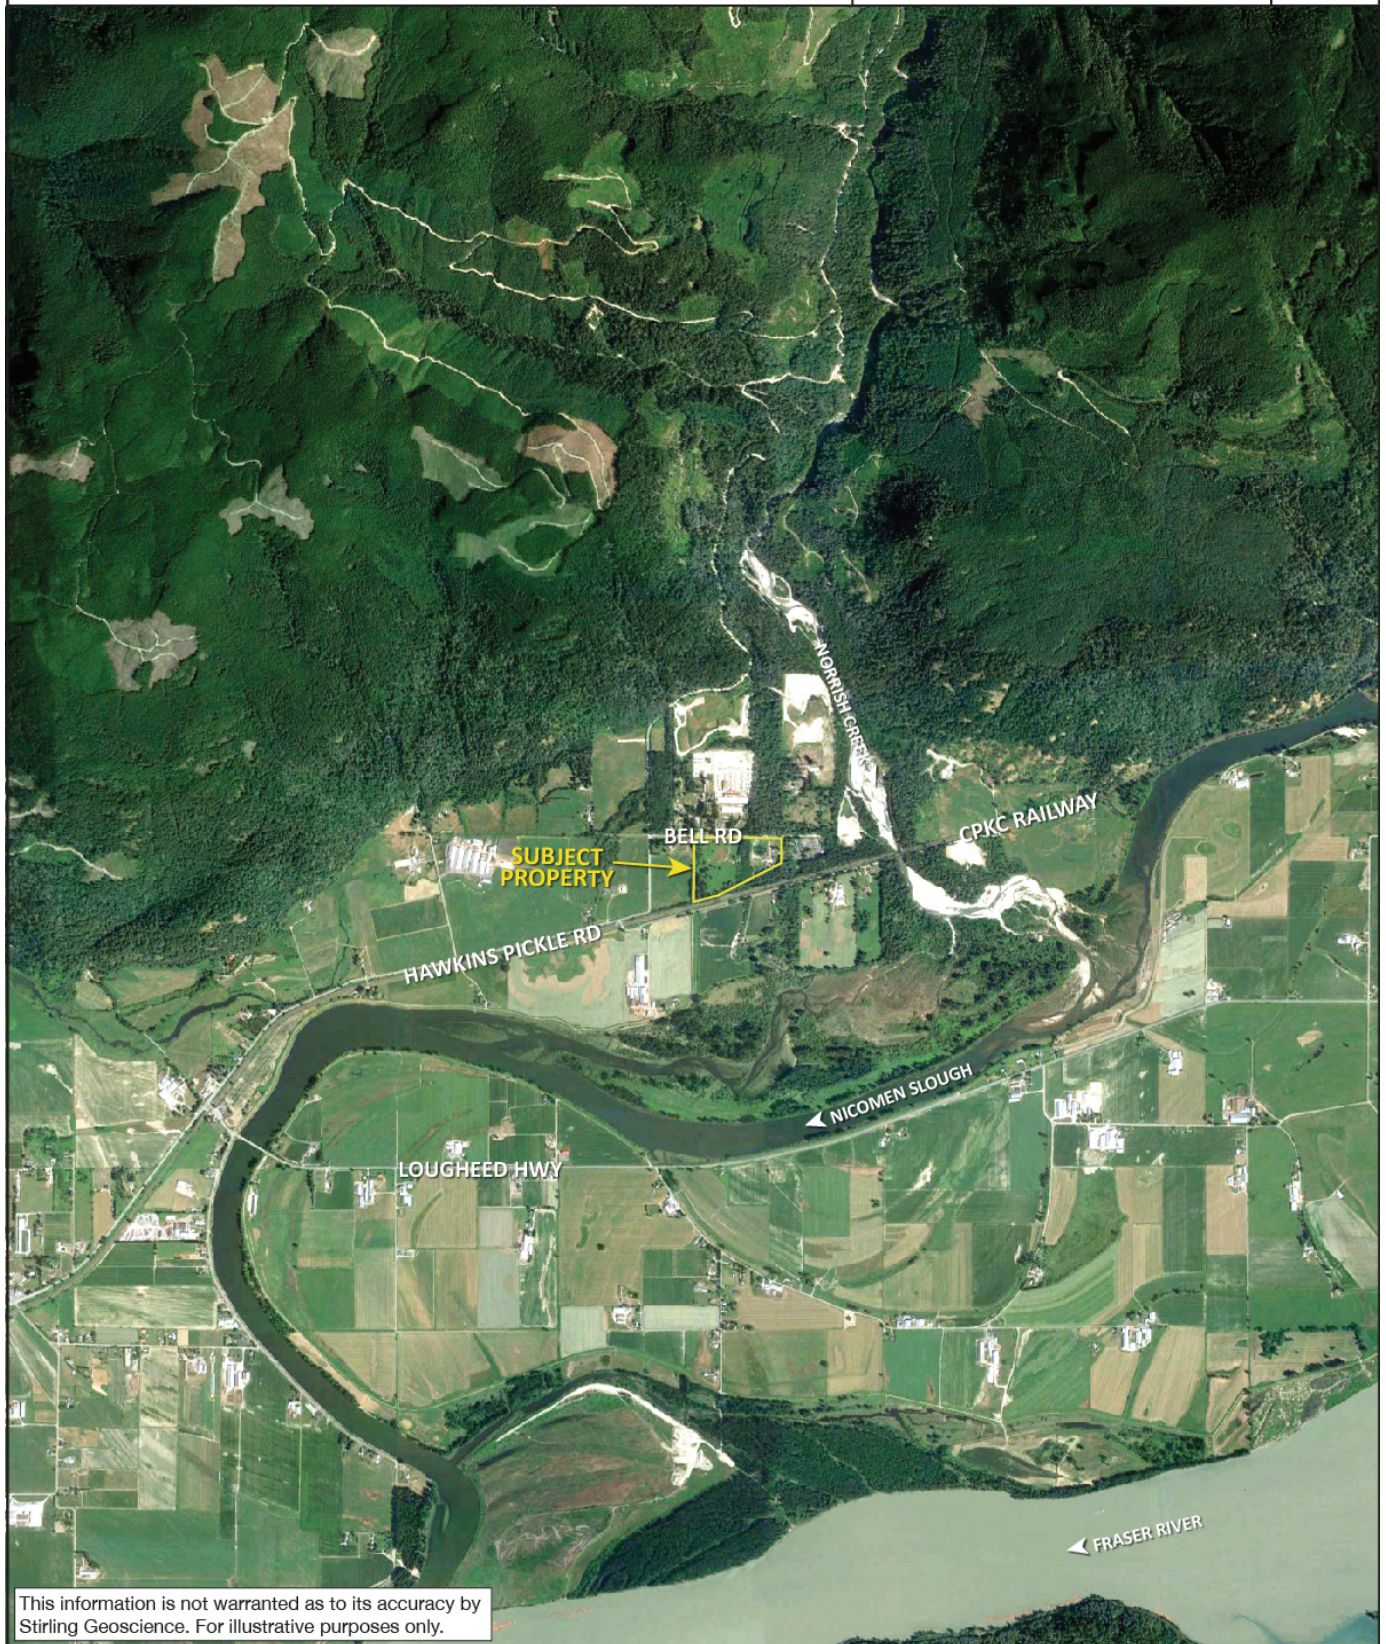
Figure 2: Subject Property and surrounding area (Basemap source: Google Earth, July 29, 2022).

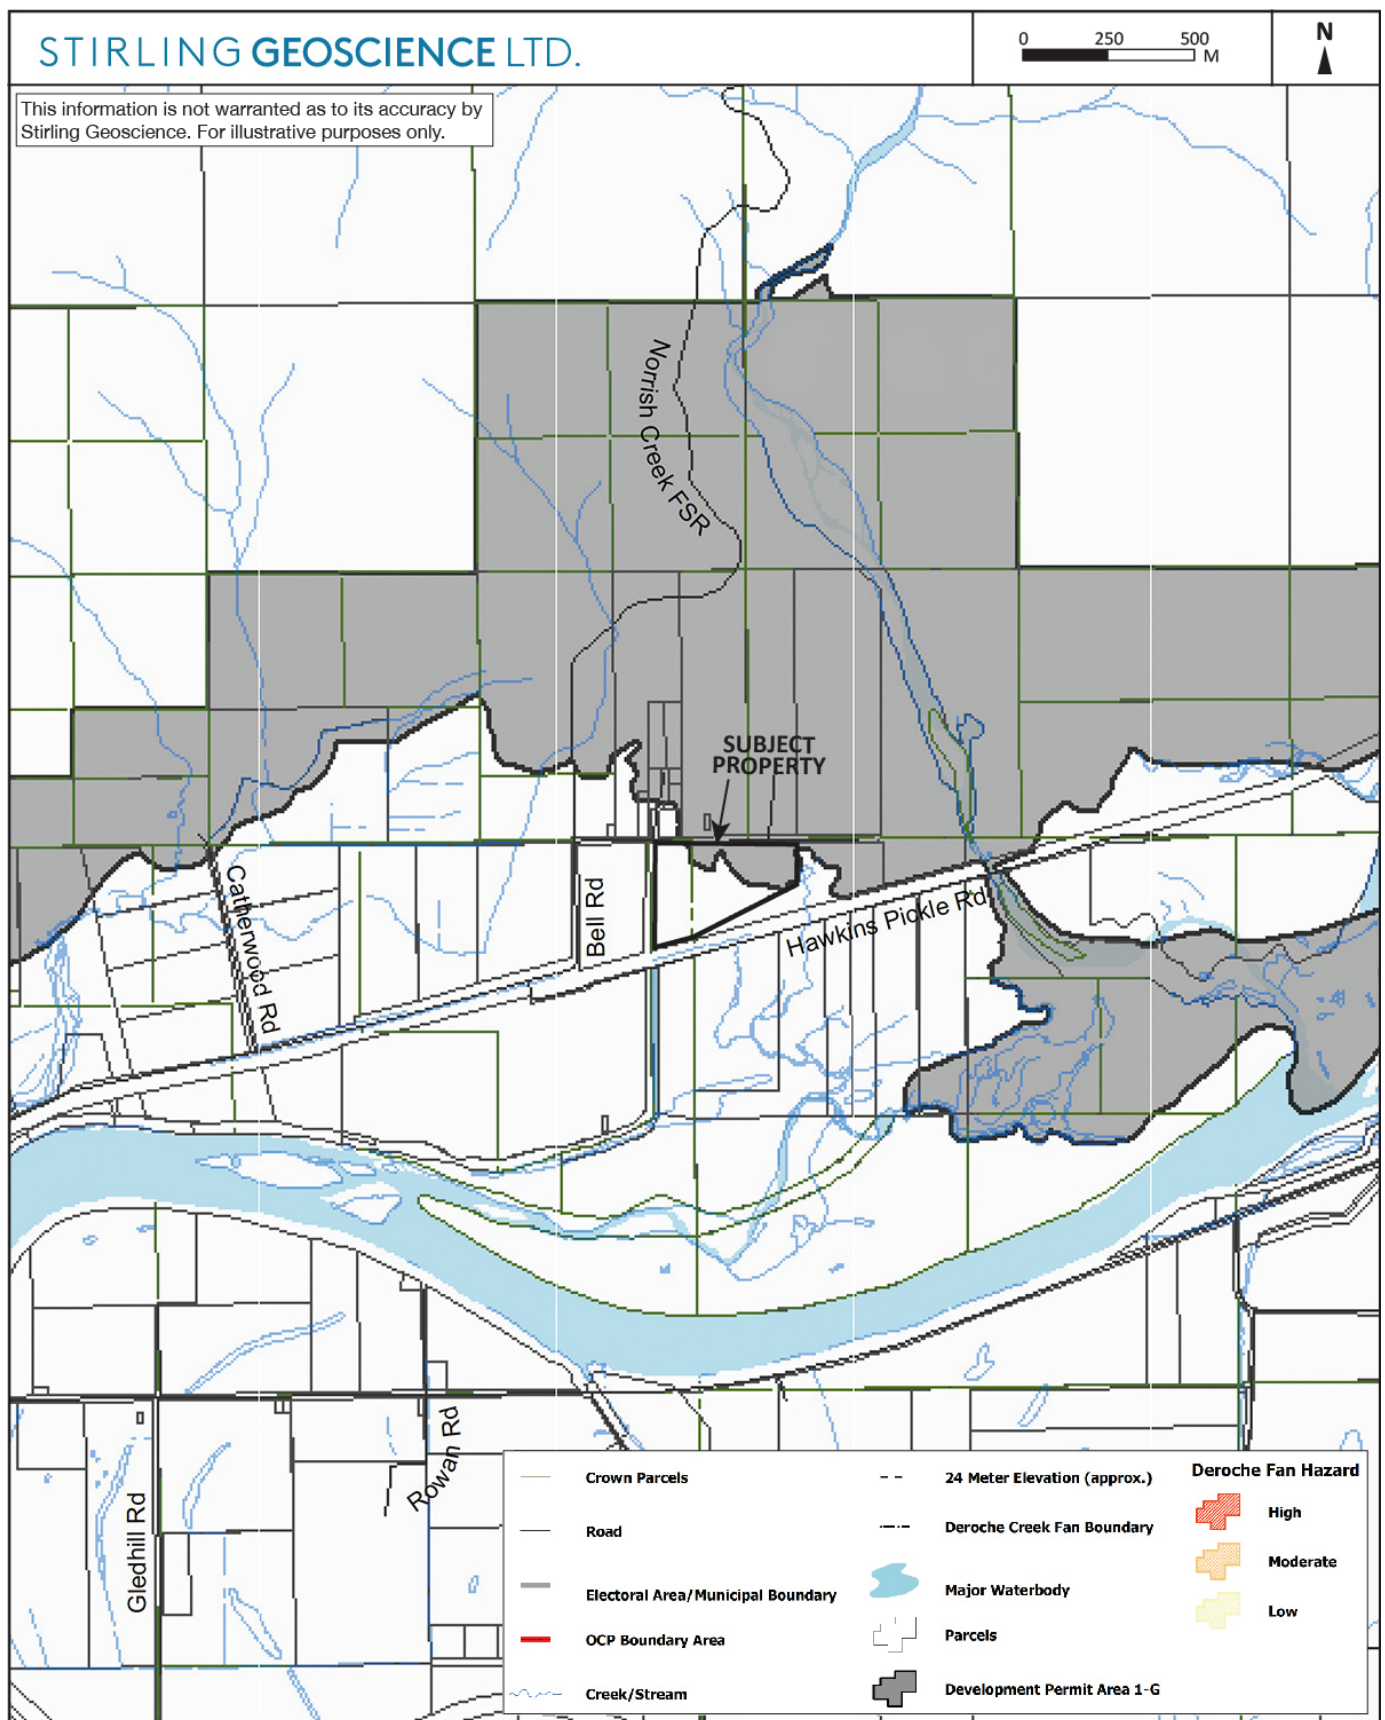
Figure 9: Development Permit Area 1-G in proximity to the Subject Property (Basemap source: FVRD OCP for Electoral Area G, Bylaw No. 0866, 2008, Schedule 4).

The northeastern portion of the Subject Property is within Development Permit Area (DPA) 1-G as shown on Figure 9. DPA 1-G refers to area with potential geologic or stream hazards. A DP is required for any development within DPA 1-G. All of the Site is within DPA 2-G and 2-G includes all of Electoral Area G. DPA 2-G refers to Riparian Areas DPA. Because the Subject Property is within the Riparian Areas DPA an environmental assessment was carried out to support the proposed development and the DP application. The environmental assessment (Environmental Constraints Assessment) was prepared for the property owner by Keystone Environmental and is dated October 10, 2024.

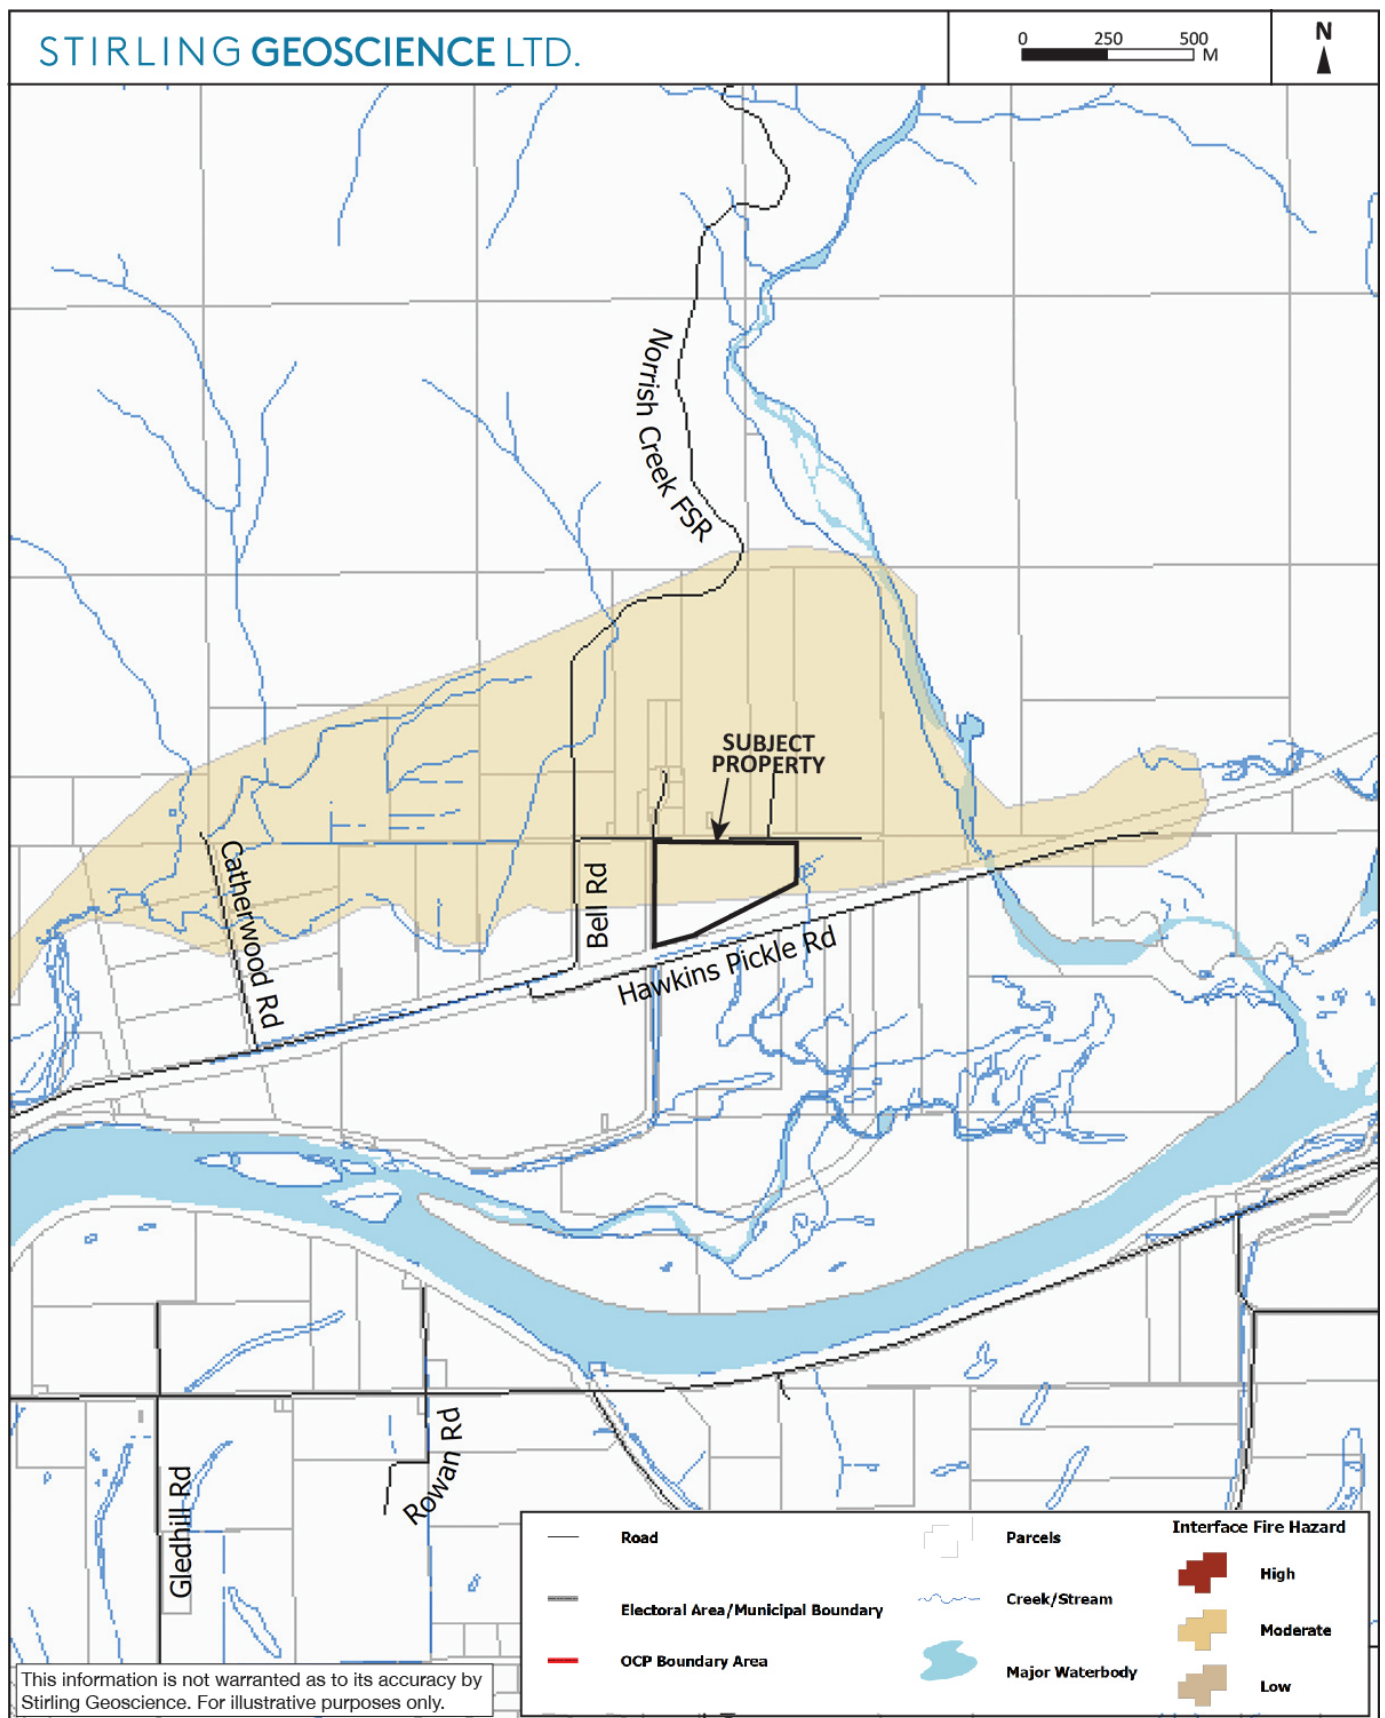
Figure 13: Interface fire hazards in proximity to the Subject Property (Basemap source: FVRD OCP for Electoral Area G, Bylaw No. 0866, 2008, Map 9).

The northern 75% of the Subject Property is identified as being within moderate interface fire hazard as per the OCP (Figure 13). Because the Subject Property is within a moderate fire hazard area a wildfire hazard assessment was carried out to support the proposed development and the DP application. The wildfire hazard assessment and risk mitigation plan were prepared for the property owner by Forte Urban Forestry and is dated December 6, 2023.

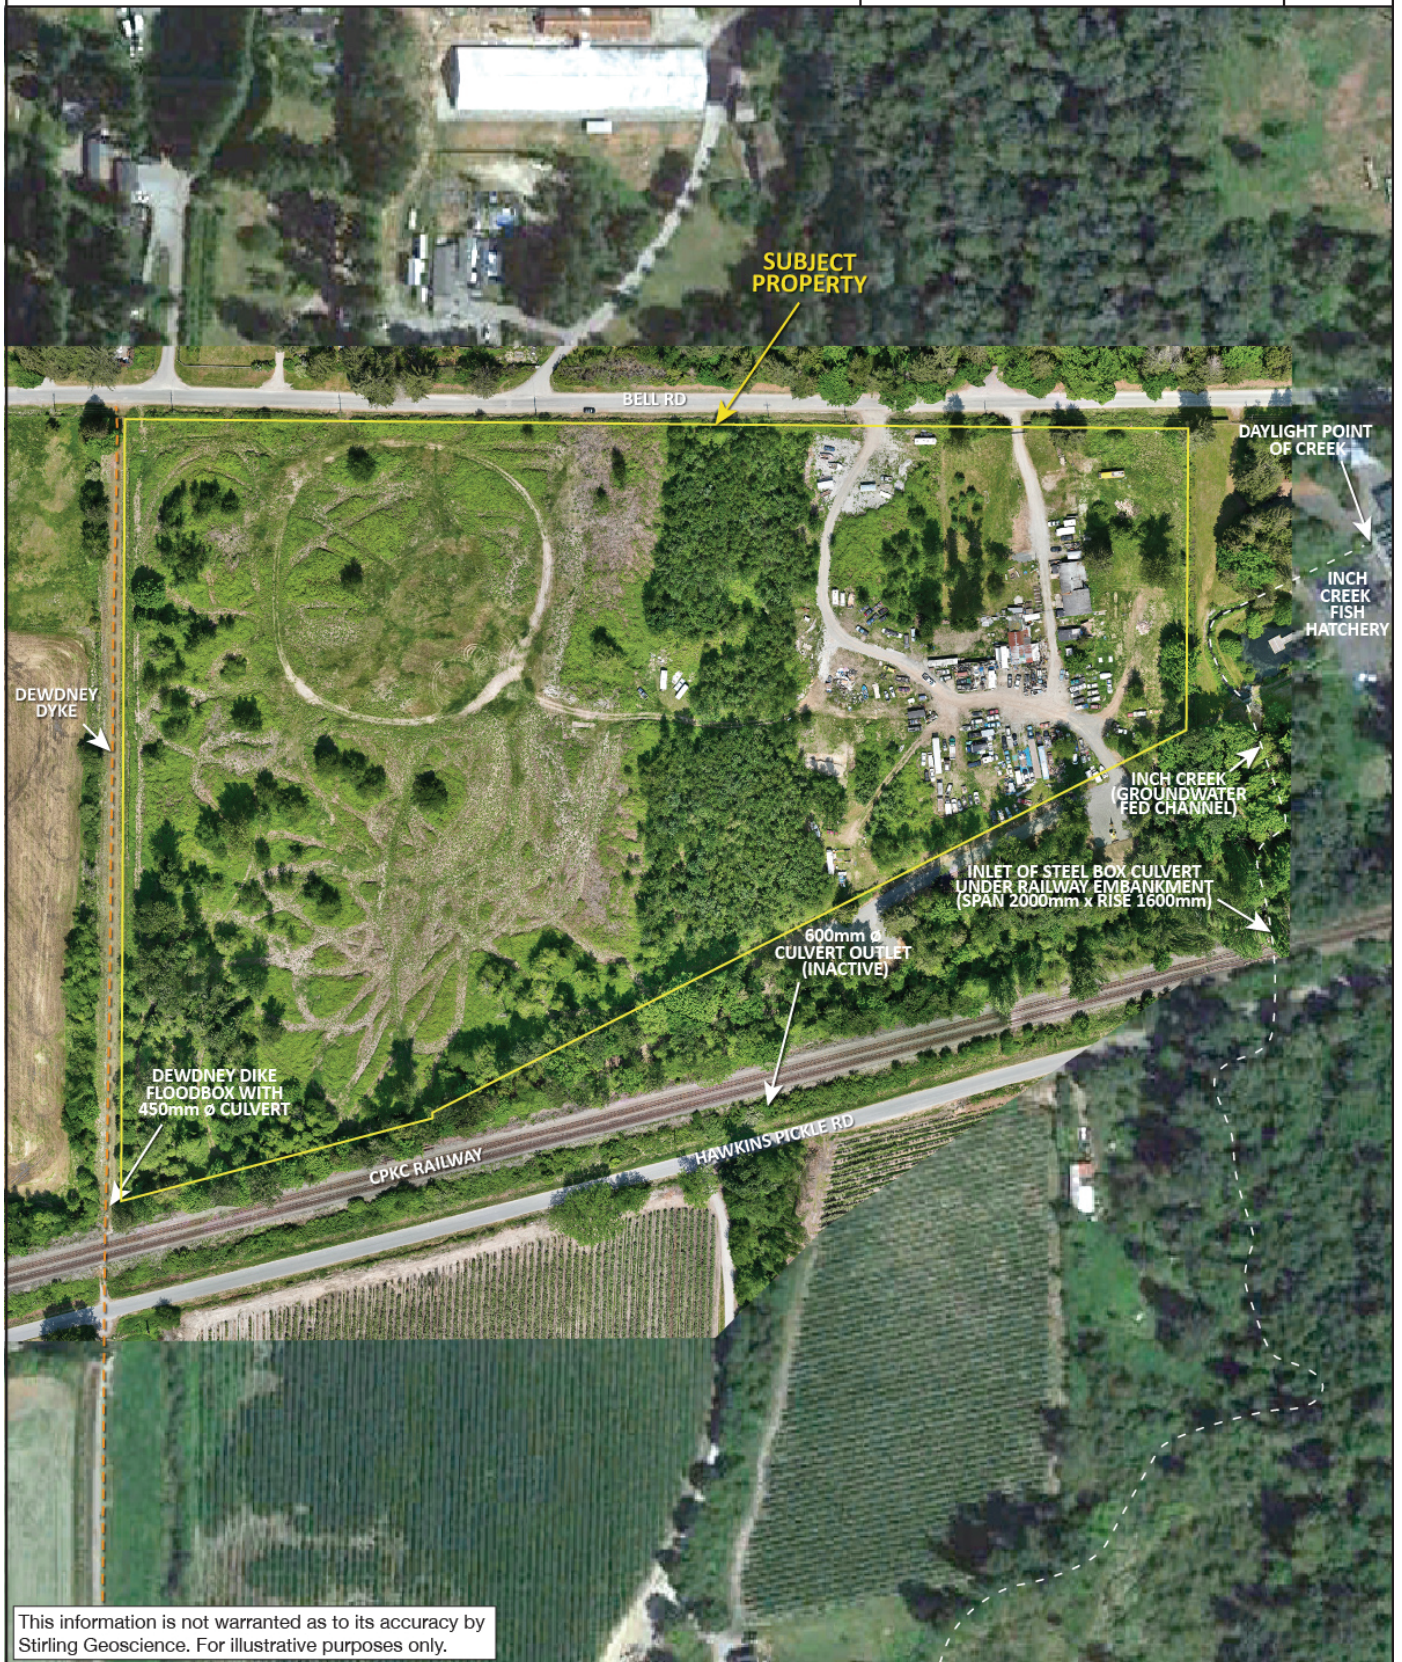
Figure 16: Drone image of the Subject Property from May 17, 2023 (Drone image from SGL and surrounding imagery from Google Earth July 29, 2022).

Drone imagery of the Subject Property was collected by SGL in May 2023 (Figure 16) and February 2024 (Figure 17) to capture the Site during spring and winter vegetation canopy conditions. These high-resolution images represent current conditions on the Site.

The topography of the Site has not changed since the Axis survey in 2018, and this survey still represents current topographic conditions. The survey shows that the Site is relatively flat with a gentle downslope away from Norrish Creek from the northeast to the southwest of approximately 1% (Appendix D). This topographic survey shows more detail than the LiDAR contours in Appendix C. Based on the topographic survey, the western half of the property averages from 8 to 9 m GD and the eastern half averages from 9 to 10.5 m GD. The lowest area on the property is in the southwest corner and averages approximately 7 m GD and the highest area is near the northeast corner averaging approximately 11 m GD. The Site currently has one residential building along the eastern part of the property (Figures 16 and 17).

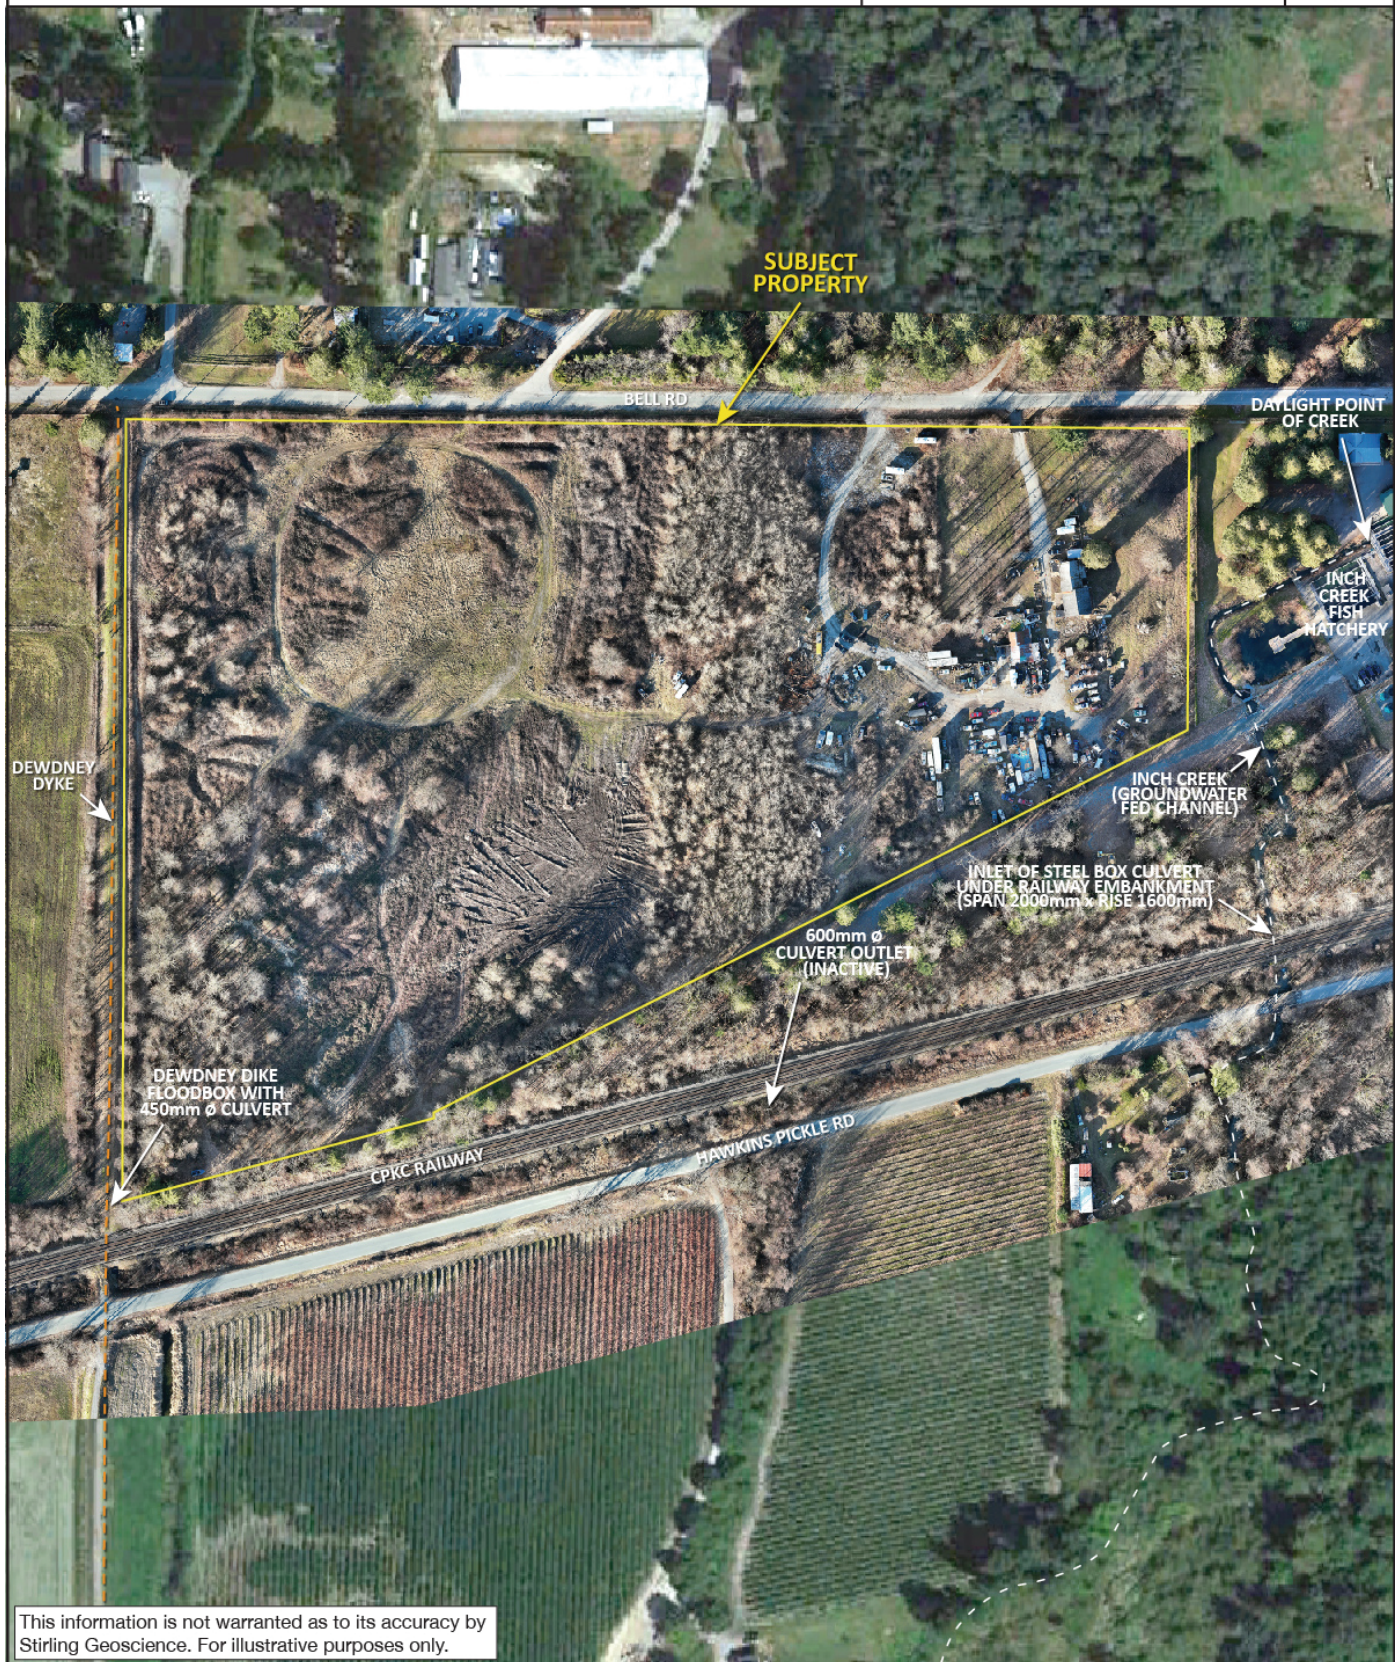
Figure 17: Drone image of the Subject Property from February 4, 2024 (Drone image from SGL and surrounding imagery from Google Earth July 29, 2022).

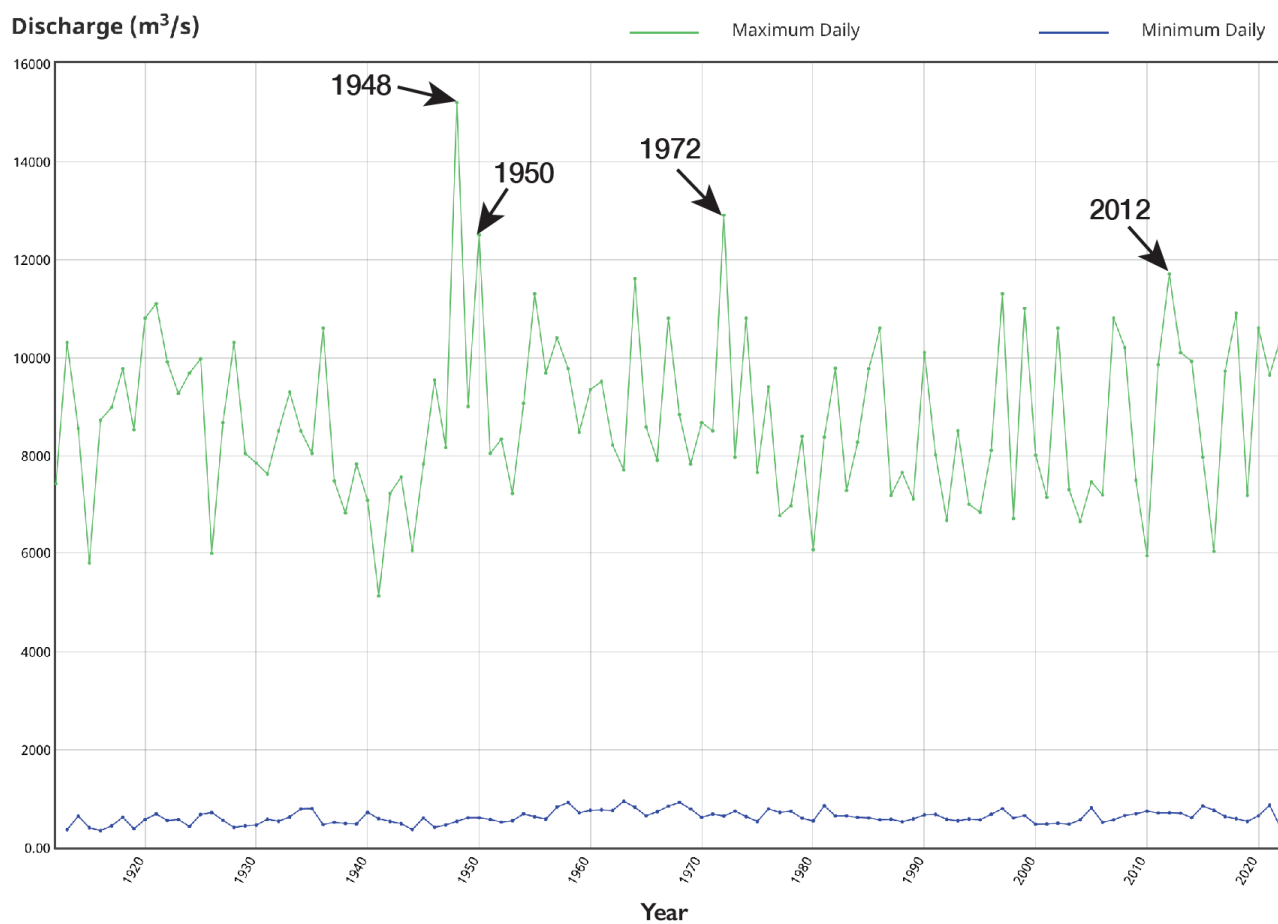
Figure 18: Fraser River at Hope (Station 08MF005) annual maximum daily floods from 1912 to 2022 (Source: Water Survey of Canada, April 16, 2024).

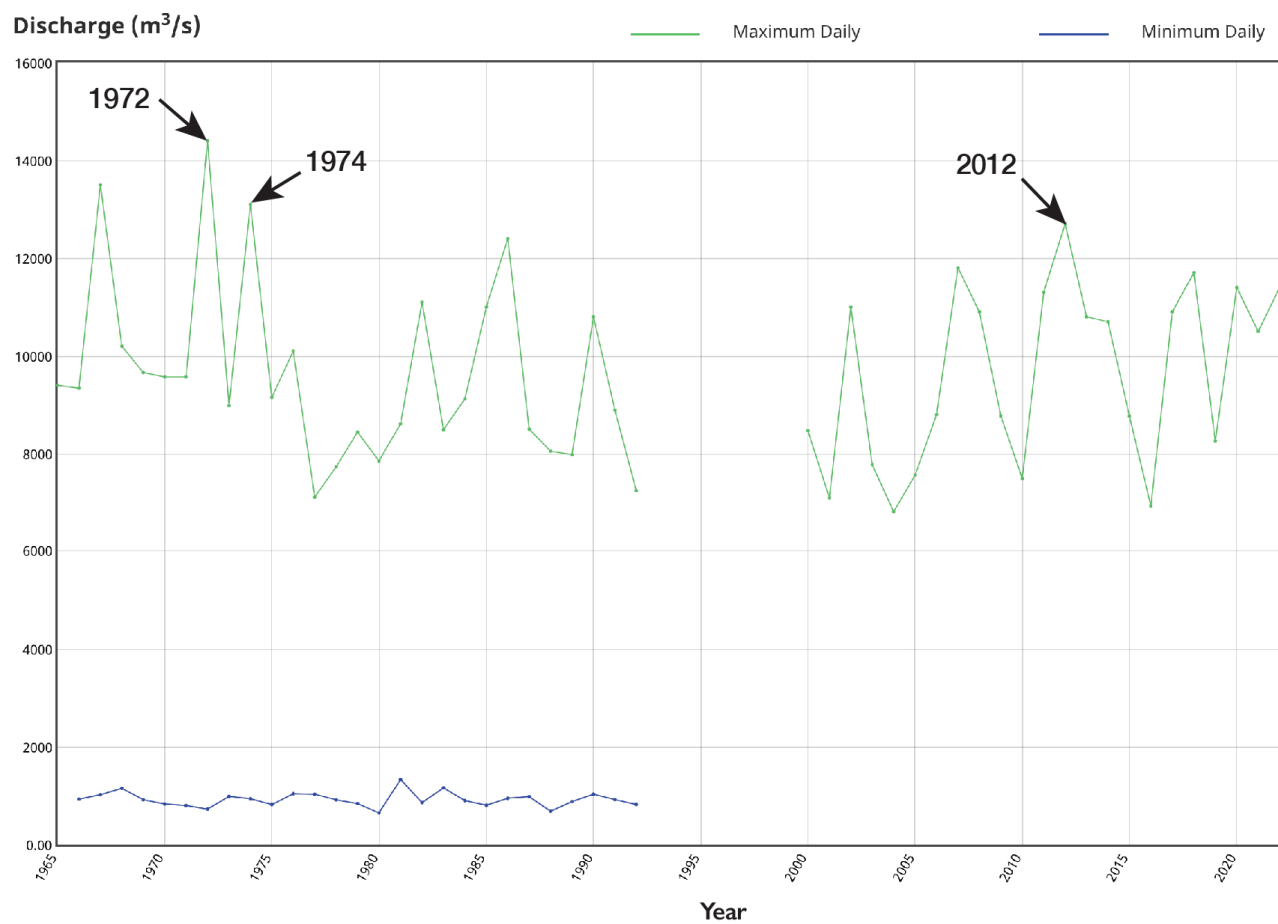
Figure 19: Fraser River at Mission (Station 08MH024) annual maximum daily floods from 1965 to 2022 (Source: Water Survey of Canada, April 16, 2024).

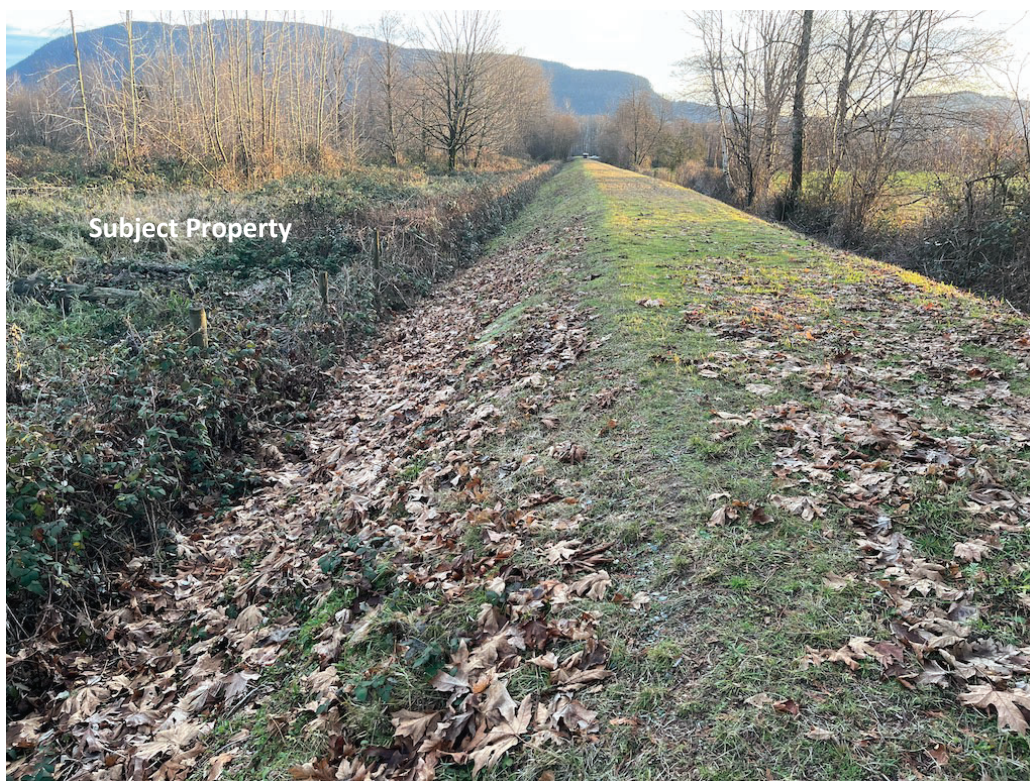
Photo 2: December 15, 2023. Looking south along the Dewdney Dike from the northwest corner of the Subject Property.

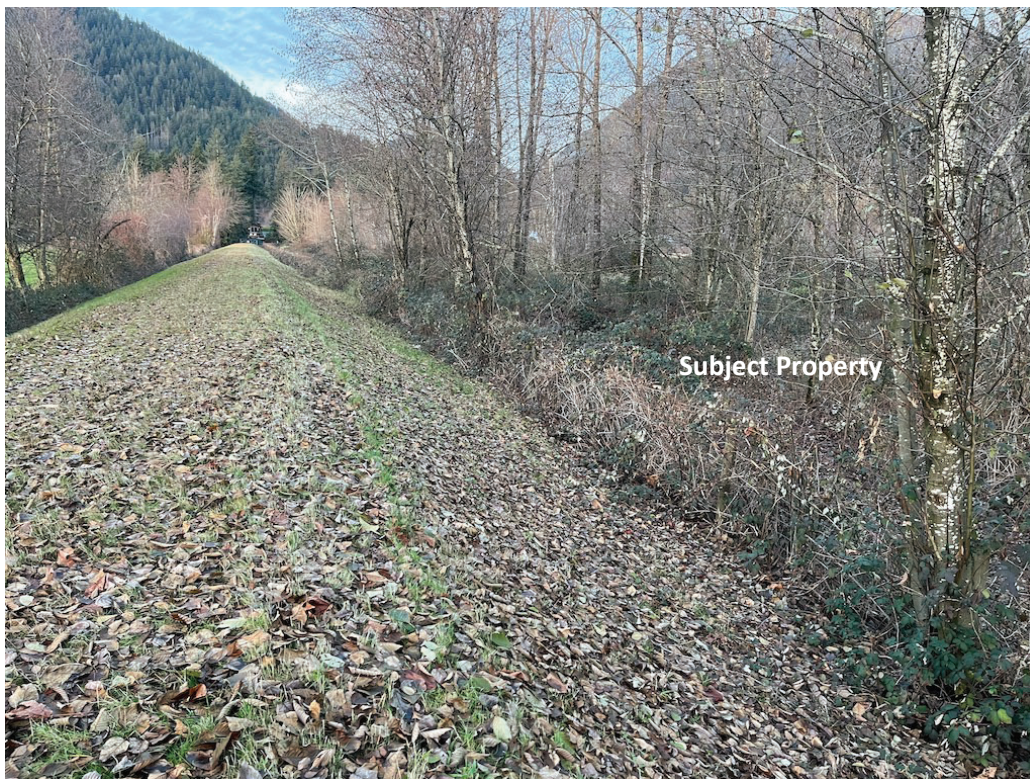
Photo 4: December 15, 2023. Looking north along the Dewdney Dike from the southwest corner of the Subject Property.

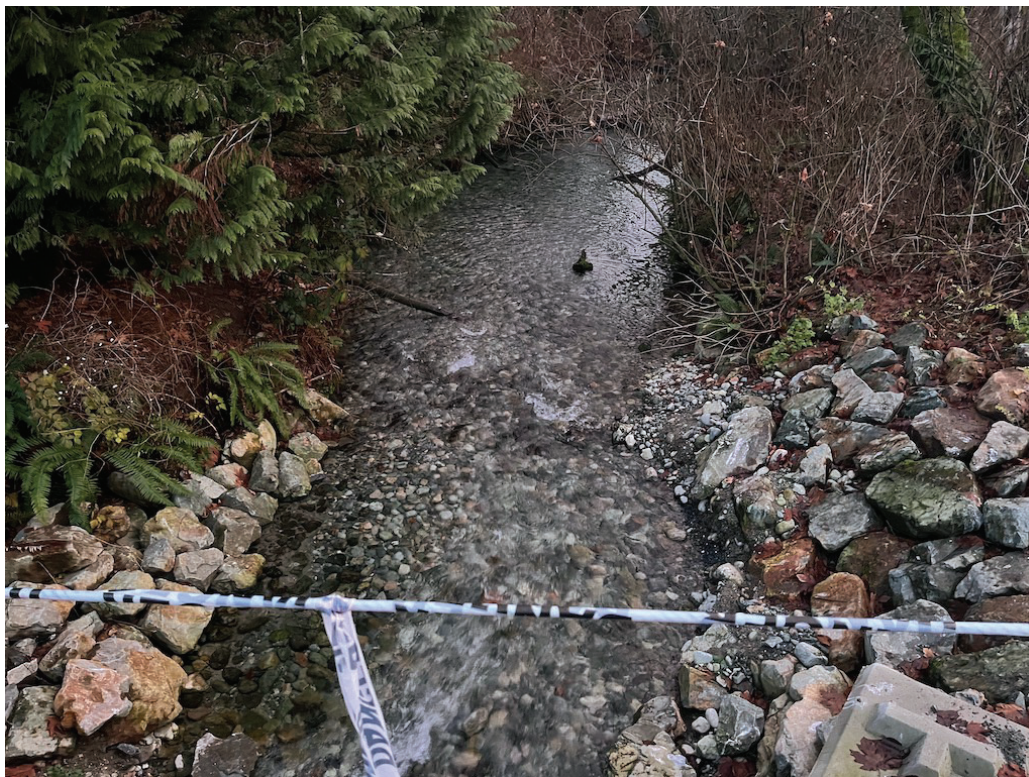
Photo 10: December 15, 2023. Looking south (downstream) on Inch Creek from the DFO Inch Creek fish hatchery bridge adjacent to the southeast corner of the Site.

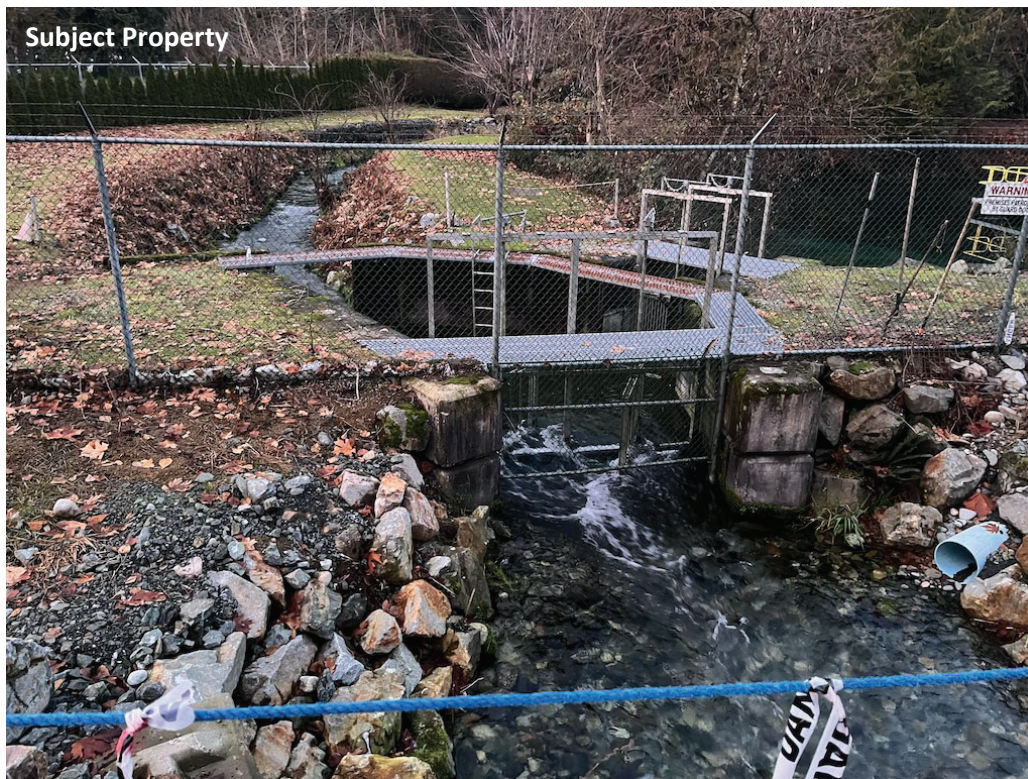
Photo 11: December 15, 2023. Looking north (upstream) on Inch Creek and the fish hatchery from adjacent to the southeast corner of the Site.

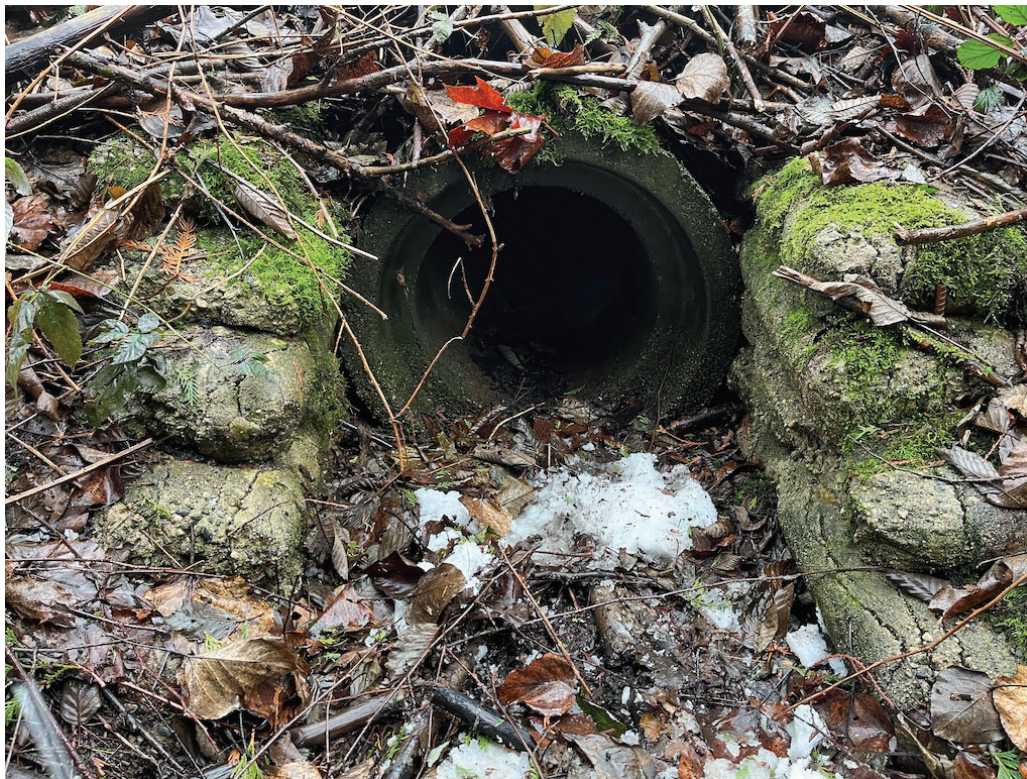
Photo 17: January 23, 2024. Looking at the inlet of the 450 mm diameter concrete culvert as part of the Dewdney Dike floodbox. The inlet is at El. 6.35 m and is adjacent to the southwest corner of the Subject Property which is the lowest point on the Site.

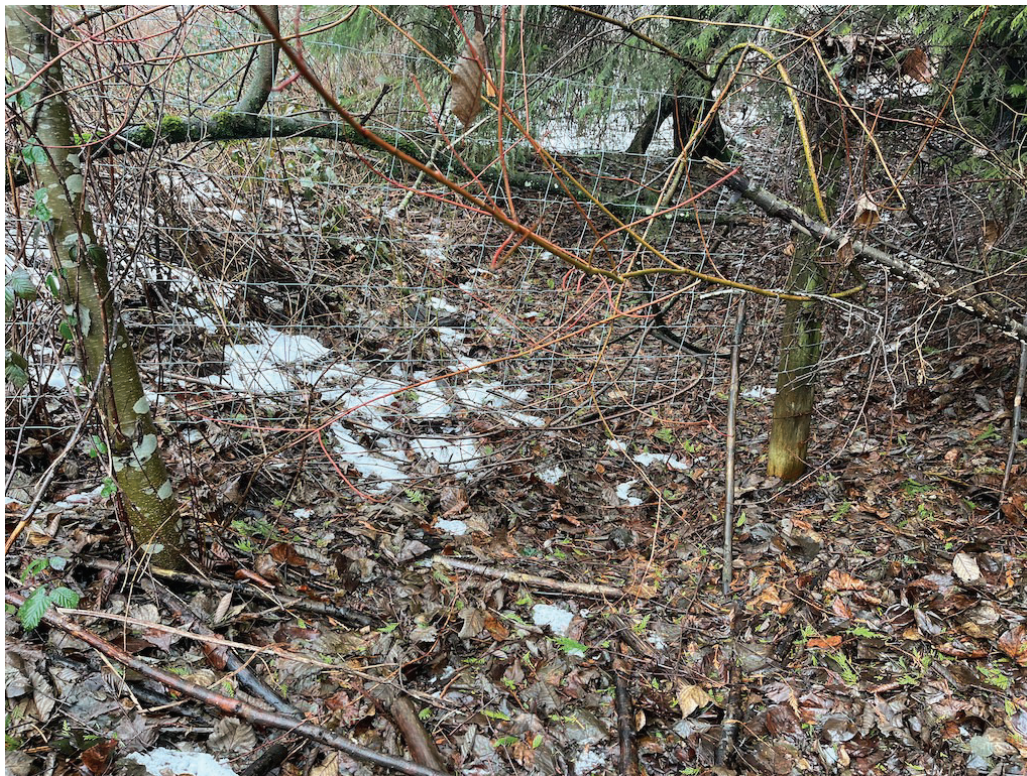
Photo 18: January 23, 2024. Looking northeast from the floodbox culvert inlet adjacent to the southwest corner of the Subject Property which is the lowest area on the Site.

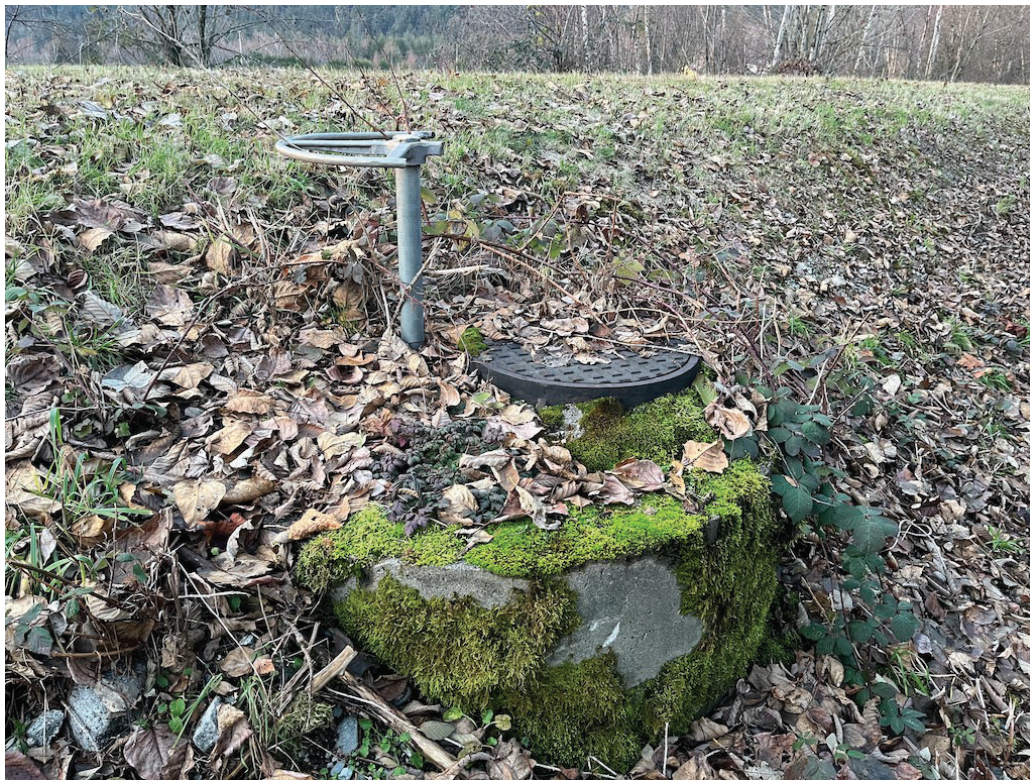
Photo 19: December 15, 2023. Looking at the floodbox manhole cover and wheel on the Dewdney Dike adjacent to the southwest corner of the Subject Property.
