FRASER VALLEY REGIONAL DISTRICT DEVELOPMENT PERMIT

Permit No.	2025-02	Folio No.	775.02616.000
Issued to:	Wladyslaw Wojcik		
Applicant:	Jamie Stirling, P.Geo. (Stirling Geoscience Ltd.)		
Site Address:	38482 Bell Road, Area G

**38482 Bell Road, Deroche, BC – Flood Hazard Assessment and Development Permit Application,
dated April 16, 2025, prepared by Jamie Stirling, P. Geo. of Stirling Geoscience Ltd.**

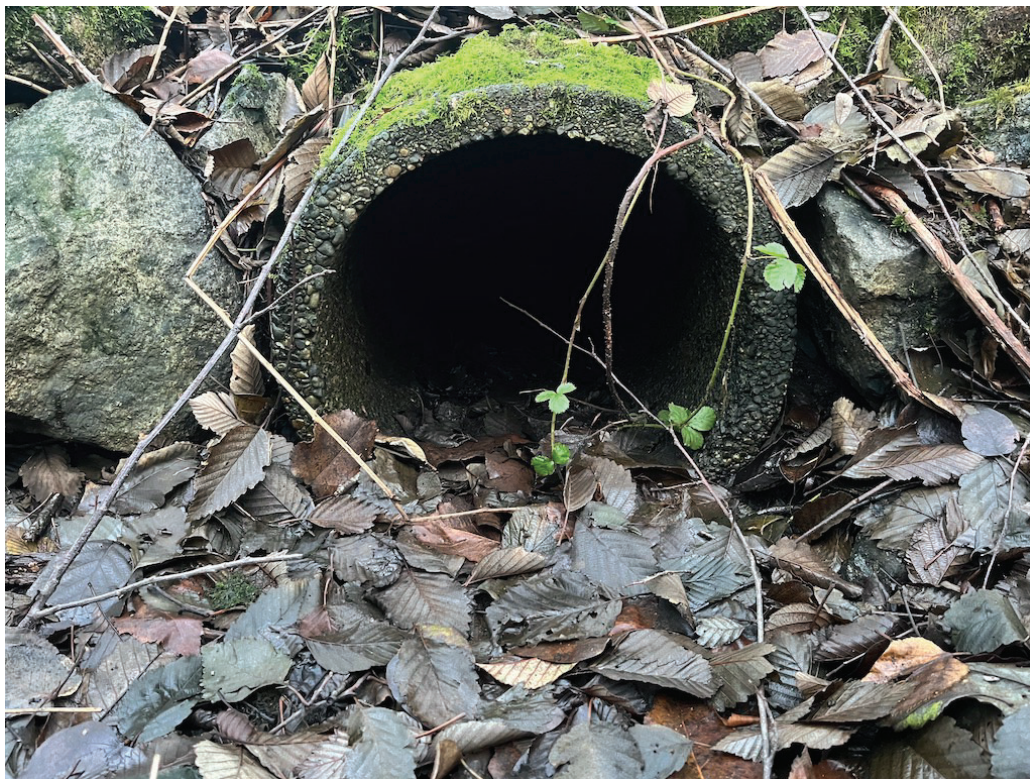
Photo 20: December 15, 2023. Looking at the outlet of the 450 mm diameter concrete culvert as part of the Dewdney Dike floodbox. The outlet is on the west side of the dike.

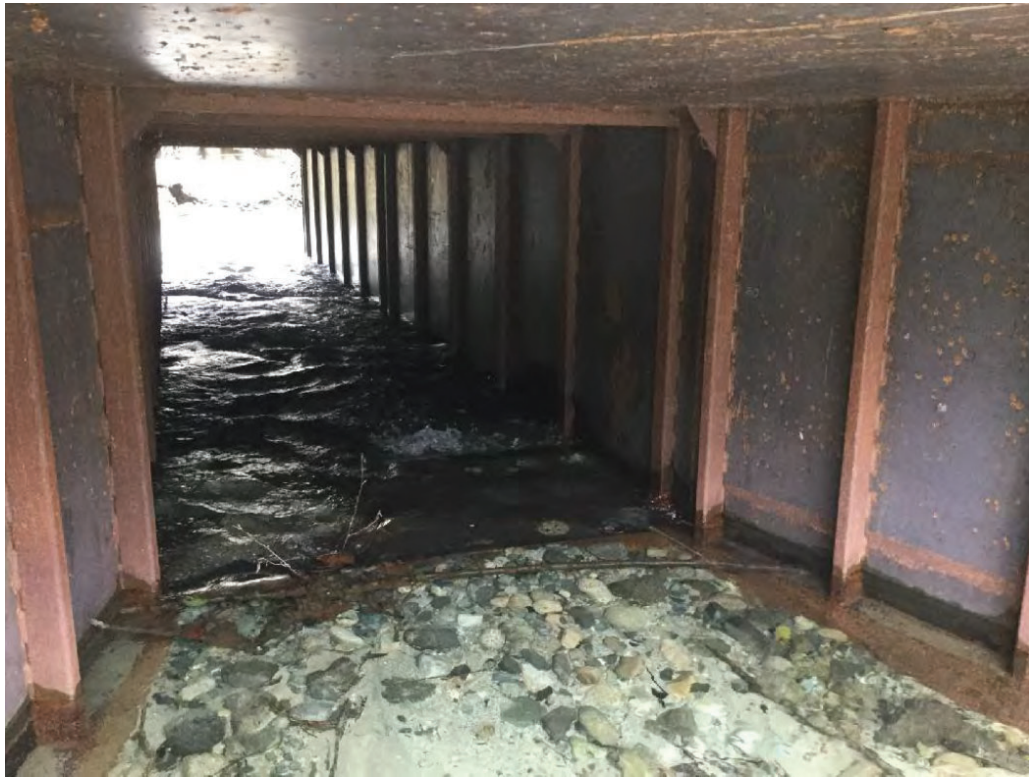
Photo 21: March 28, 2018. Looking downstream on Inch Creek at the inlet of the steel box culvert under the CP Railway. The culvert has a span of 2000 mm and a rise of 1600 mm (SGL 2018).

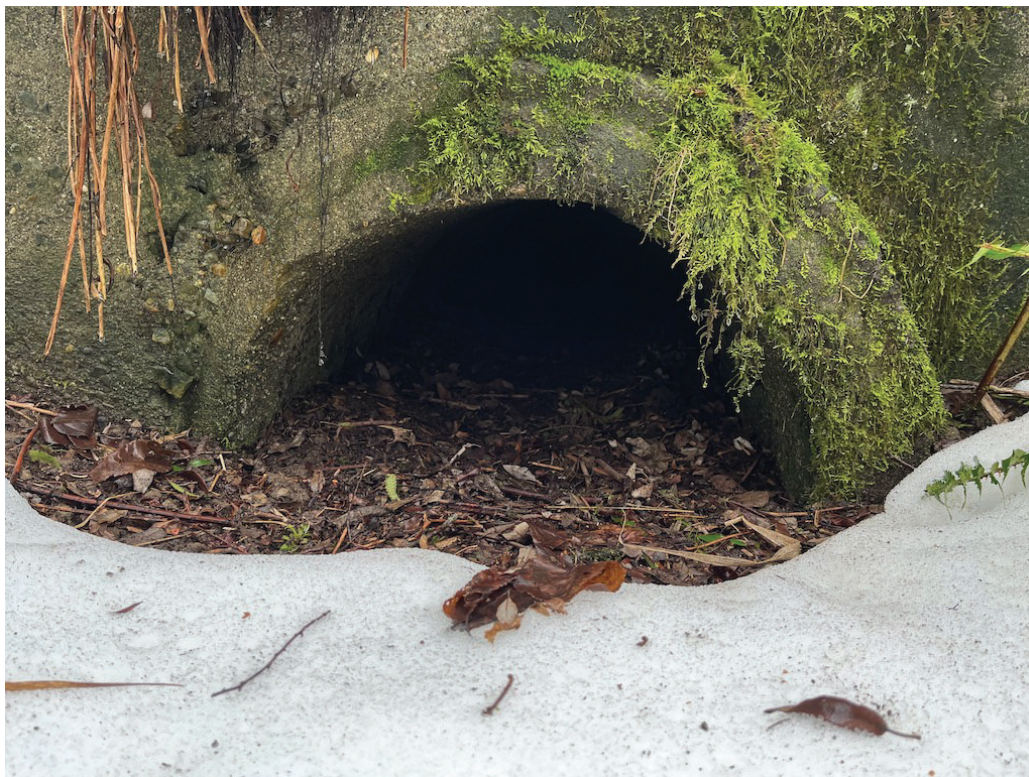
Photo 22: January 23, 2024. Looking at the outlet of the 600 mm concrete culvert located under the CP Railway adjacent to the middle of the Subject Property. This culvert does not convey flow, there is no defined channel, and the inlet is buried and could not be located.

of the 600 mm concrete culvert outlet and south of the Railway and Hawkins Pickle Road, which runs south of, and parallel to, the Railway (Appendix C and Figures 16 and 17), no culvert was found under Hawkins Pickle Road at this location to convey this potential drainage. Additionally, the blue creek symbol shows Inch Creek as a surface channel upstream of Bell Road, which is not accurate as Inch Creek is subsurface in this area. Finally, the blue creek symbol shows a creek passing the southwest corner of the Subject Property and there is no creek following this alignment. With respect to Norrish Creek, the watercourse symbol on the LiDAR images shows the low-lying area along the right bank at the end of Bell Road and just upstream of the Railway bridge as part of the active channel. However, this area is isolated from the mainstem by the Norrish Creek Dike as shown by the green line symbol. The low-lying area was one of the borrow sources for construction of the Norrish Creek Dike.

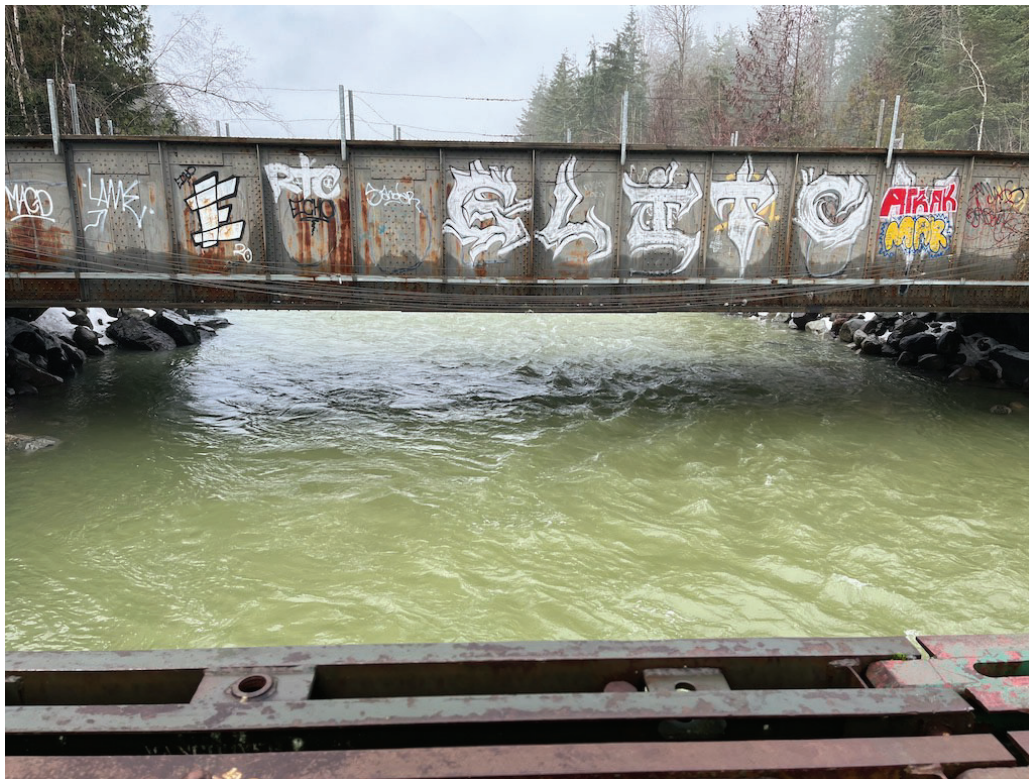
Photo 23: January 23, 2024. Looking north (upstream) on Norrish Creek at the Railway bridge from the Hawkins Pickle Road bridge.

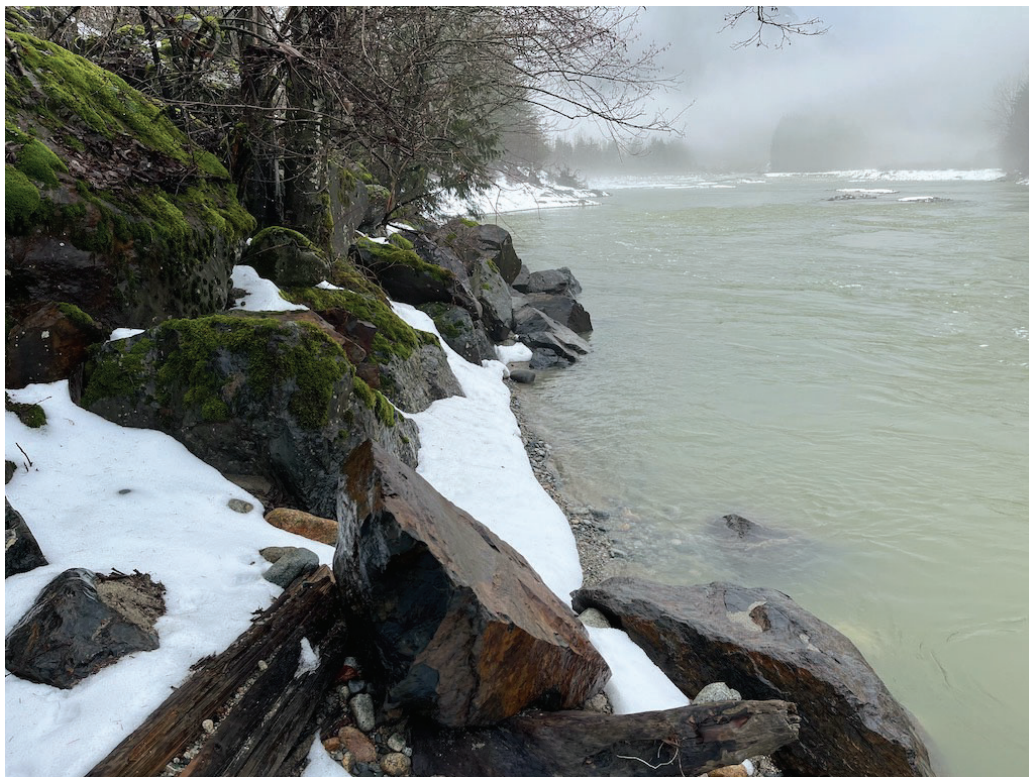
Photo 24: January 23, 2024. Looking north (upstream) on Norrish Creek at the armoured right bank river dike just upstream of the CP Railway.

Regarding Norrish Creek, potential transfer of flood risk to neighbouring properties is possible but considered unlikely in the event of a creek avulsion or a failure of the Norrish Creek Dike. If the right bank of Norrish Creek were to be breached, floodwaters would likely travel down the fan in a southwest direction possibly inundating the Subject Property. Under current conditions the water would flow across the Site and pool in the southwest portion of the Site due to the Dewdney Dike. There is a floodbox on the dike in this corner, but the culvert is only 450 mm (Photo 17). Under the proposed fill conditions, fill will not extend to the edge of Site and the proposed 7.5 m wide non-filled portion of the infiltration gallery will also act as a flood corridor along the perimeter of the Subject Property. The surface elevation of the 7.5 m wide non-filled portion of the infiltration gallery that is cleared will be slightly below the elevation of the adjacent existing ground by approximately 0.1 m on average. The northern perimeter infiltration gallery will be below the elevation of Bell Road. This will allow potential floodwaters from Norrish Creek to travel along the northern perimeter of the Site and then flow along the western property boundary adjacent to the Dewdney Dike toward the floodbox. The properties north of Bell Road adjacent to the Subject Property generally slope upward away from Bell Road as shown in Figure 6 and Appendix C. On Sheet 2 in Appendix C, the 10 m contour is at Bell Road adjacent to the Subject Property and the 12 m contour is shown approximately 80 m north of Bell Road. Hence, floodwaters would flow southwest and generally away from the properties on the north side of Bell Road. Alternatively, or in addition, floodwaters would travel along the eastern portion of the Site and enter Inch Creek or flow west along the southern property boundary adjacent to the Railway embankment to the floodbox.

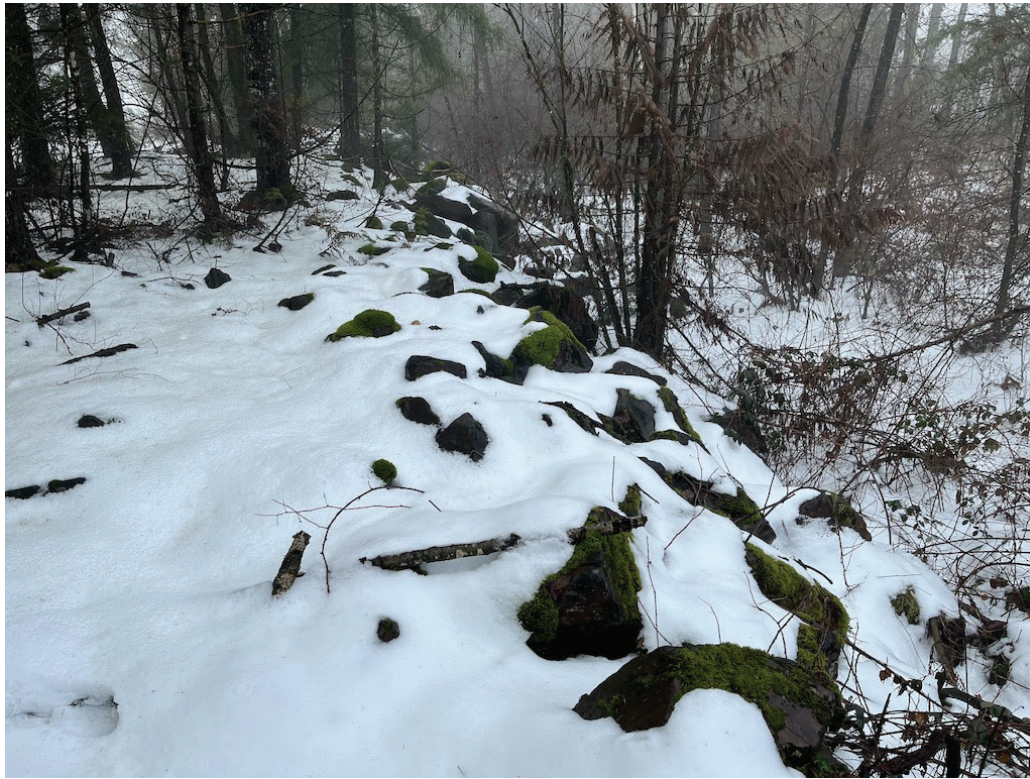
Photo 25: January 23, 2024. Looking north (upstream) on Norrish Creek at the armoured right bank setback dike approximately 150 m upstream of the CP Railway.

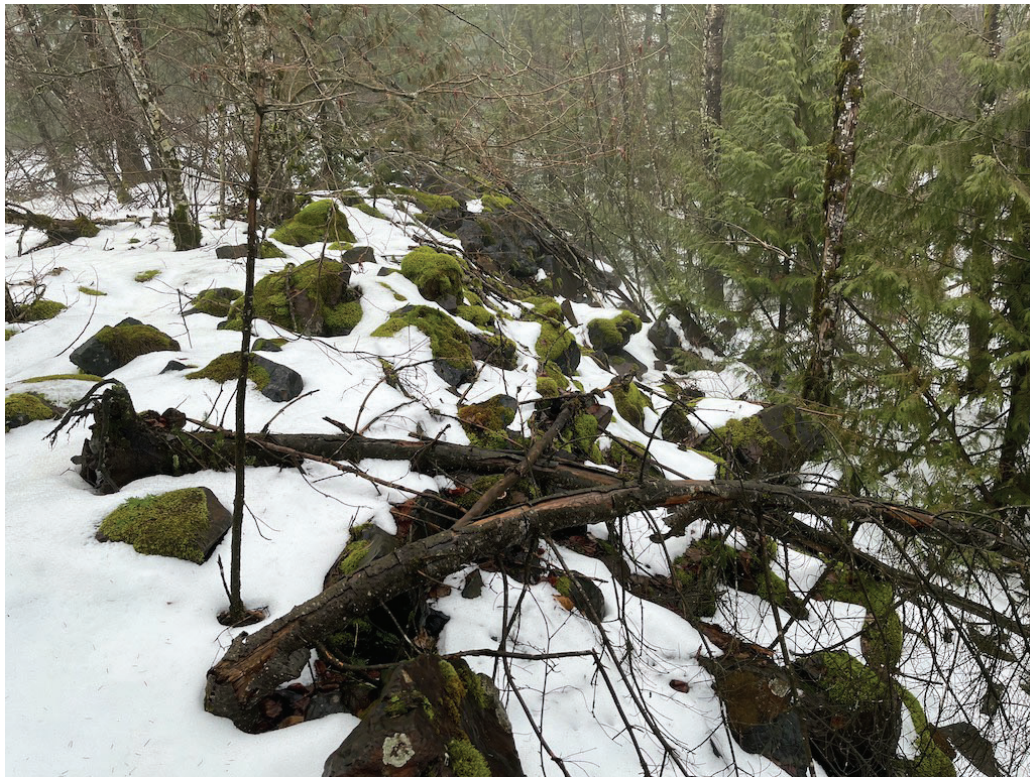
Photo 26: January 23, 2024. Looking north (upstream) on Norrish Creek at the armoured right bank setback dike approximately 800 m upstream of the CP Railway.

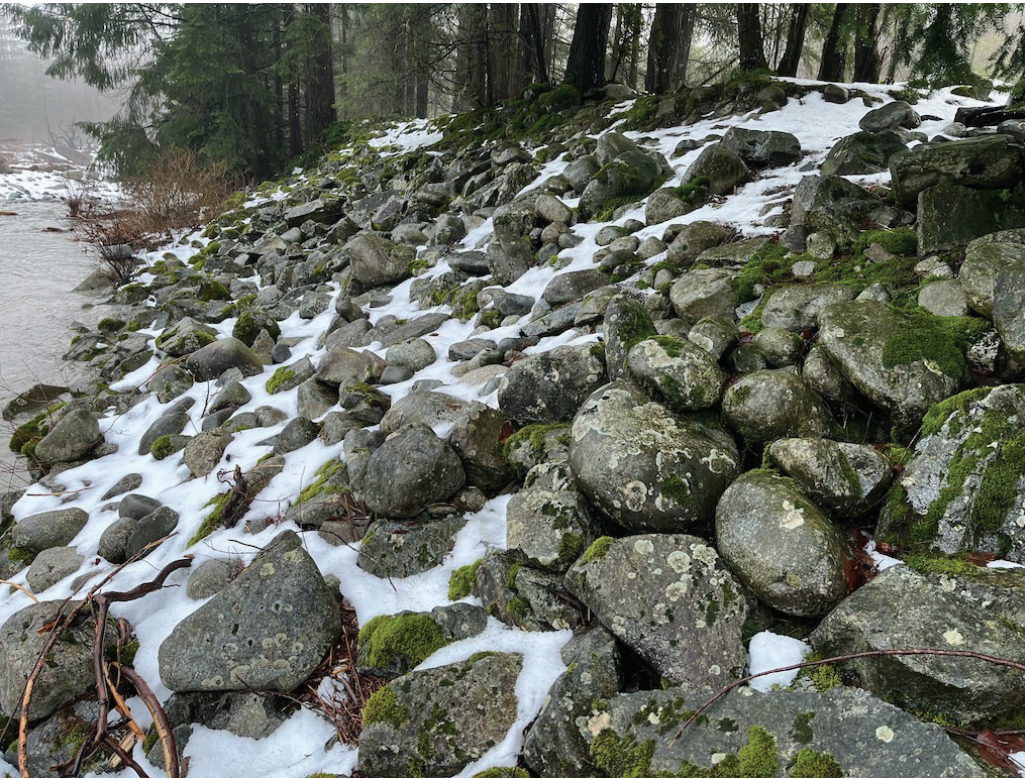
Photo 27: January 23, 2024. Looking south (downstream) on Norrish Creek at the upstream end of the armoured right bank river dike near the fan apex.

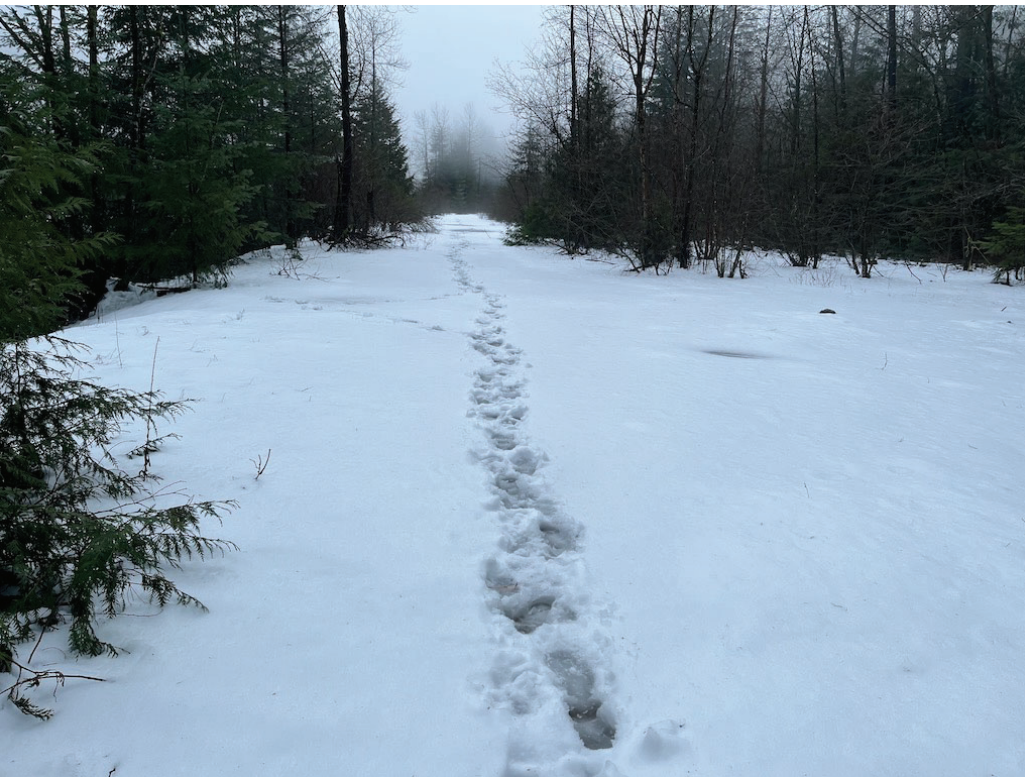
Photo 28: January 23, 2024. Looking south at the top of the bank adjacent to the eroding right bank near the fan apex of the Norrish Creek fan.

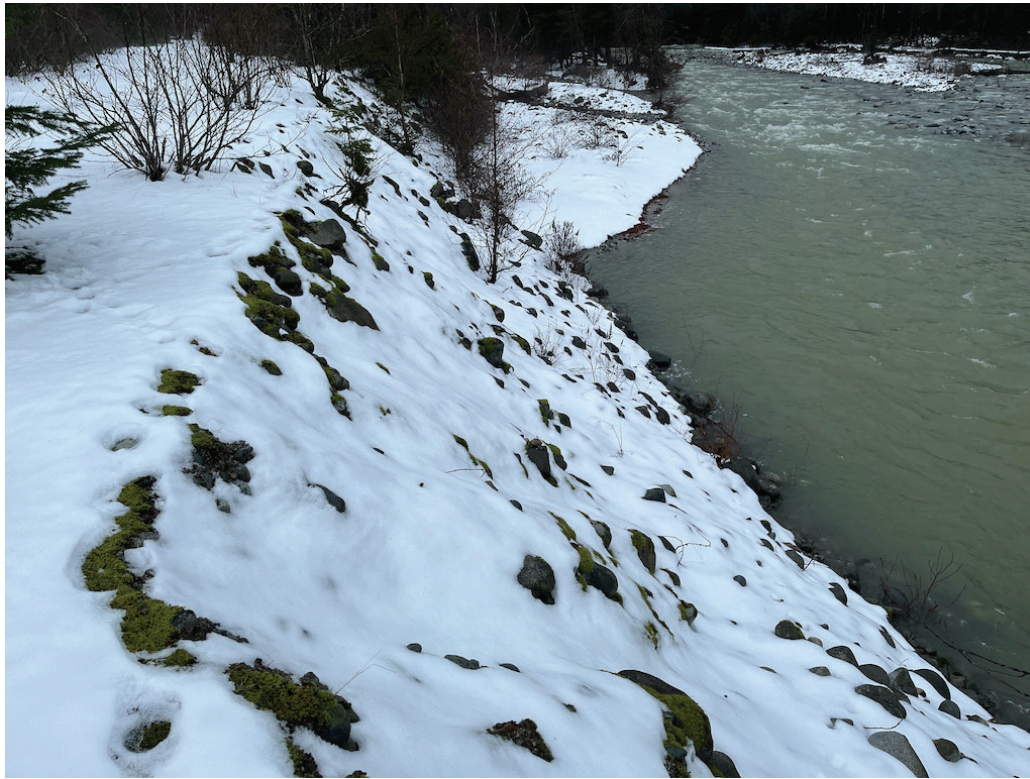
Photo 29: January 23, 2024. Looking north (upstream) on Norrish Creek at the eroding right bank upstream of the dike near the fan apex.

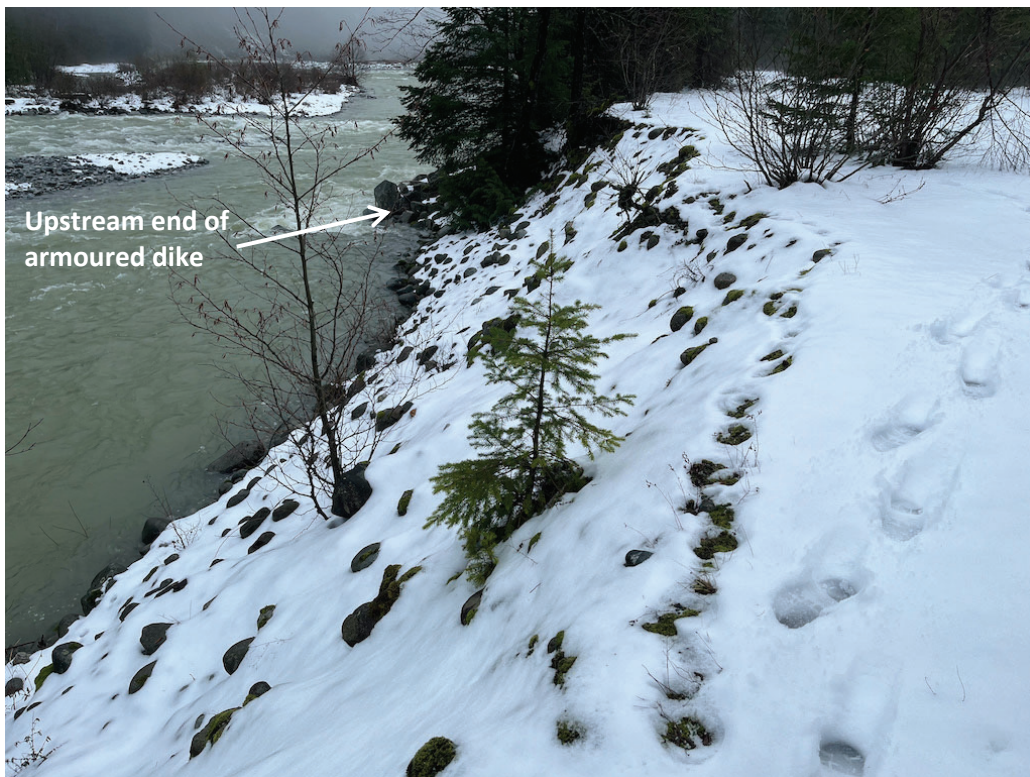
Photo 30: January 23, 2024. Looking south (downstream) on Norrish Creek at the eroding right bank upstream of the dike near the fan apex. The upstream end of the armoured river dike is in the background.

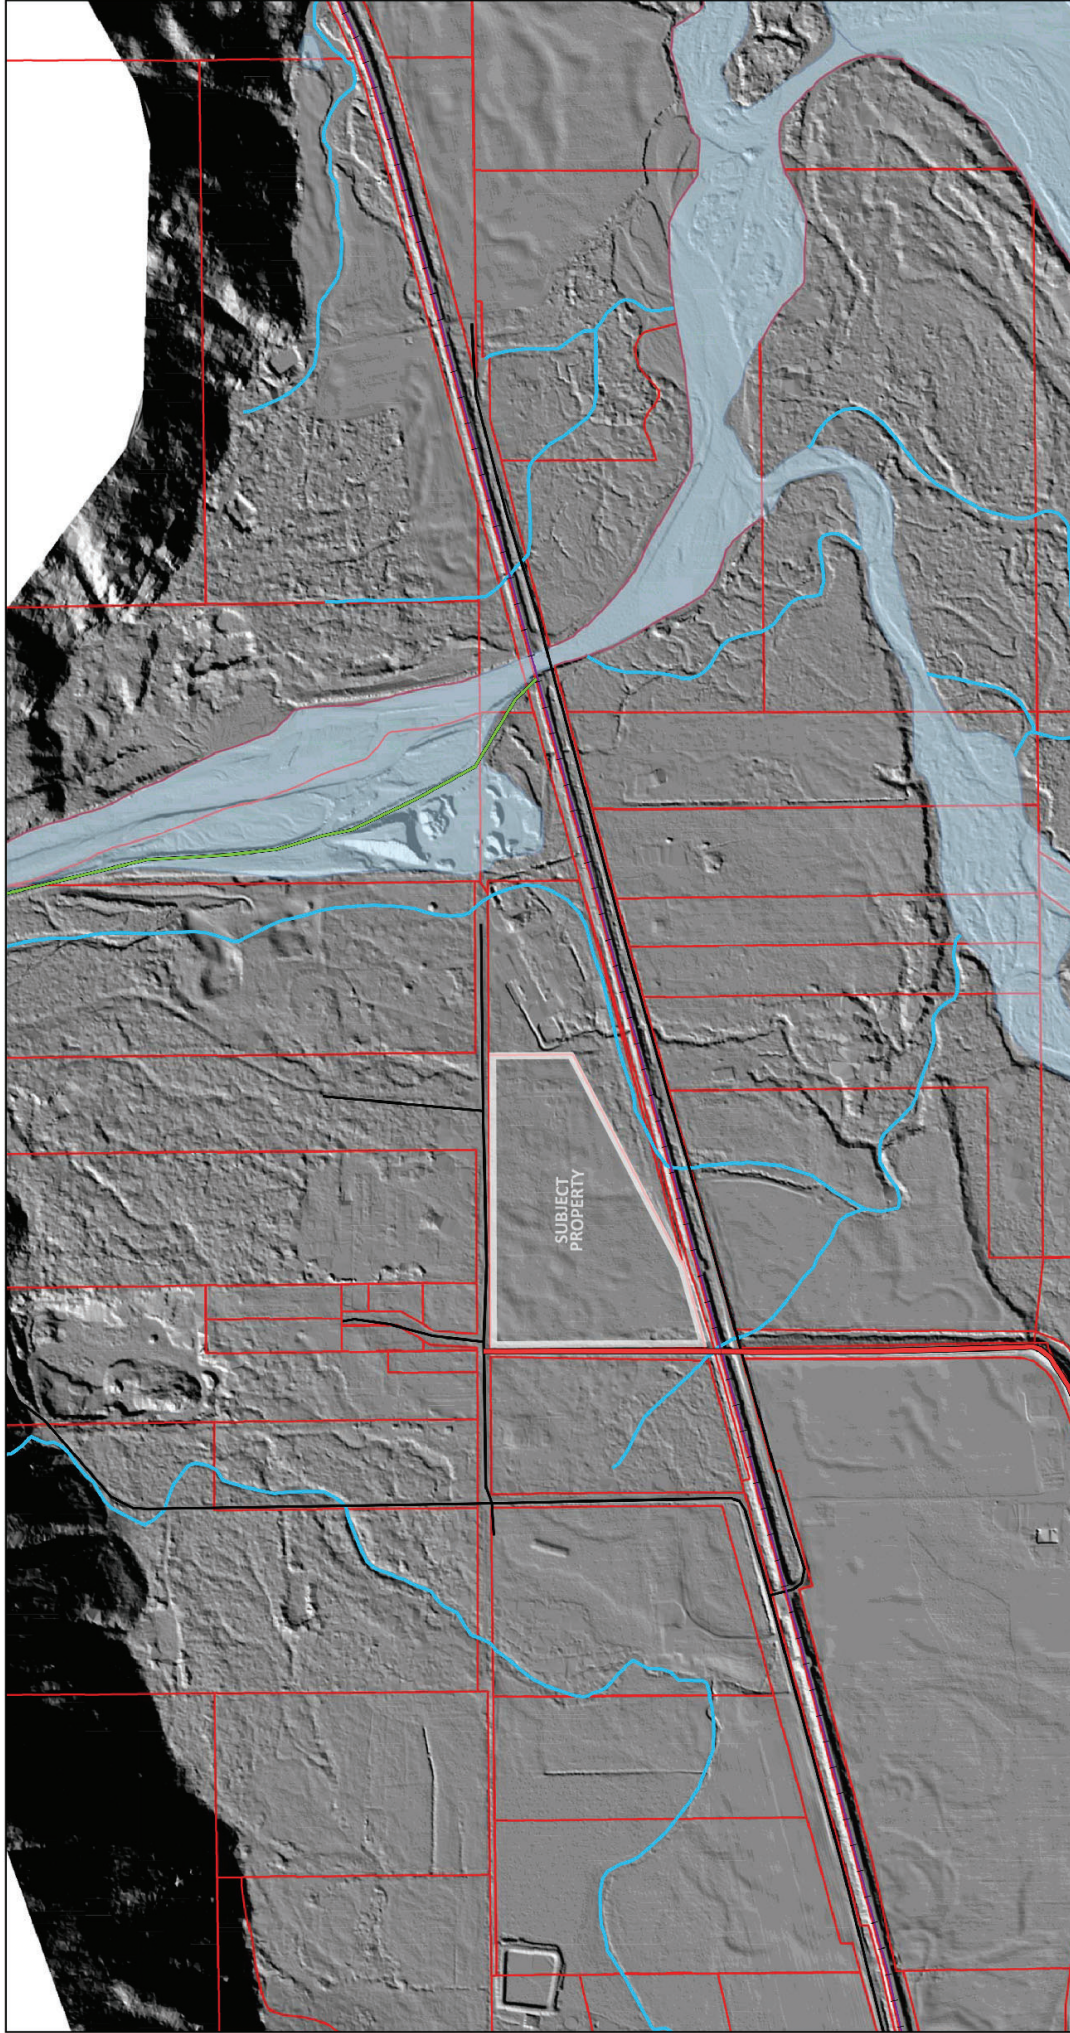
LiDAR & Contour Map 38482 Bell Rd

LiDAR Images of the Norrish Creek Fan and Surrounding Area

main relic side channels were documented by Westrek (2013). They are both west of the Norrish Creek Dike and one is downstream of the fan apex and the other is in proximity to the East Gravel Pit (Figure 3). It was noted that these channels sometimes contain pools or standing water or even ephemeral streamflow but there was no evidence of flow reaching as far downstream as Bell Road. Also, there are no drainage structures crossing under Bell Road. These relic channels can be clearly seen on the hillshading LiDAR image (Appendix C).

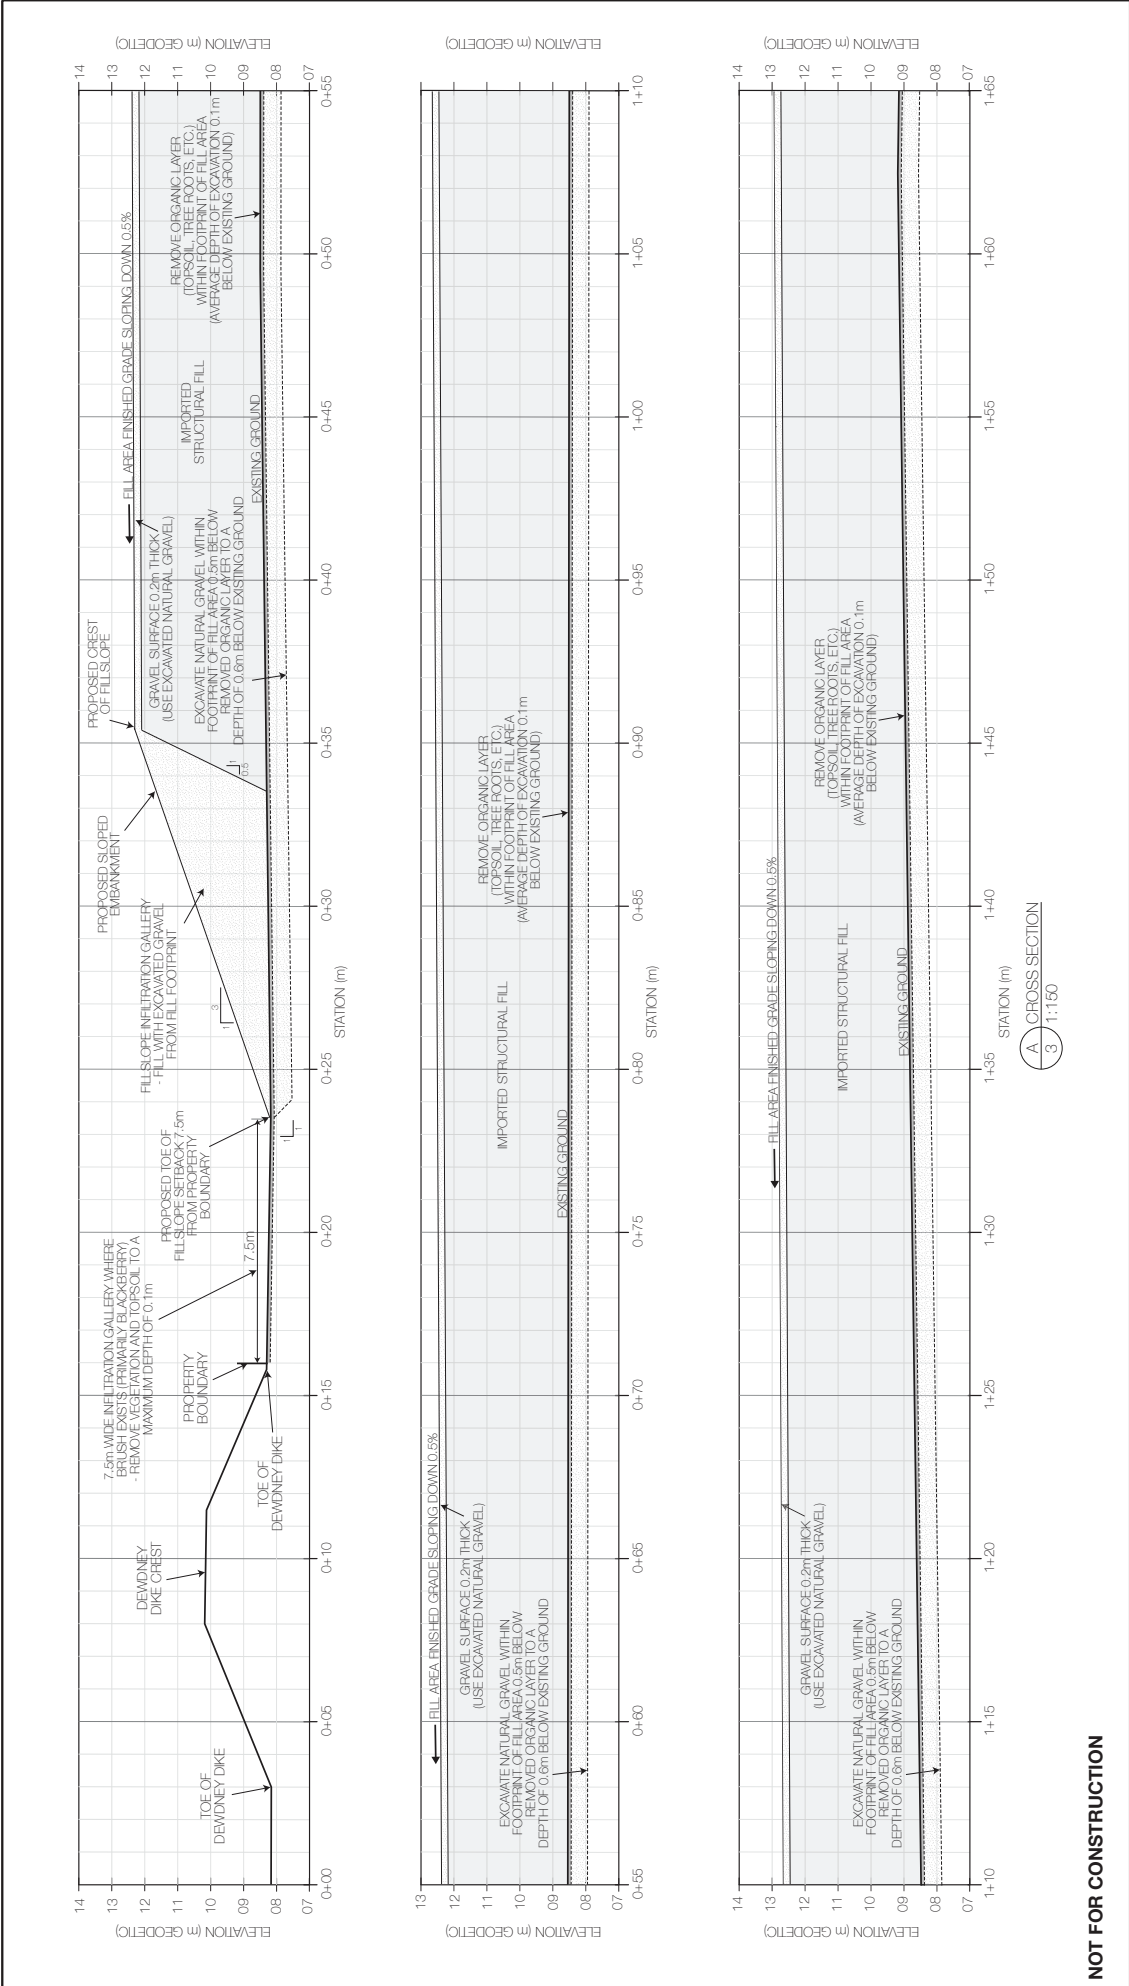
38482 BELL ROAD - IMPORTED FILL PROJECT			NOTES			
CROSS SECTION A - SHEET 1 OF 3			INTENDED FOR PRINTING ON 11X17 SIZED PAPER.			
			BACKGROUND: DRONE IMAGE STIRLING GEOSCIENCE LTD. FEBRUARY 24, 2024			
			TOPOGRAPHIC SURVEY BY AXIS LAND SURVEYING LTD. MARCH 29, 2018			
			TREE AND FENCELINE SURVEY BY WADE AND ASSOCIATES LAND SURVEYING LTD. OCTOBER 10, 2024			
PROJECT 23-13			DATE OCT 10, 2024		SHEET 5 OF 9	
			DRAFT JUS		APP AGC	
					DESIGN JFS	
					REVISION B
