Technical Memorandum

RE: **CR-33 LORENZETTA CREEK FLOOD RECOVERY PROJECT**
Operation and Maintenance of Lorenzetta Creek Flood Recovery Works
Our File 3427.023-300

1.1 Purpose

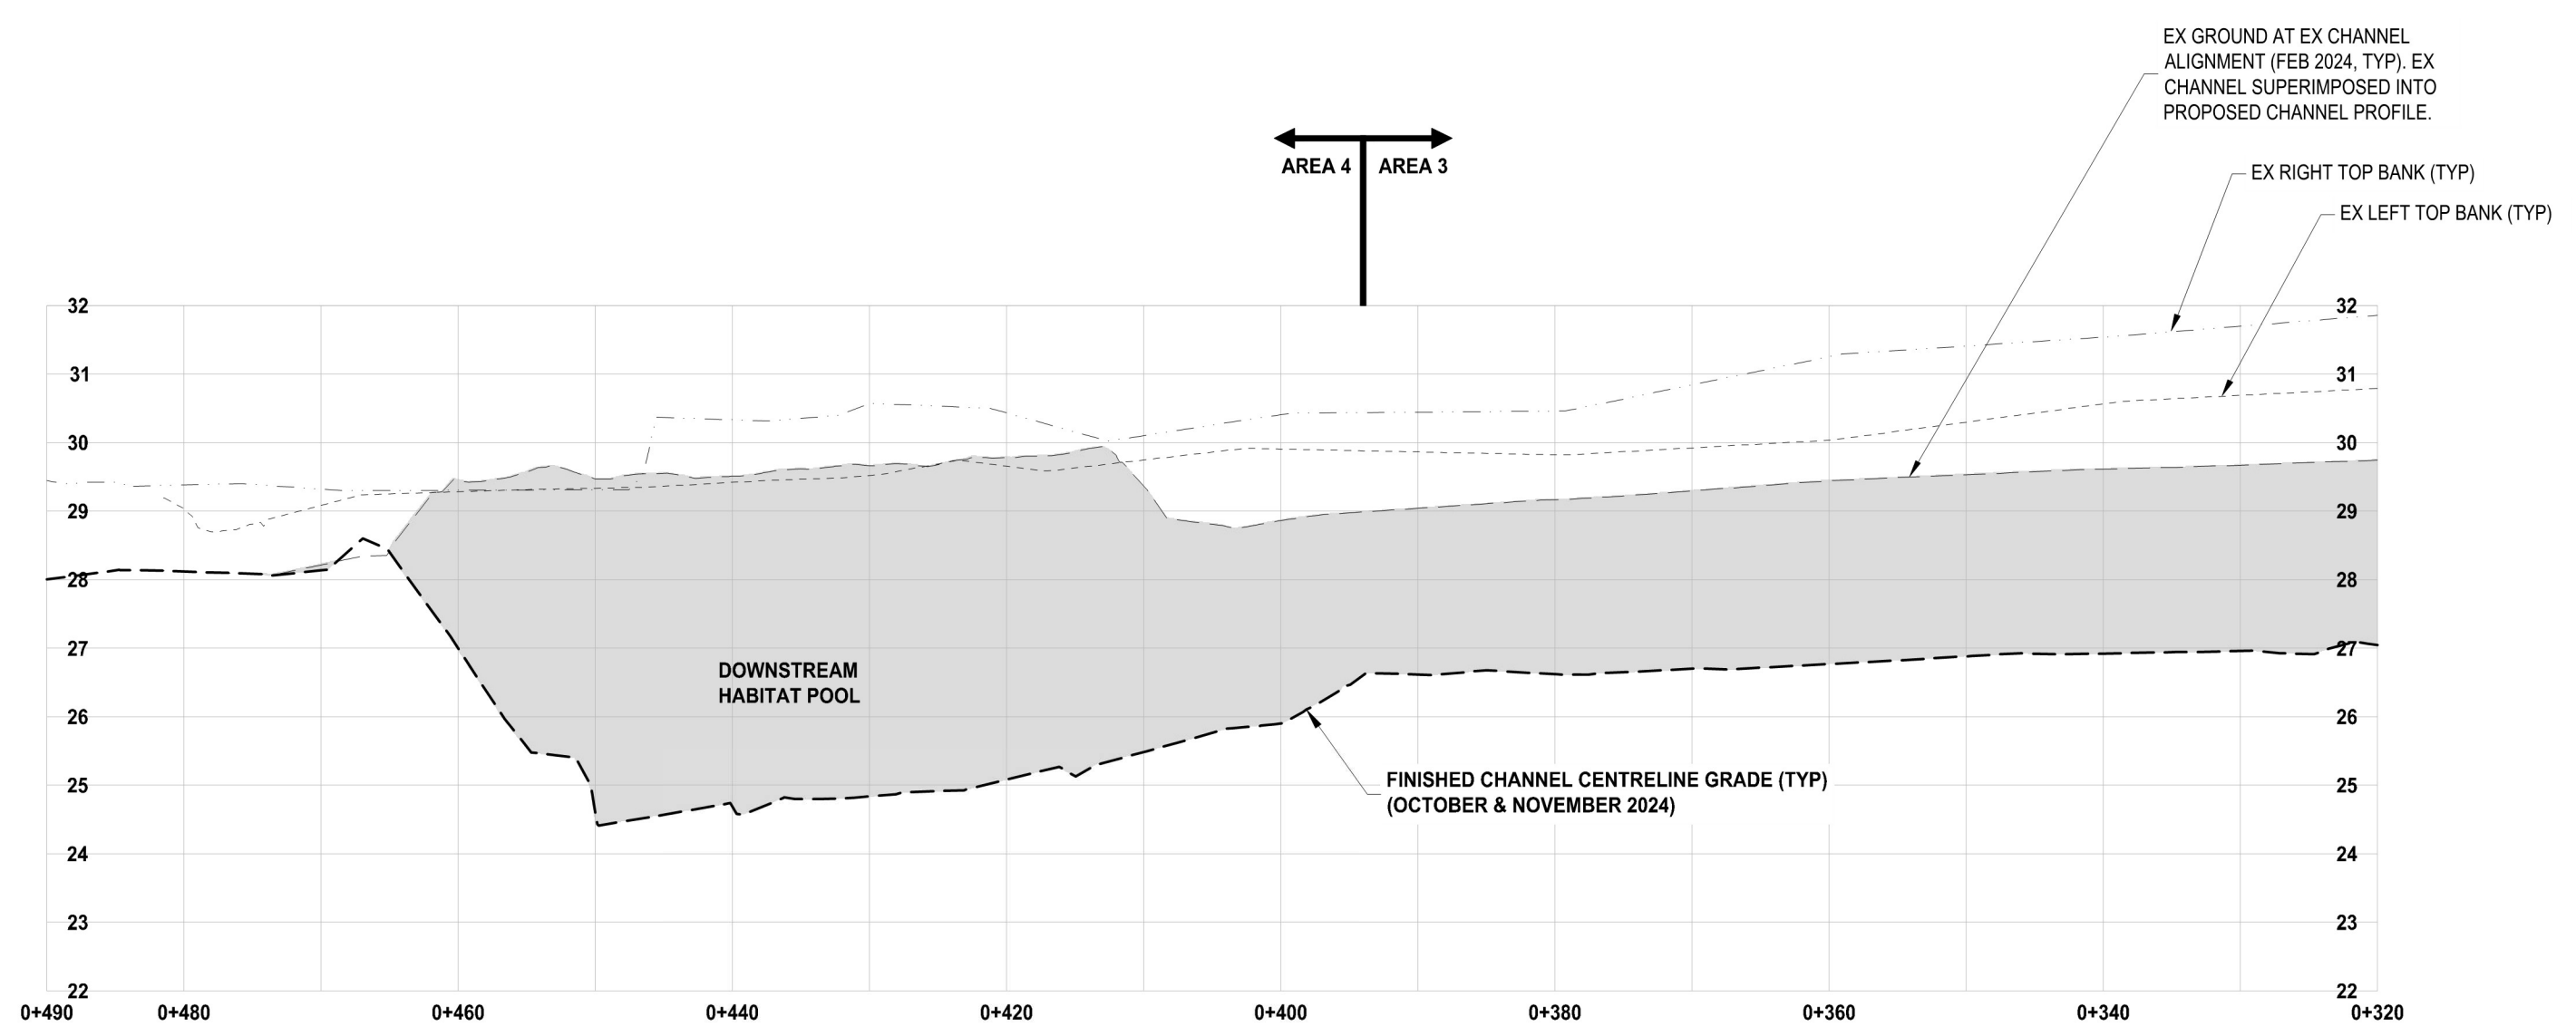
Project No.	3427-023	Drawing No.	C-112	Rev.	1
Group	CIVIL

SAVED: 2025/02/24, 1:11 PM
Page Size = ANSI D
A Full Size, this border measures 20 mm x 80 mm
0 10 50 100
millimeters
kwl
KERR WOOD LEIDAL
consulting engineers
BRITISH COLUMBIA
Ministry of Environment and Climate Change Strategy
S. B. ROBERTSON
59972
BRITISH COLUMBIA
ENGINEER
2025-04-16
Permit to Practice #1000696
Rev 0 2024-08-14 SBR T2 MVC ISSUED FOR CONSTRUCTION
Rev 1 2025-04-11 SBR PAC MVC ISSUED FOR RECORD
Project No. 3427-023
Group CIVIL
Drawing No. C-113
Rev. 1
BC MINISTRY OF ENVIRONMENT & CLIMATE
CHANGE STRATEGY
CR-33 LORENZETTA CREEK - PHASE 3B
LORENZETTA CREEK (STA 0+320 TO 0+490)
PLAN AND PROFILE

PLAN
Scale 1:500

PROFILE
Scale H 1:500, V 1:50

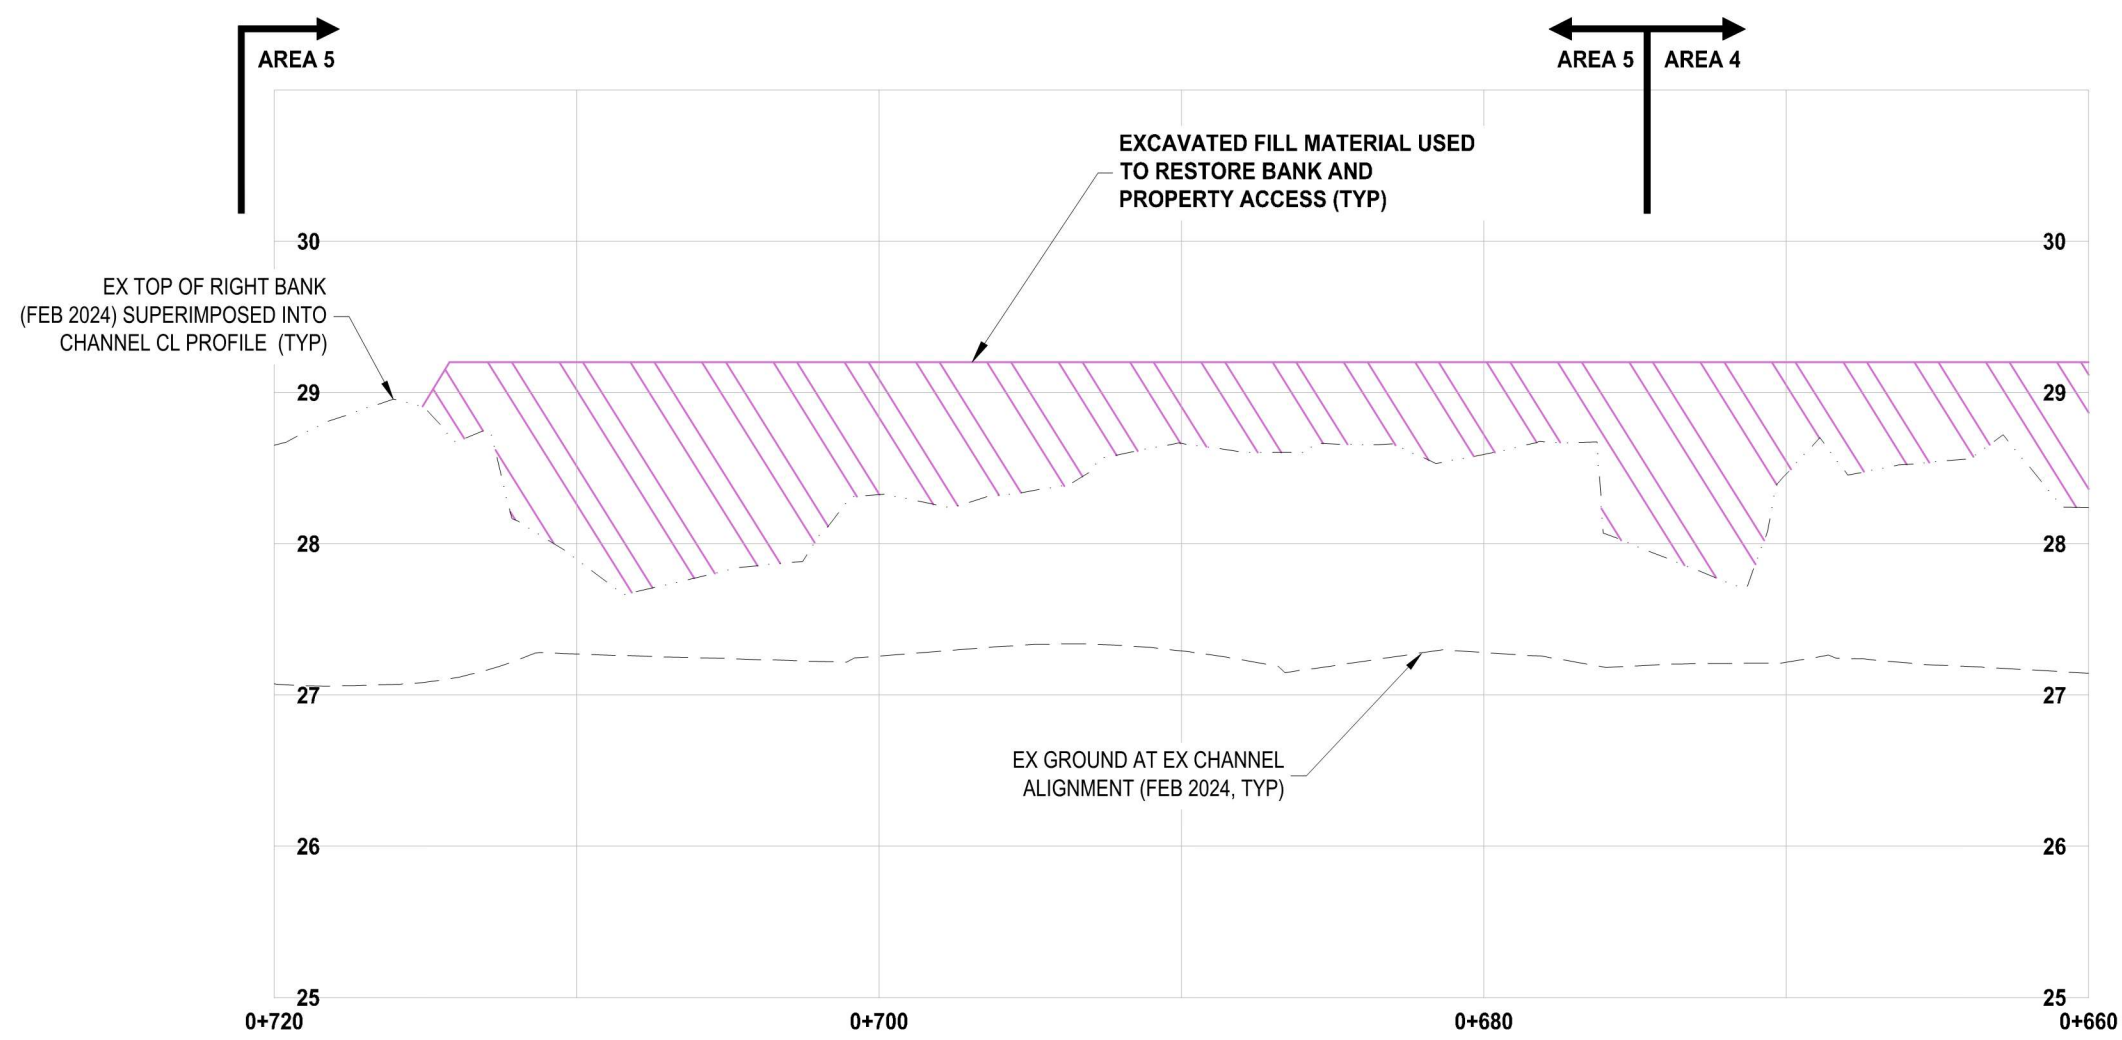
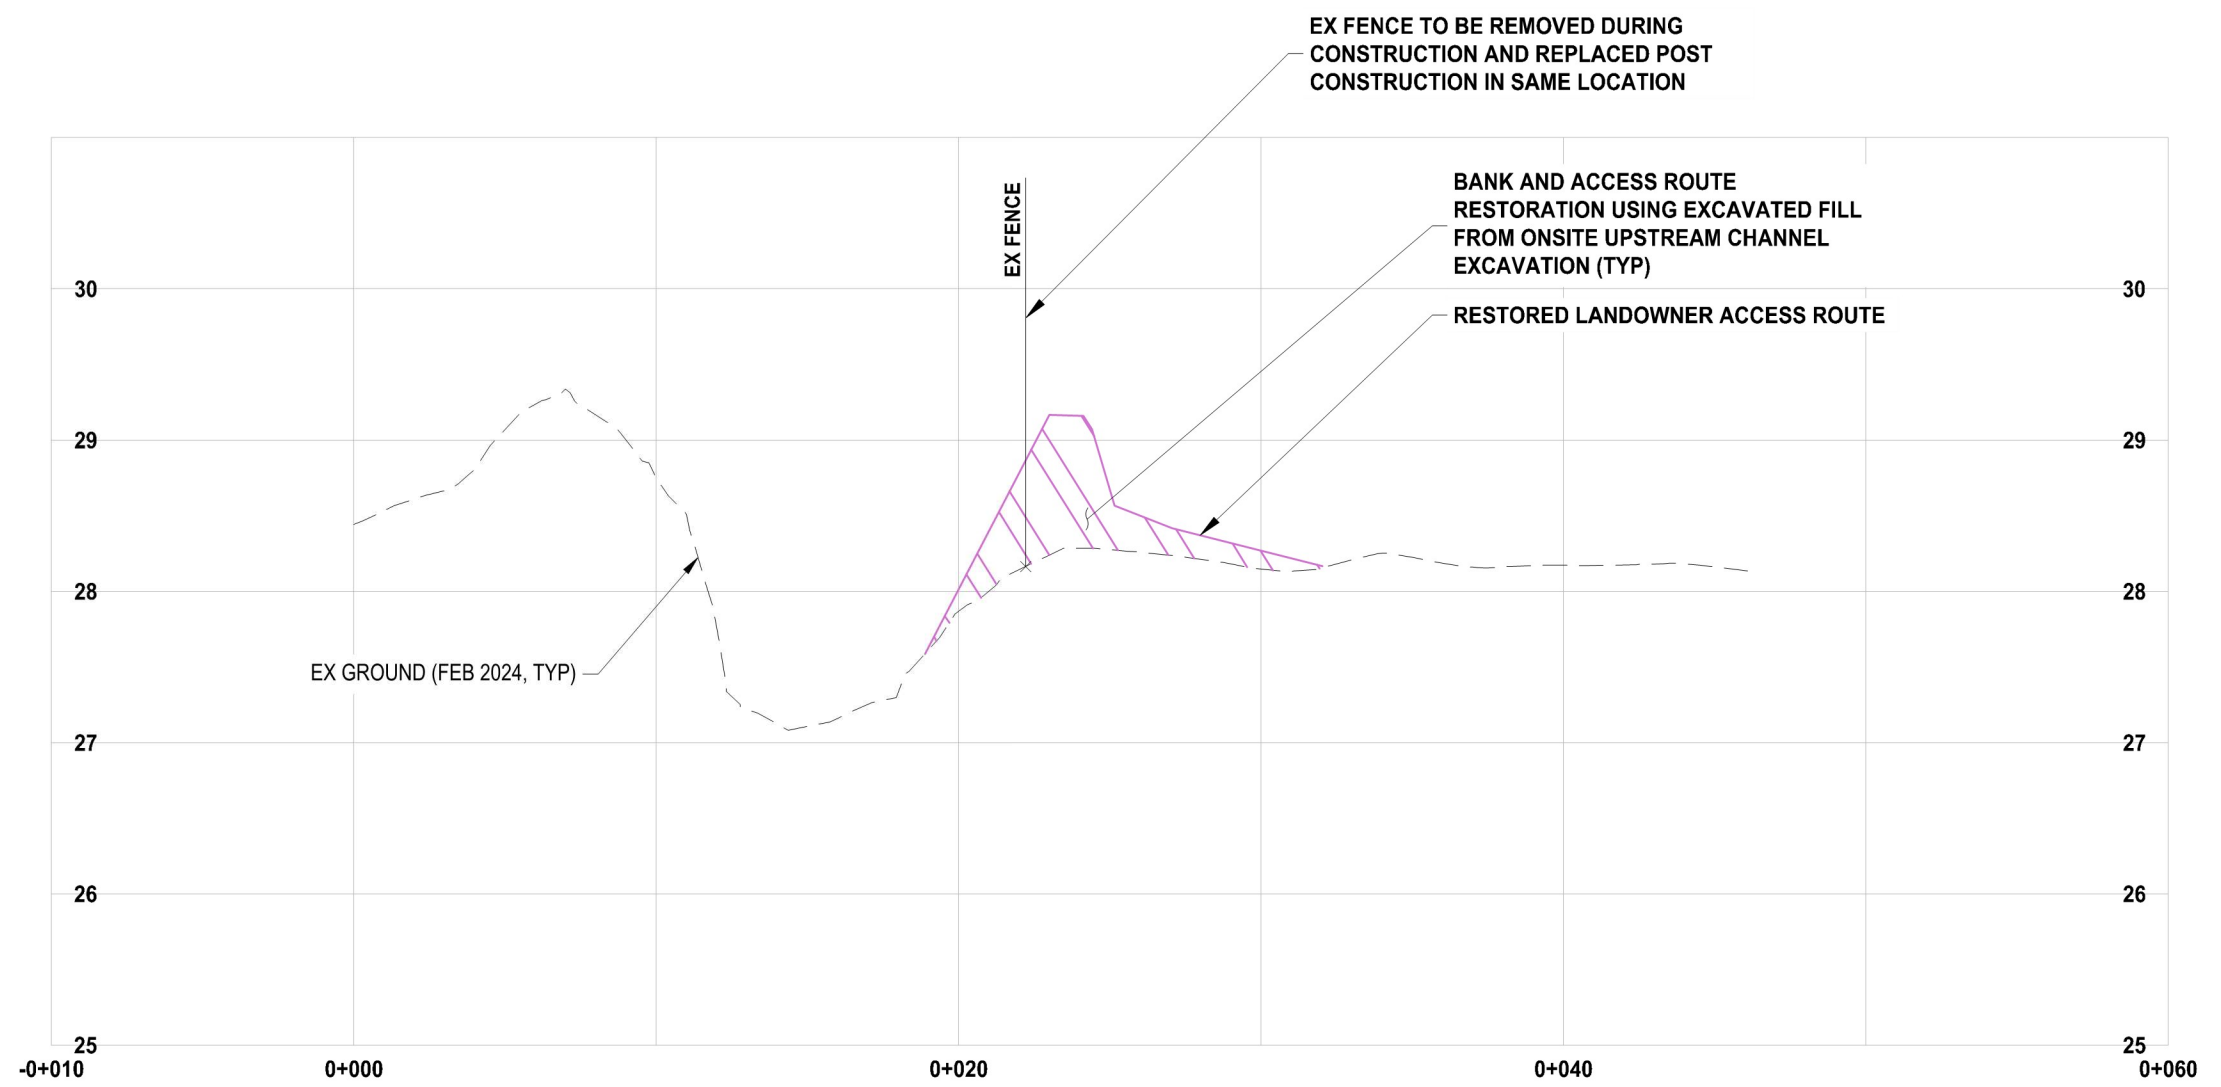
Drawing No. C-113
Rev. 1

PLAN
Scale 1:500

PROFILE
Scale H 1:250, V 1:50

CROSS SECTION
Scale H 1:250, V 1:50

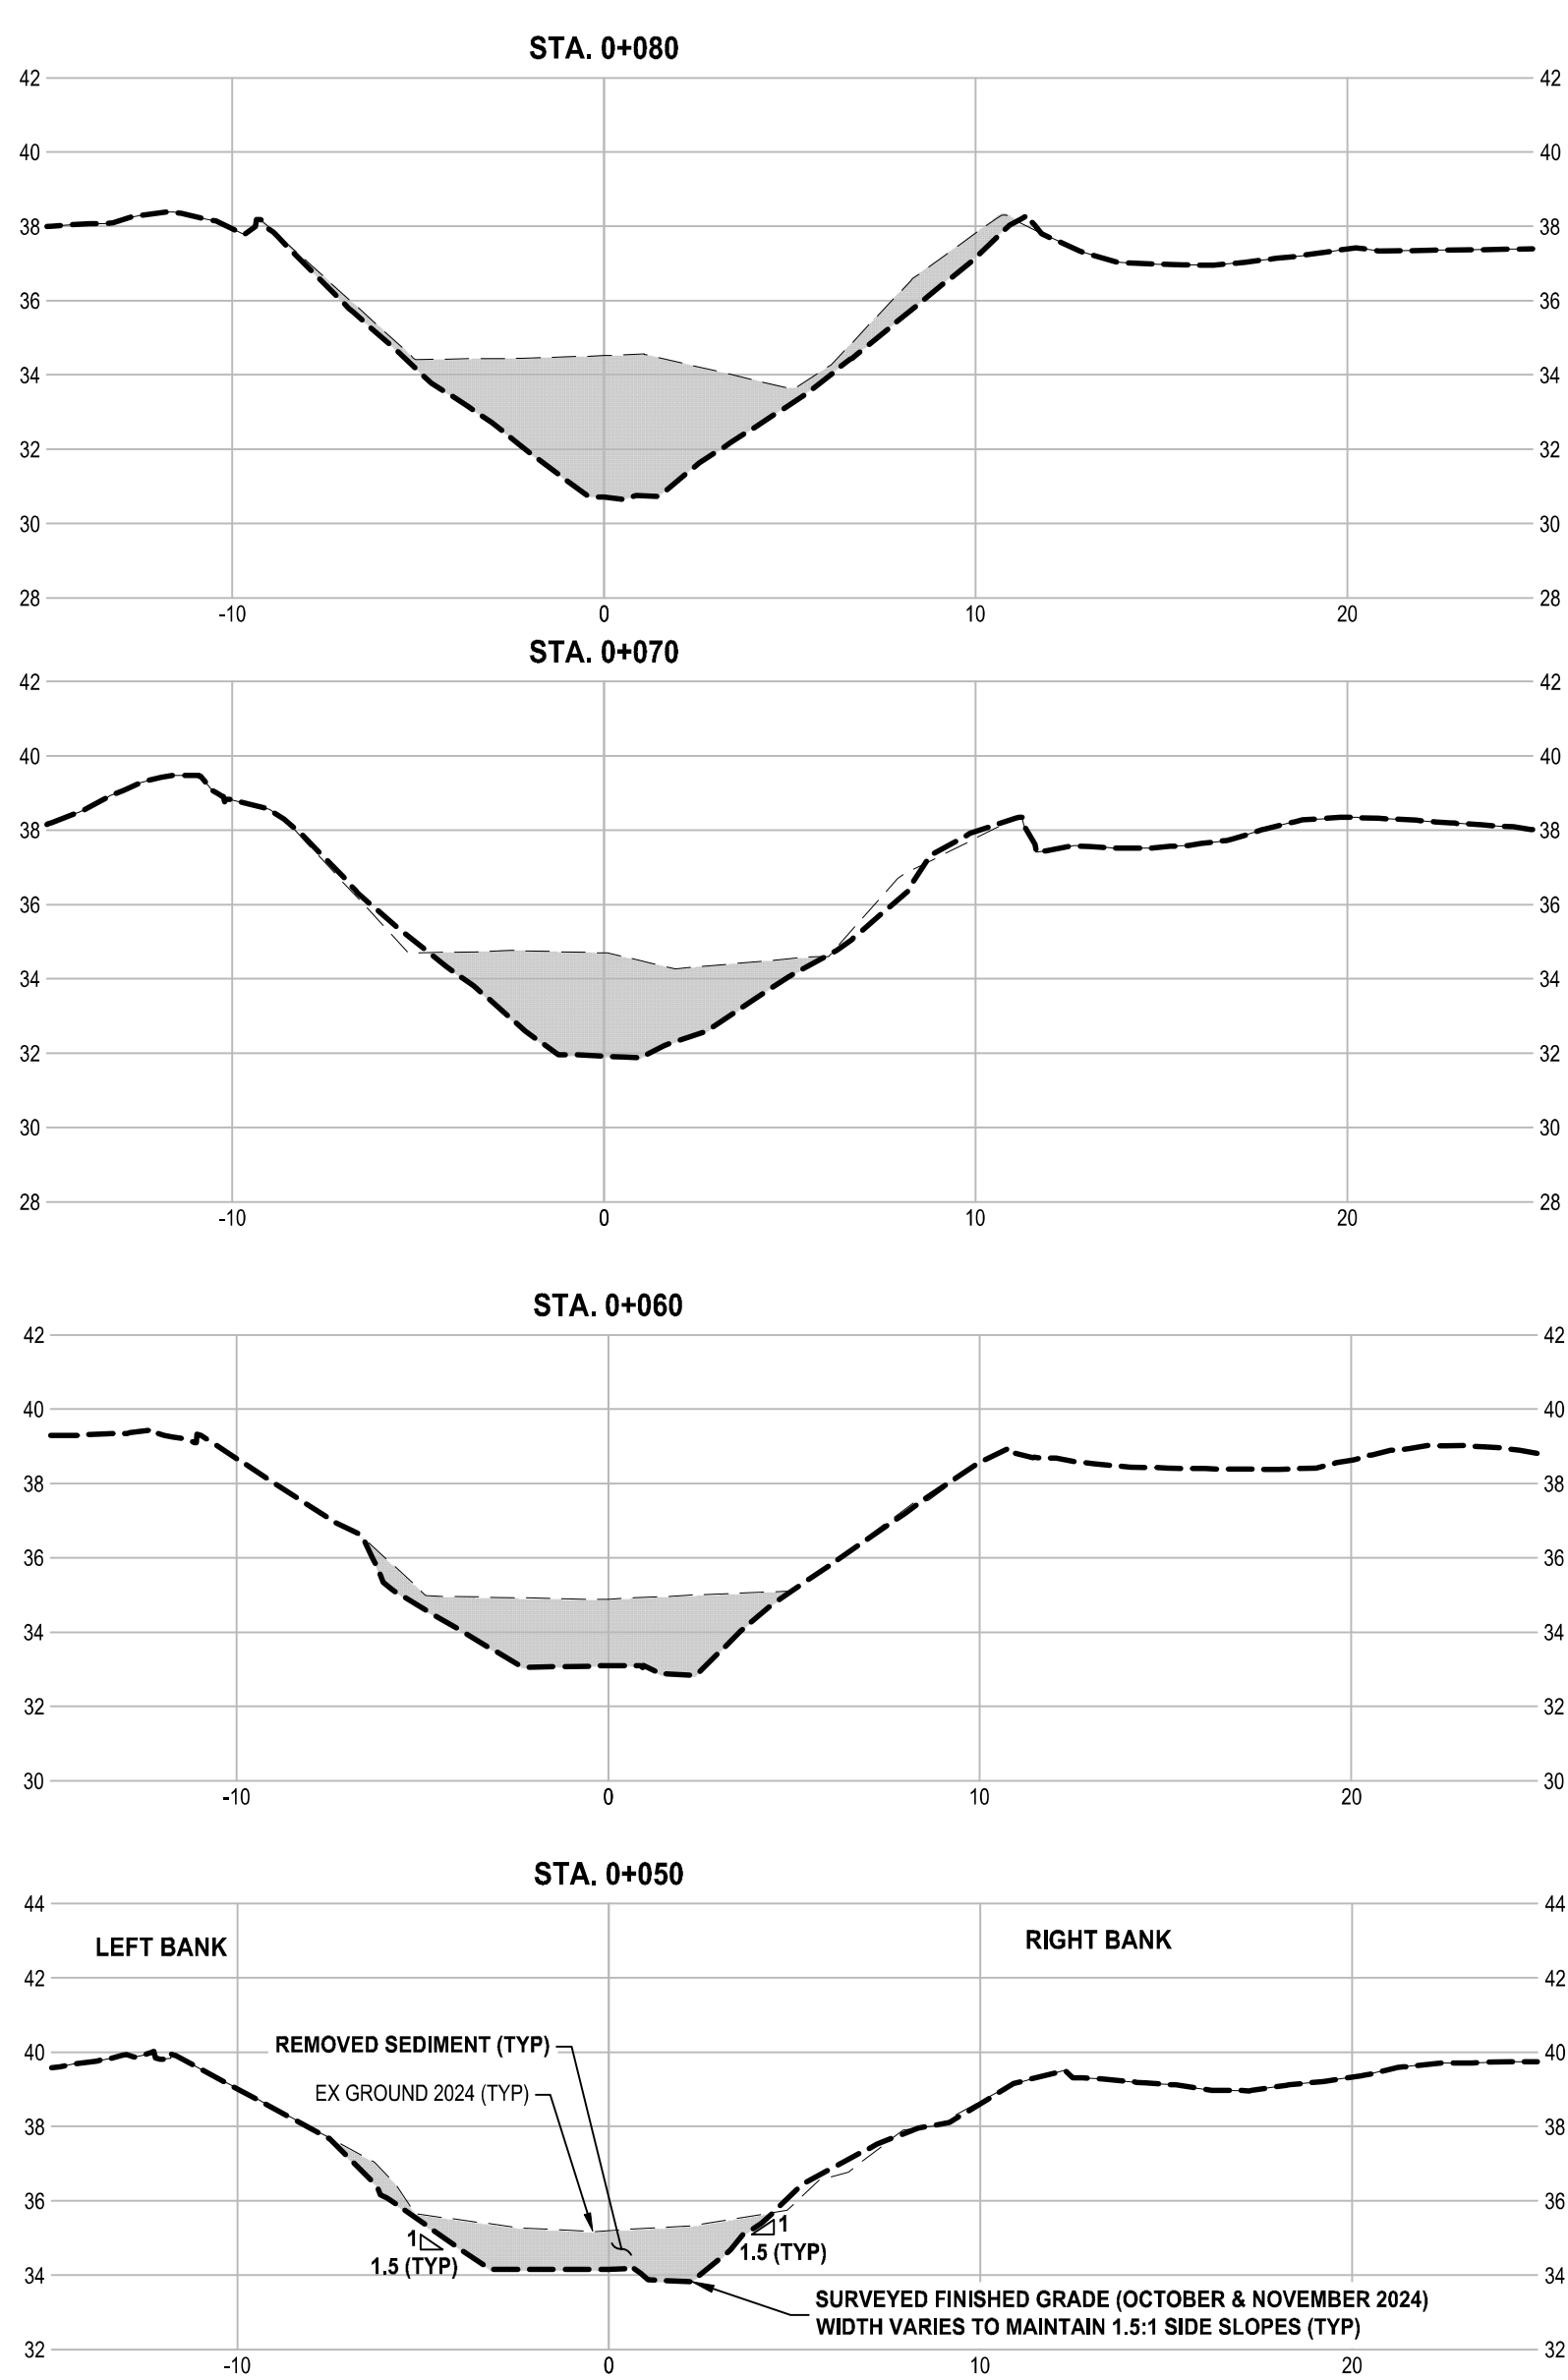
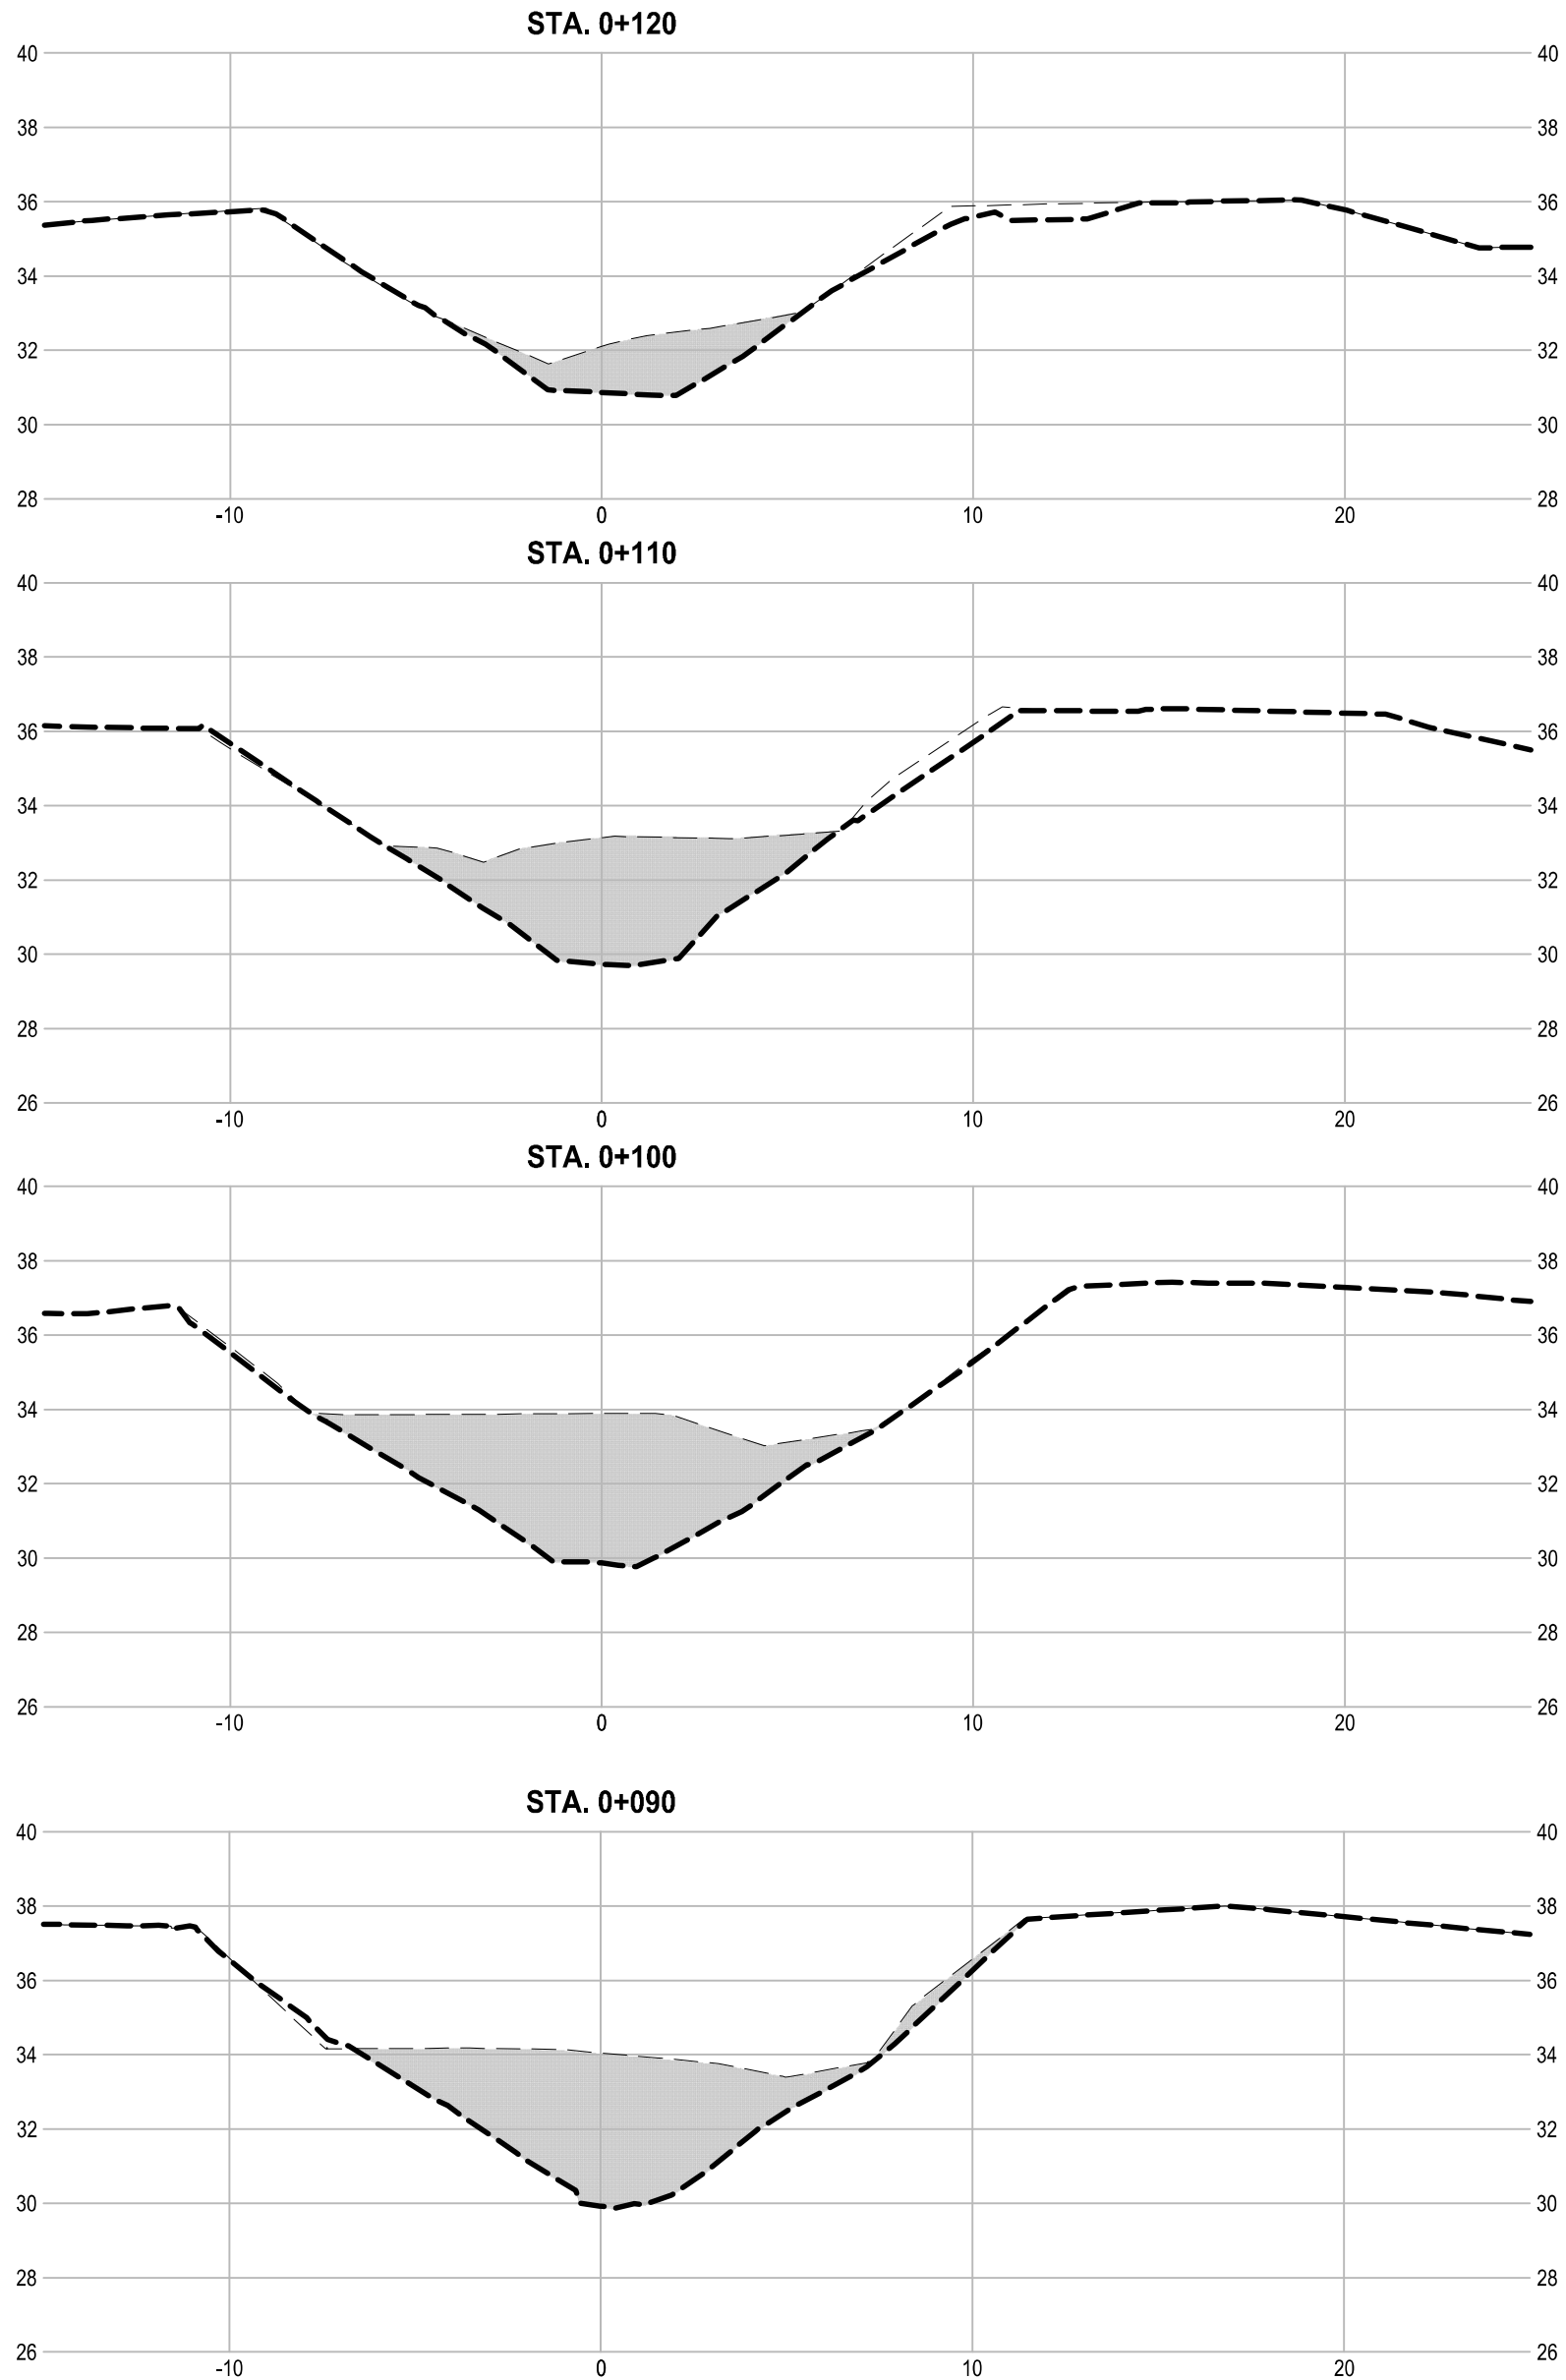
BC MINISTRY OF ENVIRONMENT & CLIMATE CHANGE STRATEGY			
CR-33 LORENZETTA CREEK - PHASE 3B CROSS SECTIONS - AREA 1 & 6 STA 0+050 TO 0+120			
Project No.	3427-023	Drawing No.	
Group	CIVIL		
Rev.			
	C-301		1

AREA 1

AREA 6
