FILE: 3793-TM1

TECHNICAL MEMORANDUM

DATE: October 14, 2021

RE: **Hydrogeology Assessment for Aquifer Protection
Stave Lake Quarry, Miracle Valley, B.C.**

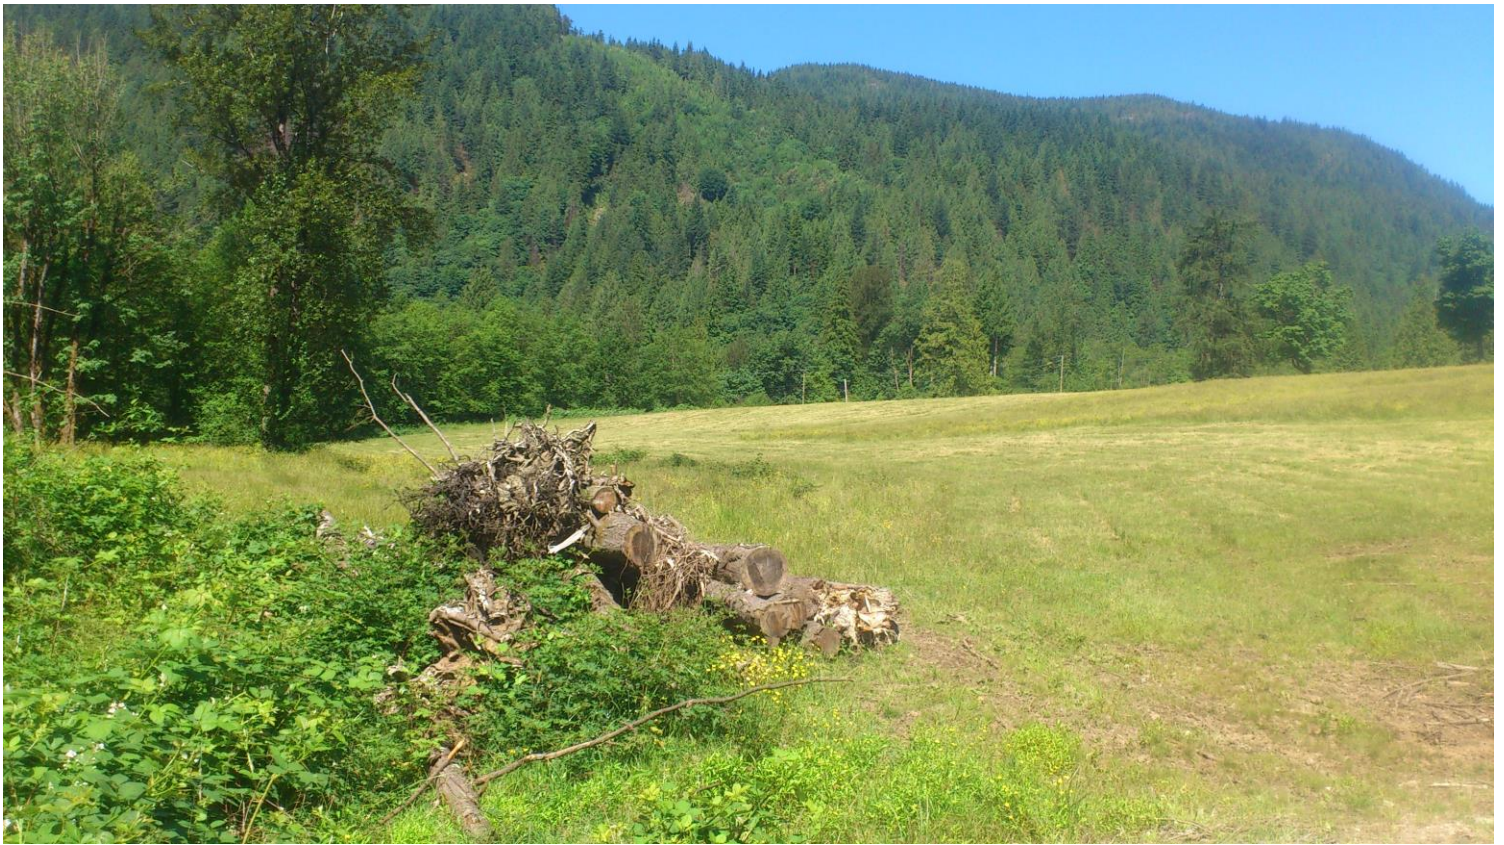
Photo 1: View northwest across the south end of the Terrace toward the steep west valley wall. The Quarry is situated on a bedrock bench near the right side of the photo. June 15, 2017.

Ground elevations rise abruptly north of Durieu Road from 20 to 100 m above sea level (m-asl), then continue to rise gradually to 140 m-asl at Hartley Road. Continuing northward, ground elevations decline gradually to about 80 m-asl at Stave Lake. The Valley is bounded by steep mountainous terrain on the east and west sides (Photo 1).

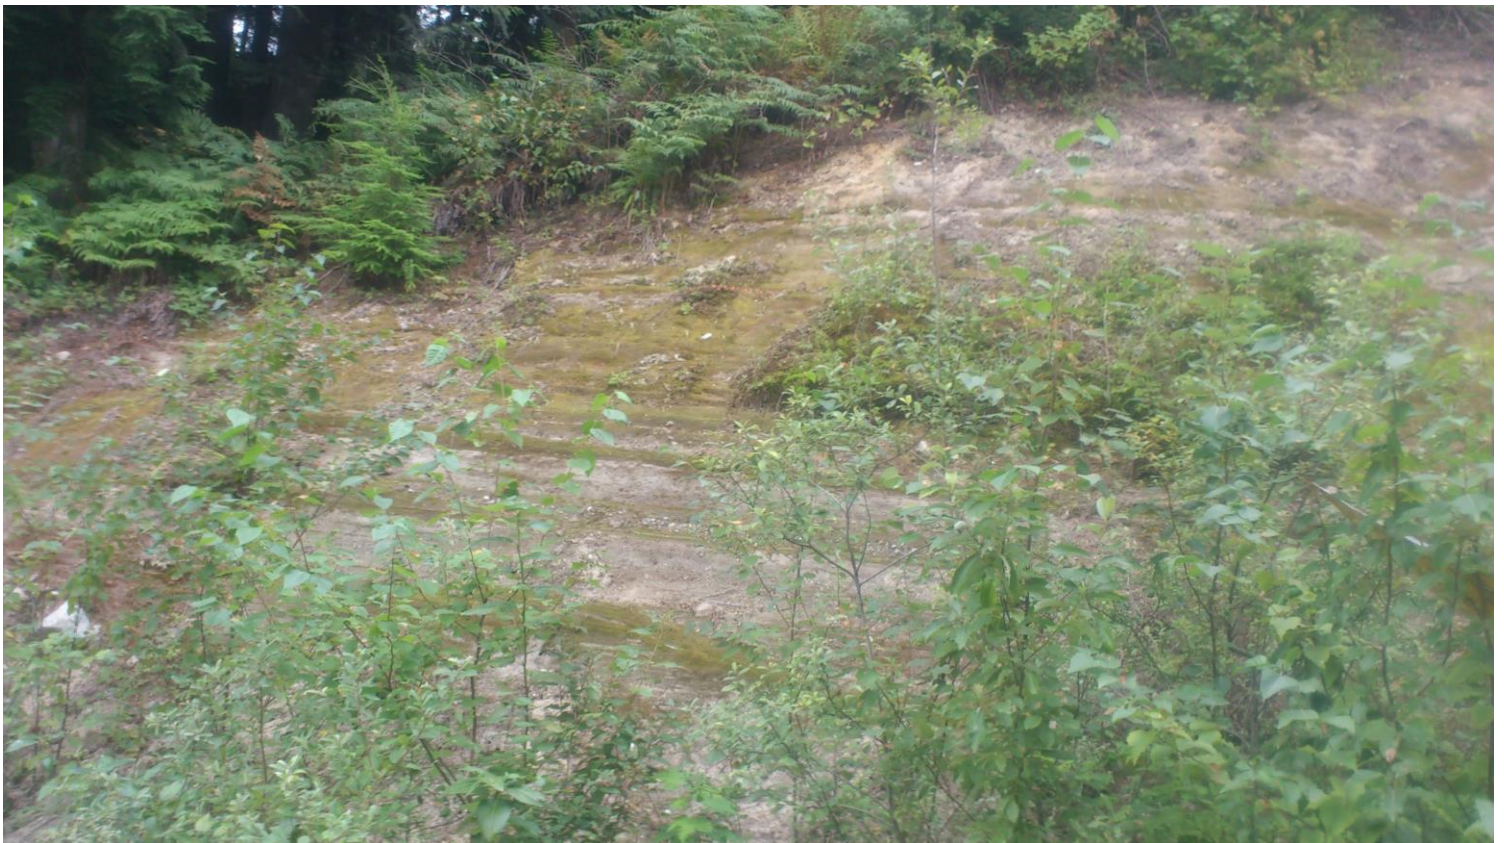
Photo 2: Laminated silt and clay in a road cut at approximately 160 m elevation along the Quarry access road. August 30, 2021.

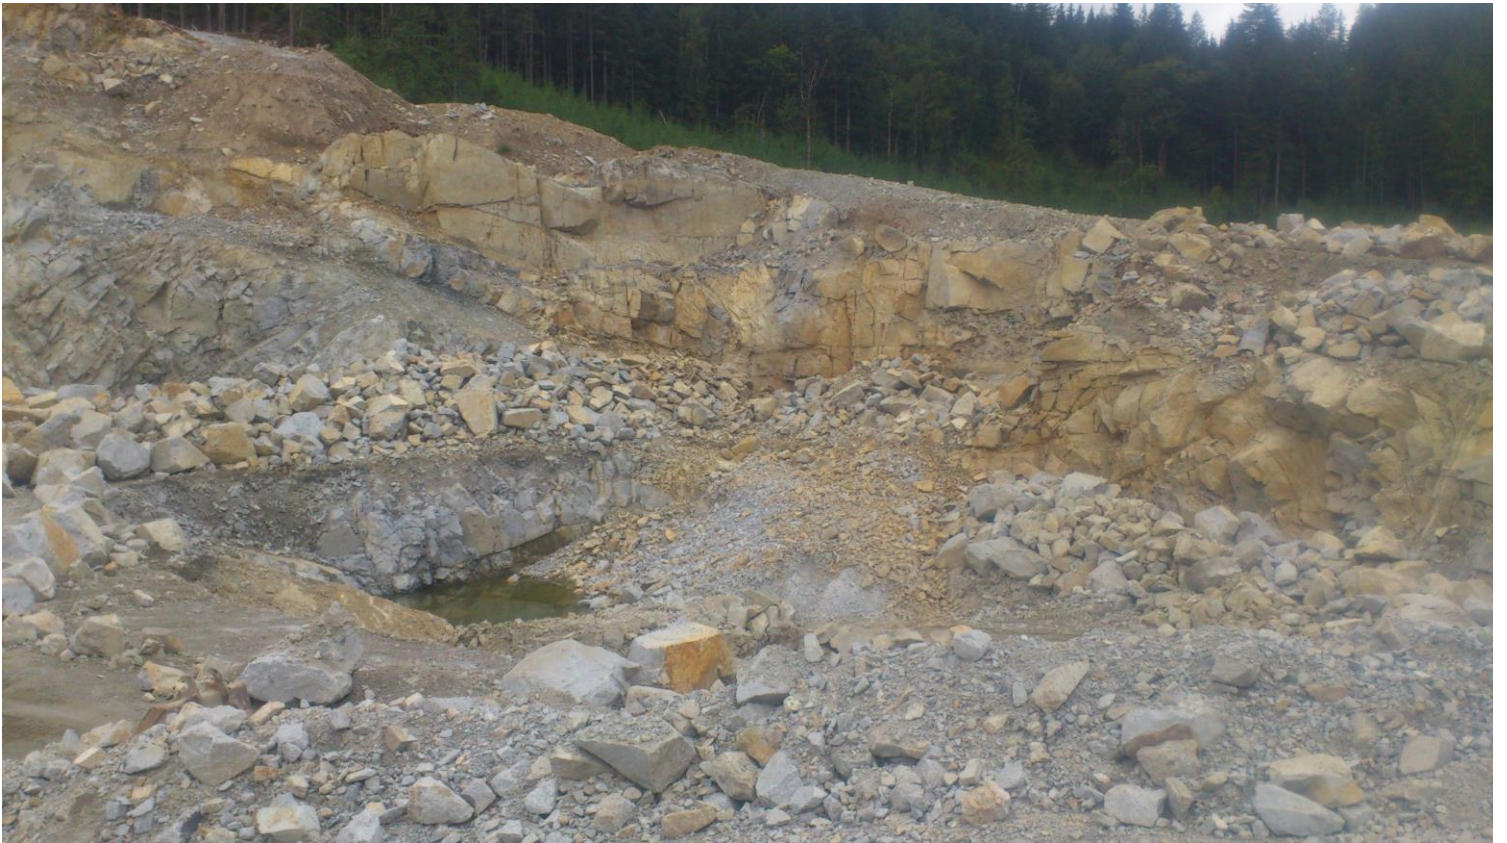
Photo 3: Fractured and jointed quartz diorite at the Quarry. The Quarry pond can be seen. August 30, 2021.

The Valley floor is covered with unconsolidated sediments including a thick (>50 m) accumulation of sand and gravel overlain by about 30 m of marine silt and clay belonging to the Fort Langley Formation. The steep Valley walls are largely bedrock mapped as quartz diorite, covered by a discontinuous veneer of Fort Langley silt/clay that extends up the Valley walls to approximately 180 m-asl elevation (Photo 2). The bedrock is fractured and planar jointing is evident at several orientations (Photo 3).

A pond is situated in a pit in the lowest portion of the Quarry (Photo 3).

The operators indicated there is no runoff from the Quarry. Rainfall accumulates in a pond that has formed in the lowest portion of the Quarry (Photo 3) where it infiltrates.

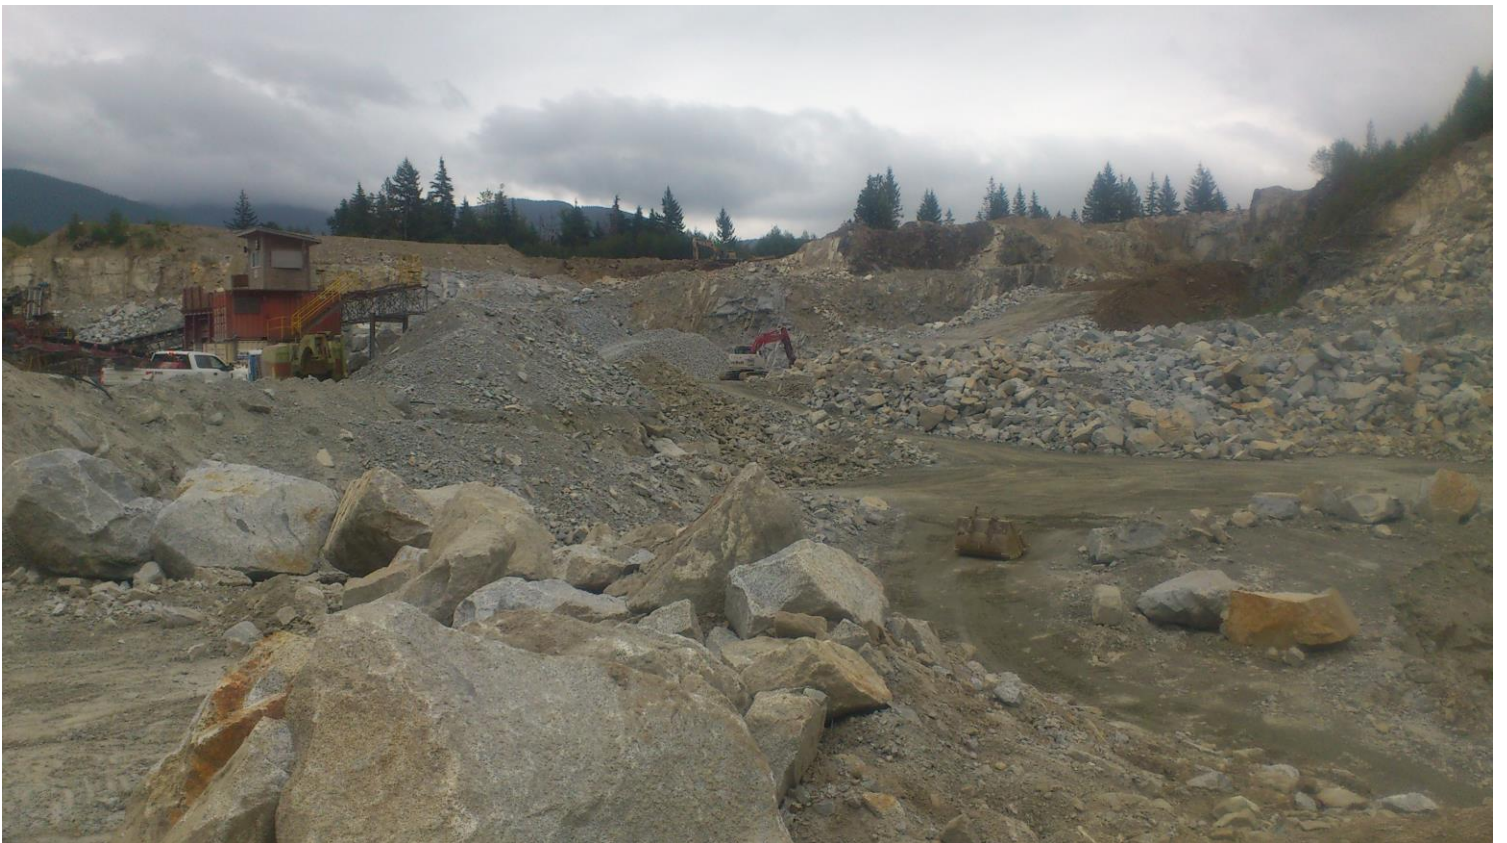
Photo 4 The Quarry, situated on a bedrock bench at approximately 240 m-asl elevation. August 30, 2021.

The Quarry is situated on a bedrock bench in the west Valley wall at an elevation of approximately 240 m-asl (Figure 1; Photo 4). The hillside between the Quarry and the Valley floor has an average grade of 57%.

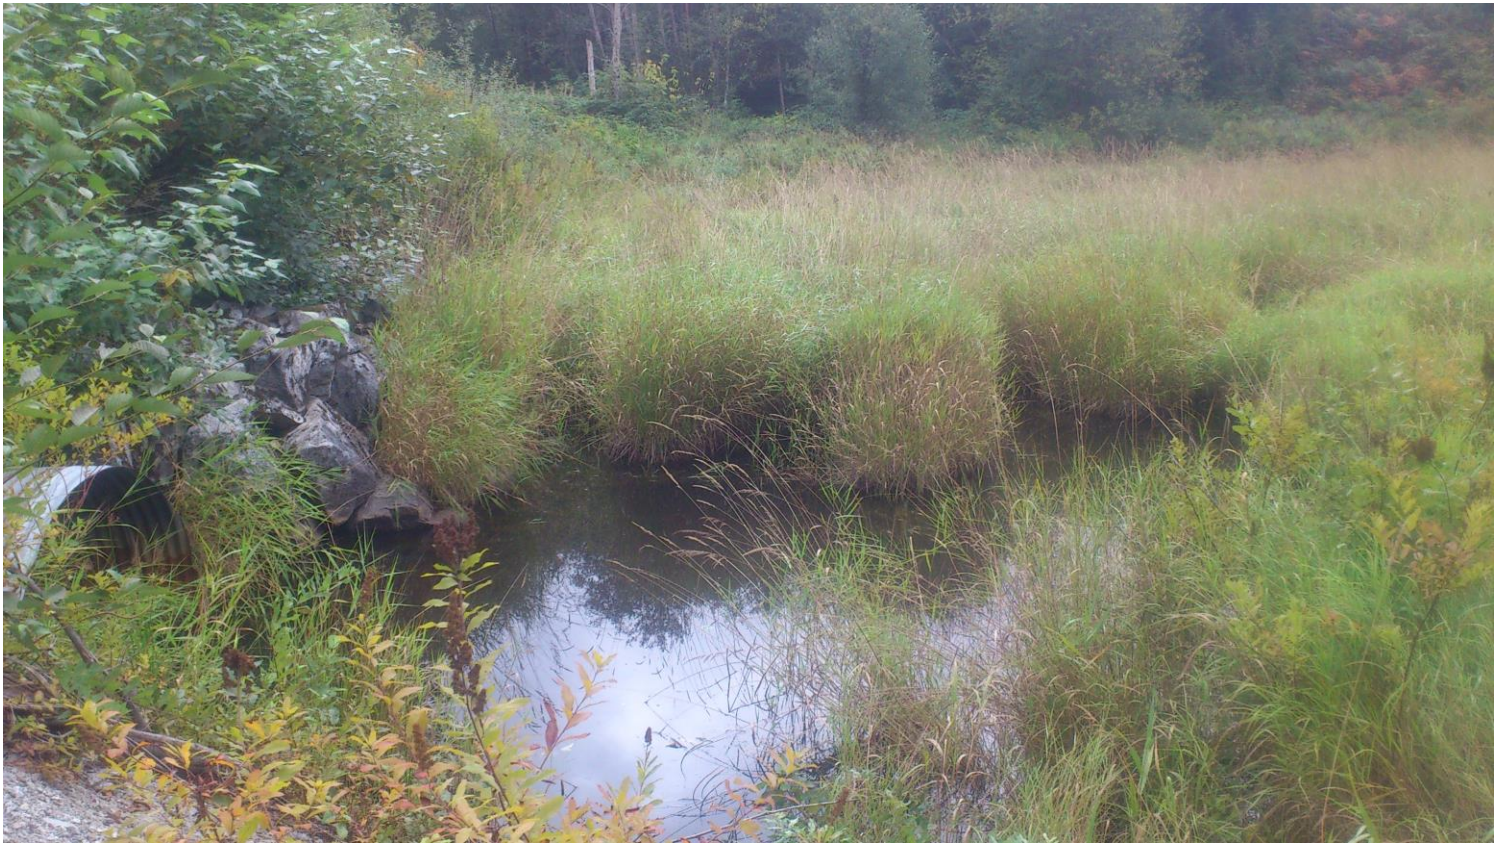
Photo 5: Harriet Lake, situated on the Terrace below the Quarry. August 30, 2021.

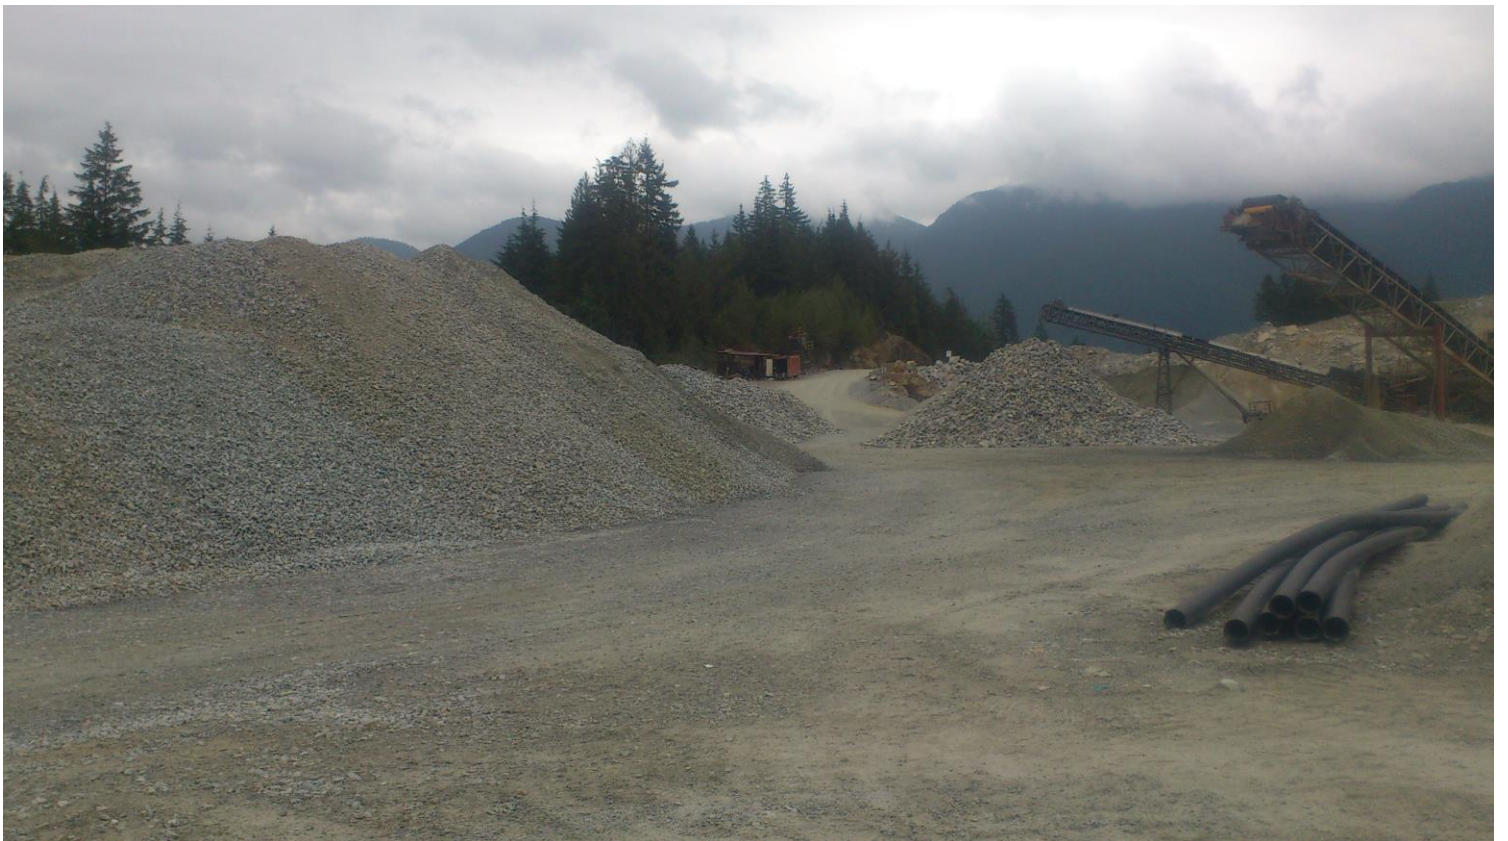
Photo 6: Various sizes of crushed rock manufactured and stockpiled at the Quarry. August 30, 2021.
