**FILE:** E06604.250/3  
**CIVIC:** 4164 Slesse Road  
**PID:** PID: 009-301-780  
**LEGAL:** Lot 25 Except: Part within Heavy Outline taken by Highway Statutory Right of Way Plan 64013, Section 33 Township 1 Range 29 West of the Sixth Meridian New Westminster District Plan 24078

**Re: Final Warning – Construction without a Building without a Permit – 4164 Slesse Road  
Demolish and reconstruct the rear of the single family dwelling with attached deck**

**SLESSE PARK PROPERTIES, CHILLIWACK  
OVERVIEW GEOTECHNICAL HAZARD ASSESSMENT**

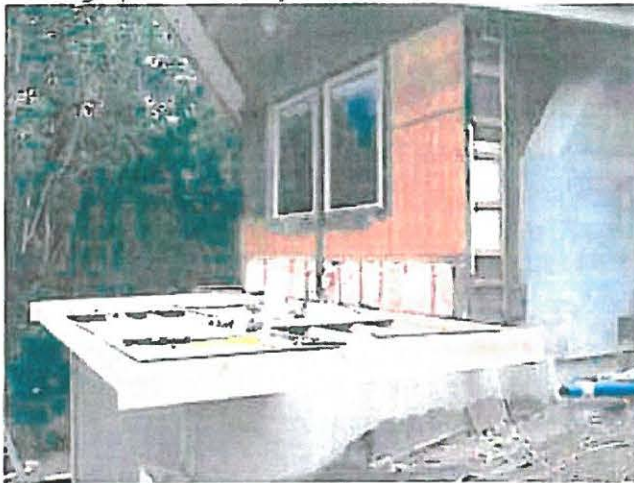
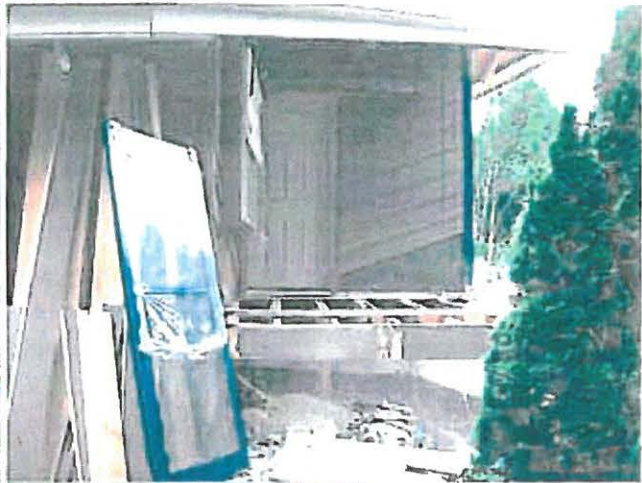
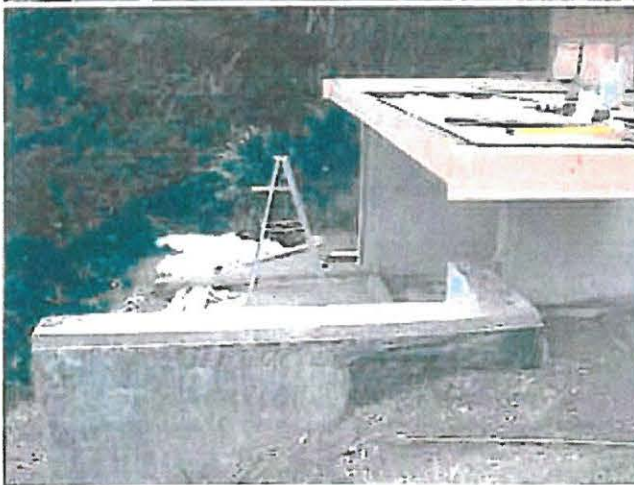
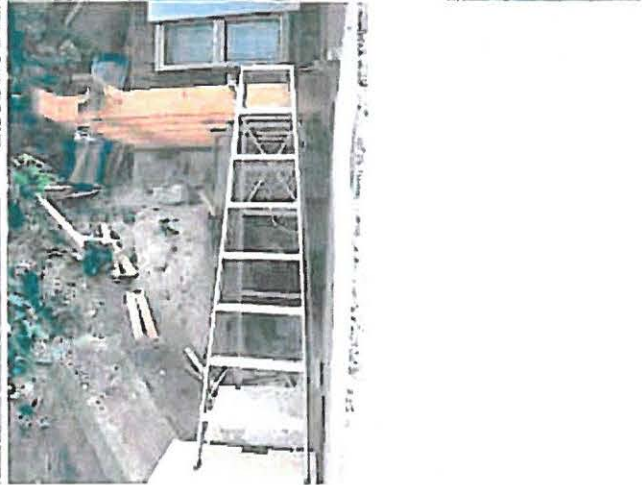
Photographs taken July 22, 2011

On June 19, 2011, staff was made aware that property owners were demolishing the back of the dwelling and a deck with plans to rebuild. Staff verified that permits had not been applied for such works and posted the structure with STOP WORK and NO OCCUPANCY notices (BE File E06604.250/3). The Building Inspector noted the following:

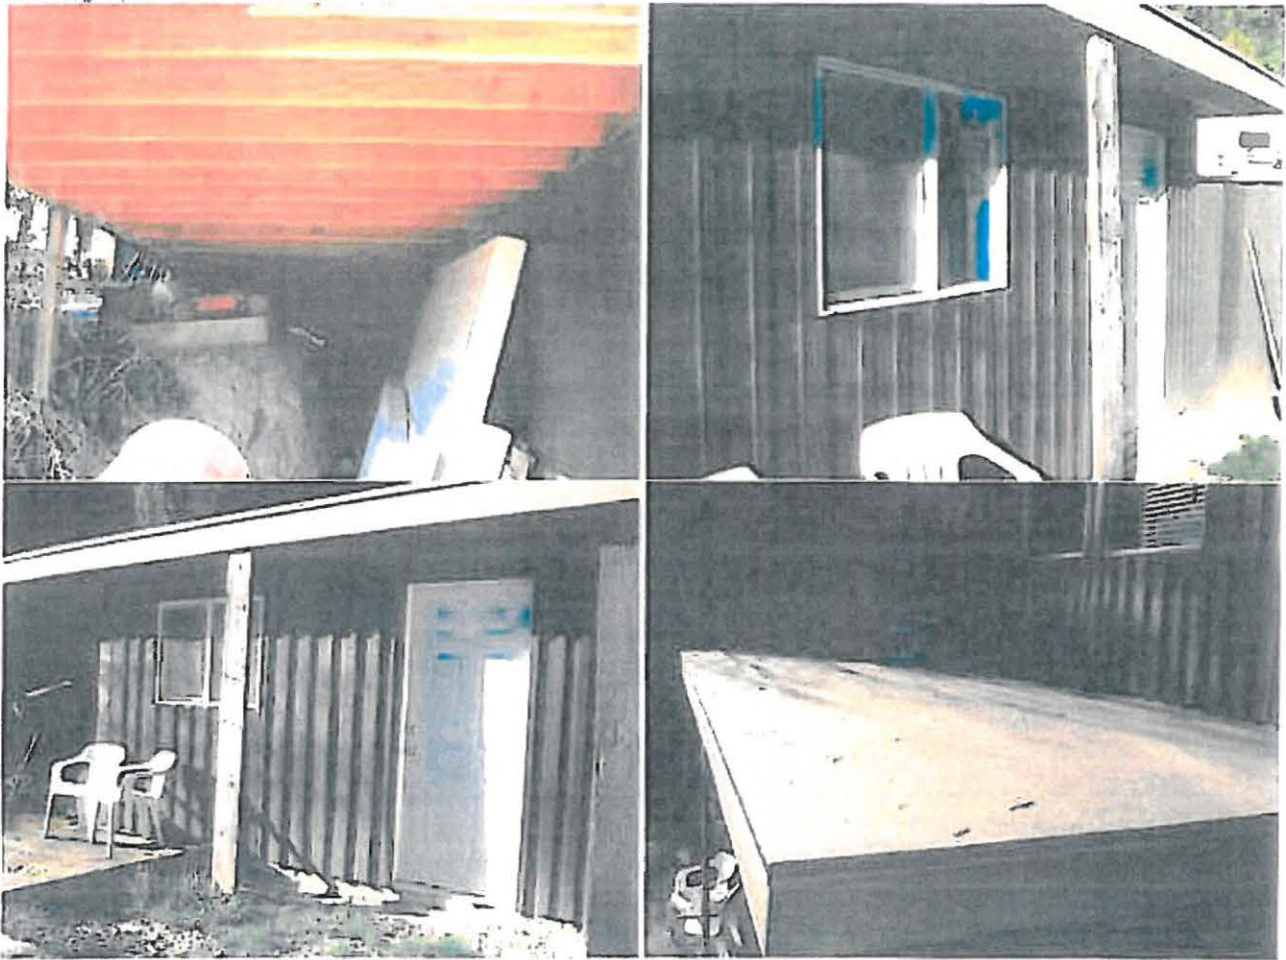
Photographs taken Feb 23, 2015

On October 2, 2014, staff contacted the owner who stated that they had reduced works so as to be exempt from requiring a Building Permit. The owner permitted staff to perform a site inspection on February 23, 2015 to confirm that the works do not exceed 215 square metres. The Building Inspector noted that the deck measures 320 square feet and a building permit is still required. The Inspector also noted that works have continued and the room below the deck is now enclosed (please note photographs below).

At this time, and due to the mitigating circumstances outlined by yourself, the Regional District is prepared to provide you **one year to apply and obtain the required permits** (prior to May 1, 2016) for the works (deck and room addition). The Bylaw Enforcement file E06604.250/3 would remain open but on hold until the extension is concluded or further information is received which would require staff to activate the file. I have attached a *Letter of Intent* for you to sign if you wish to proceed with this course of action. Should you fail to comply with this request, you may be subject to ticketing and your file may be referred to the Regional Board for their consideration and recommendation regarding further bylaw enforcement. Please do not hesitate to contact me if you have any questions or require further information.

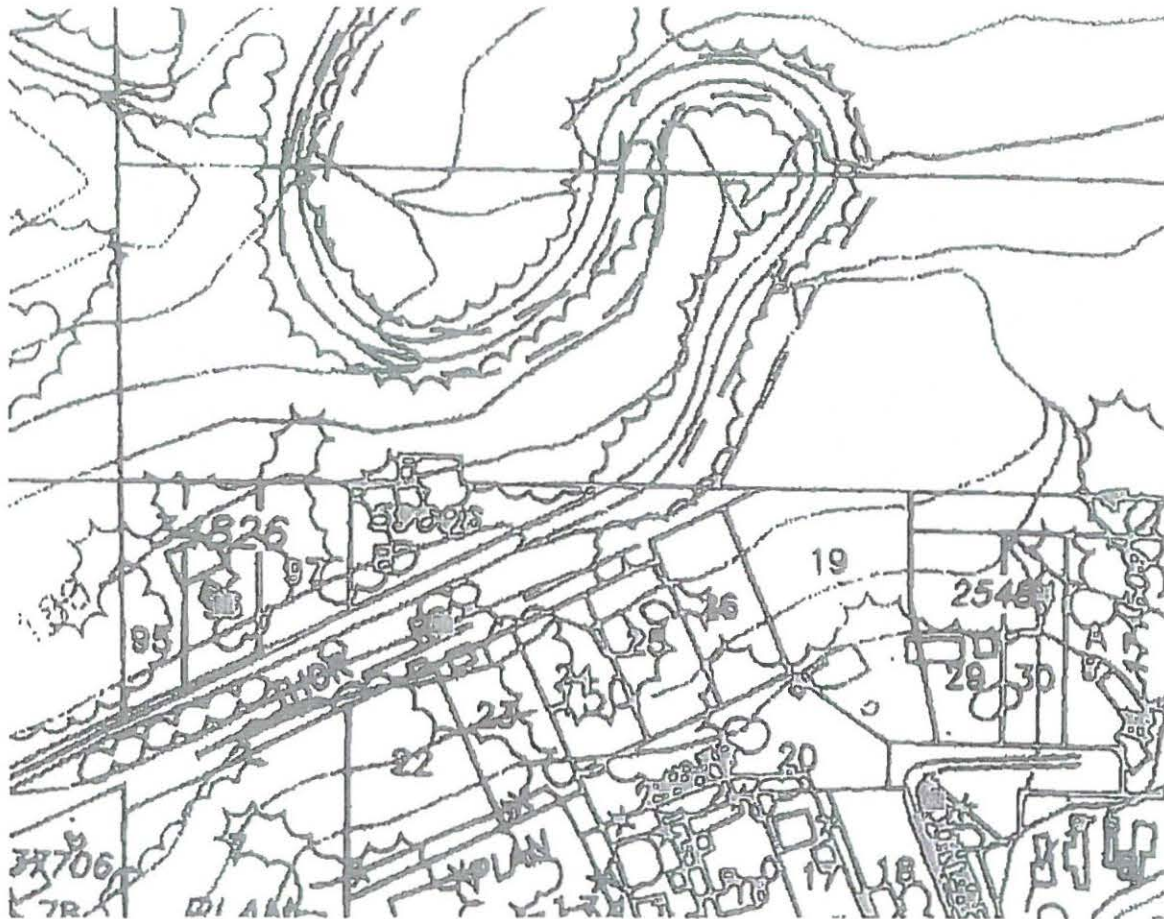
Figure 1: Topographic and property map. Contour interval is 10 m but the map is not scaled. It was produced for the BC Government in 1993. Slesse Road curves up the valley slope on the north side. Some property lines do not appear to be accurately shown or registered to physical features. Houses include what may be the MacGregor house on Lot 25 (4164 Thor Road). Surveys will be required to define actual lot limits. Lot 24 is 4160 Thor Road. Lot 26 is 4170 Thor Road. Lot 20 is the Fedick property (50761 Mountview Avenue) but the map was prepared before the house was built. Lot 19 is 50765 Mountview and its house appears to be correctly positioned relative to the immediately adjacent property boundary. Nonetheless, the boundary corner mapped just west of this house cannot be reconciled with a surveyed fence line that projects to the northeast corner of the Fedick property, as shown on Photo 4.

We received some conflicting information during March 12 phone conversations with area landowners. In particular, we are confused over the location of 4170 Thor Road's east boundary as noted on Figure 1 and Photo 4 of this report.

Figure 1 shows that the residential lots are relatively small and were subdivided in comparatively complex patterns especially considering how potentially adverse geotechnical slopes trend through the area. Most of the houses are relatively old and were sited before awareness of geotechnical hazards prevailed. Some are sited too close to the top or foot of slopes (see TEL's 1989 report) considering current levels of awareness of slope hazards and risks and the many uncertainties that apply in professional slope hazard assessment work. As a result and except for the considerable

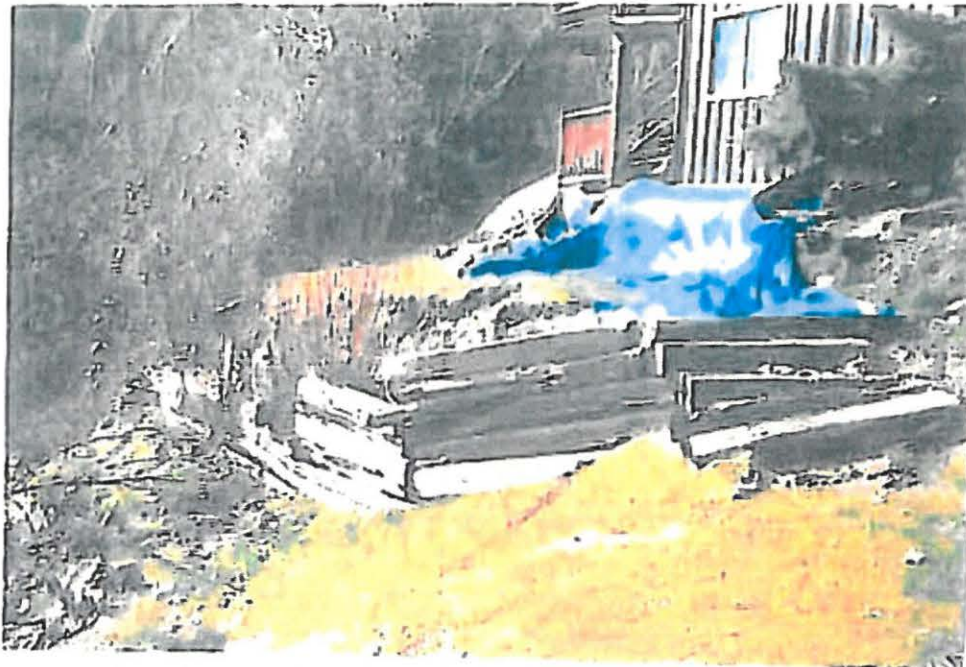
**Photo 1. View WNW showing slide below MacGregor house at 4164 Thor Road. Note the sheared soil mass in the foreground.**

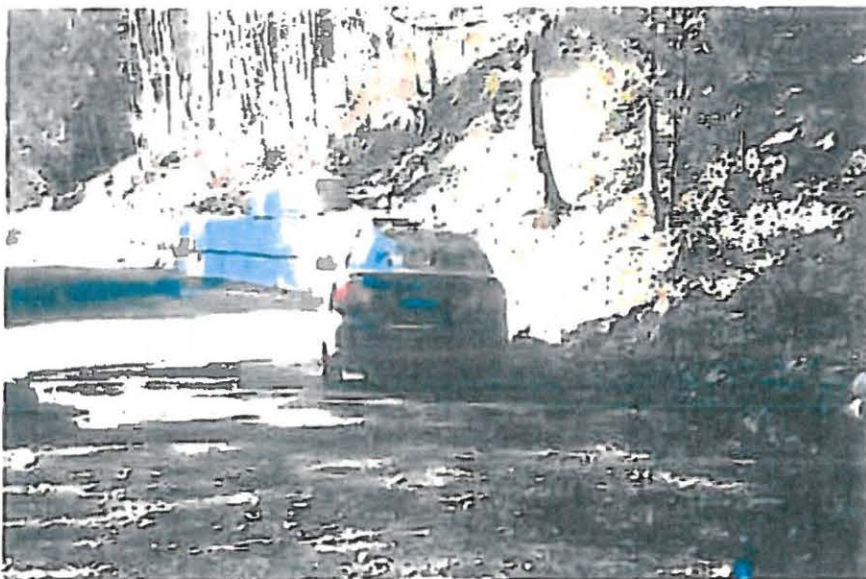
**Photo 2. View WNW showing Lock Block wall on north side of Thor Road above the MacGregor house. The wall drain flows to the east-flowing drainage ditch at lower right. It turns into the N-S ditch not far behind the photographer.**

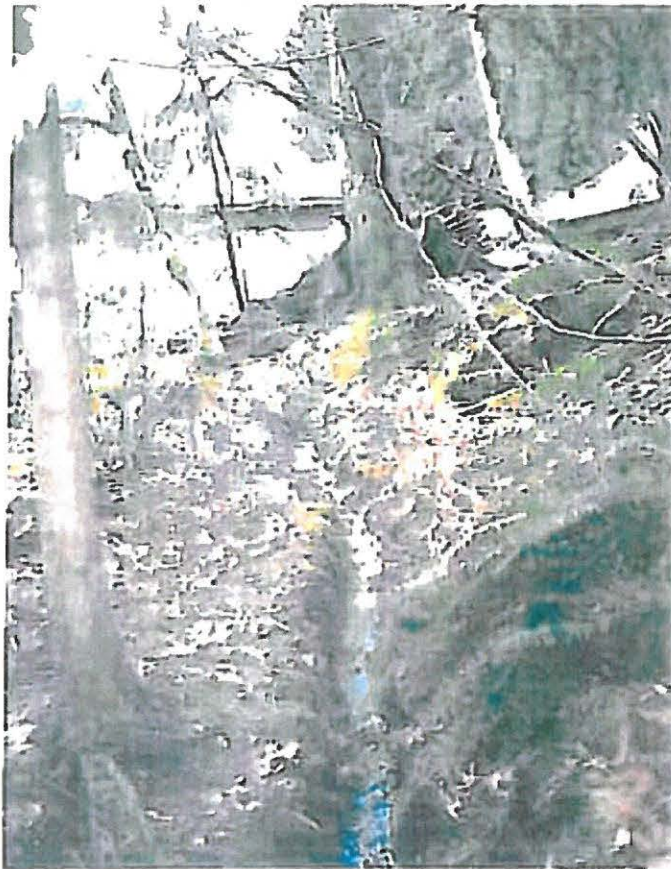
On March 16, we traced the ditch through the forest and noted that it crosses oblique to the forest slope fall line. This portion of the ditch appeared to have been recently excavated or cleaned out with a hand shovel (Photo 3). It flows to a relatively small natural gully that drains south to a point about 8 m east of the west range of the house at 50765 Mountview (Figure 1). The gully is referred to as Gully B in TEL's 1989 report to Mr. Buzzard. The house is situated very close to the foot of a moderate to steep forest slope and our 1989 report expressed concern about the geotechnical security of the house. We did not enter the property but the gully drainage is directed westward from behind the house to a concrete lined drainage ditch that follows the property line between 50761 and 50764 Mountview (Figure 1 and Photo 4) then into a road cross culvert.

**Photo 3.** View WNW showing ditch in the forest east of the MacGregor tracts at the top of the photo.

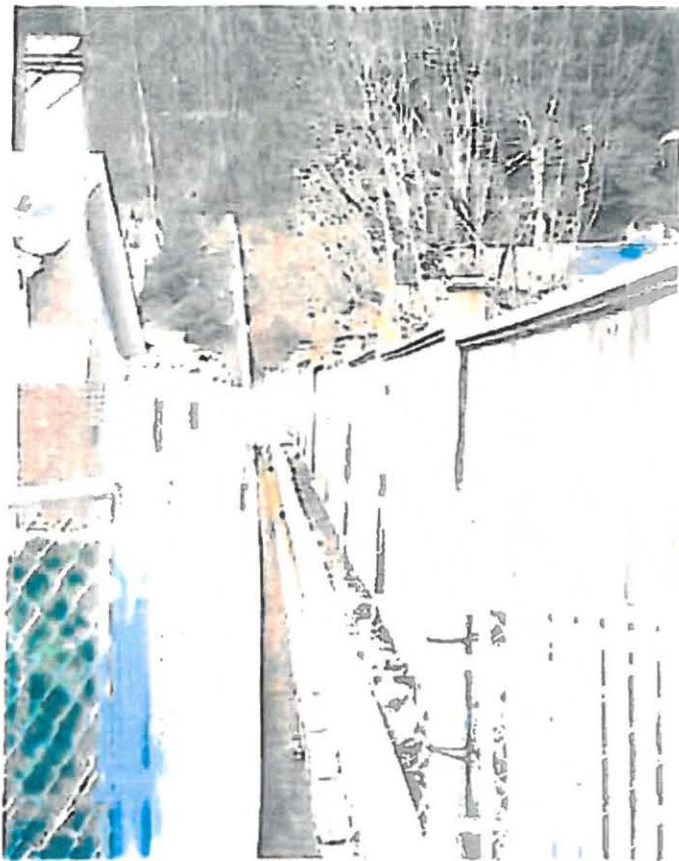
**Photo 4. View northwest showing the concrete ditch between houses at 50761 (left) and 50765 (right) Mountview Avenue. Note how a Fedick fence line strikes up slope along a line projected from the ditch and compare the projected line to the boundary shown on Figure 1. Mr. Fedick states the fence follows a survey boundary to his northeast property pin. We cannot reconcile this observation with the boundary shown on Figure 1.**

We recommend that the conflicts amongst area landowners be settled before any party seeks further geotechnical advice and before geotechnical investigation and design work is implemented. In our judgment, legal survey work will be required. We gave this information to Mr. R. Wong of GAL on March 15.

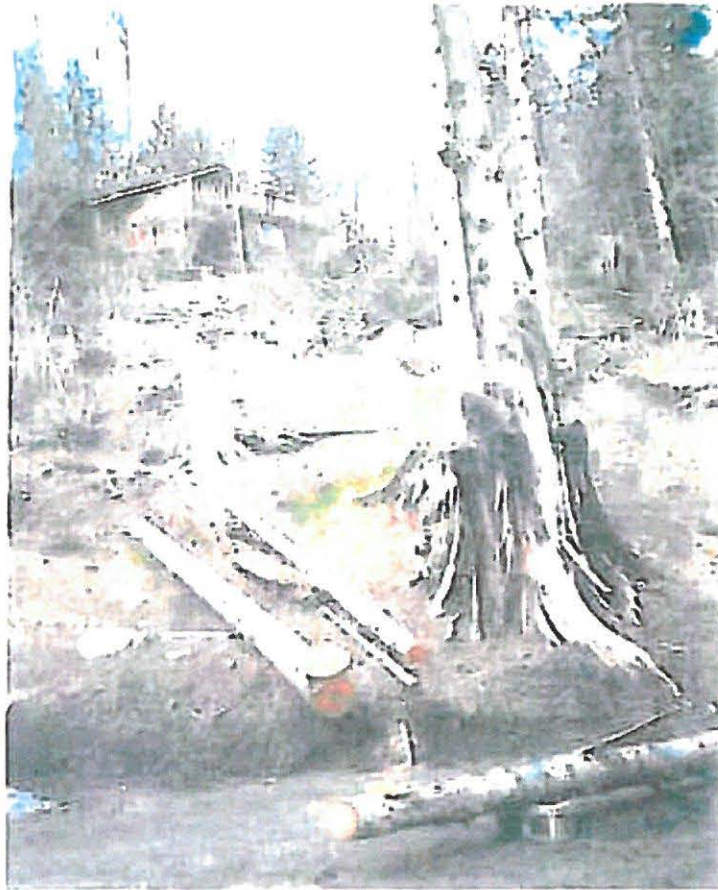
The Fedick house is situated near the east end of their lot (Photo 5) and it was the subject of the 1993 report by Cascade Engineering. Mr. Fedick explained that his house was sited in accordance with that report and that large shot rock fragments (from a single partially buried boulder) were placed along the foot slope behind and just west of his house in accordance with advice from Cascade Engineering. This rock forms a toe blanket that appears to resist slope movements but, on March 12, Mr. Fedick noted there was no slide activity prior to the rock being placed. He also notes that maple and alder trees are dying on this slope although it is not clear why.

**Photo 5. View northnortheast showing the landslide on the Fedick property. Bare soil patches mark the slide head scarp. Note the position of the MacGregor house compared to the slide. The Fedick lawn is in the foreground.**
