Provincial Agricultural Land Commission - Applicant Submission

Application ID: 58010

Proposal Type: Non-Farm Use

Regarding: Geotechnical and Hazard Assessment Report
Proposed Agricultural Building
58551A Dent Road, Laidlaw, Project: 43921-01

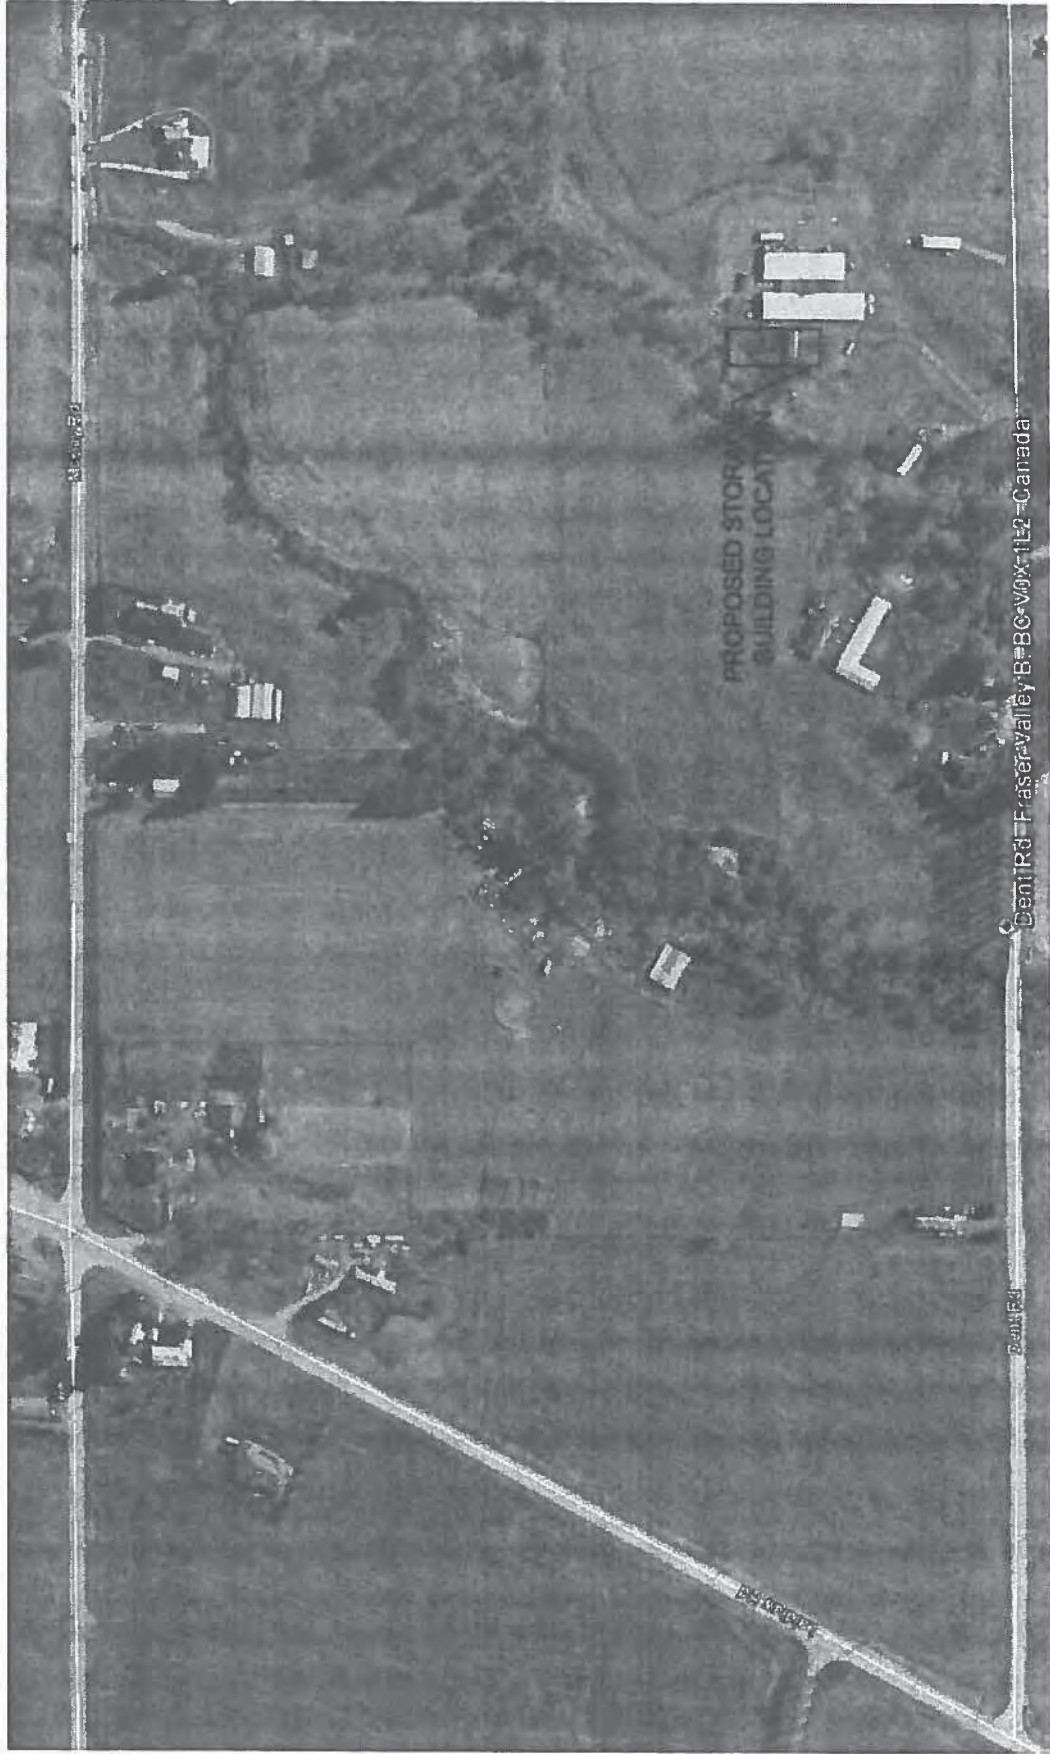
Building Drawings and Site Location Plan

KALLEY GEOTECHNICAL ENGINEERING SERVICES LTD Unit 15 20279 97th Avenue Langley BC, V1M 4B9 Phone: (604) 882-8475 Fax: (604) 882-8476	Client: MICHAEL WATSON		SEAL		FARM STORAGE ROOM SITE PLAN		Drawn: EK		Dwg No.	
	Location: 58551A DENT ROAD LAIDLAW, BC						Checked: AJ		1	
	FILE No. 43921-01						DATE OCTOBER 16, 2013			
	REV		DATE				DESCRIPTION

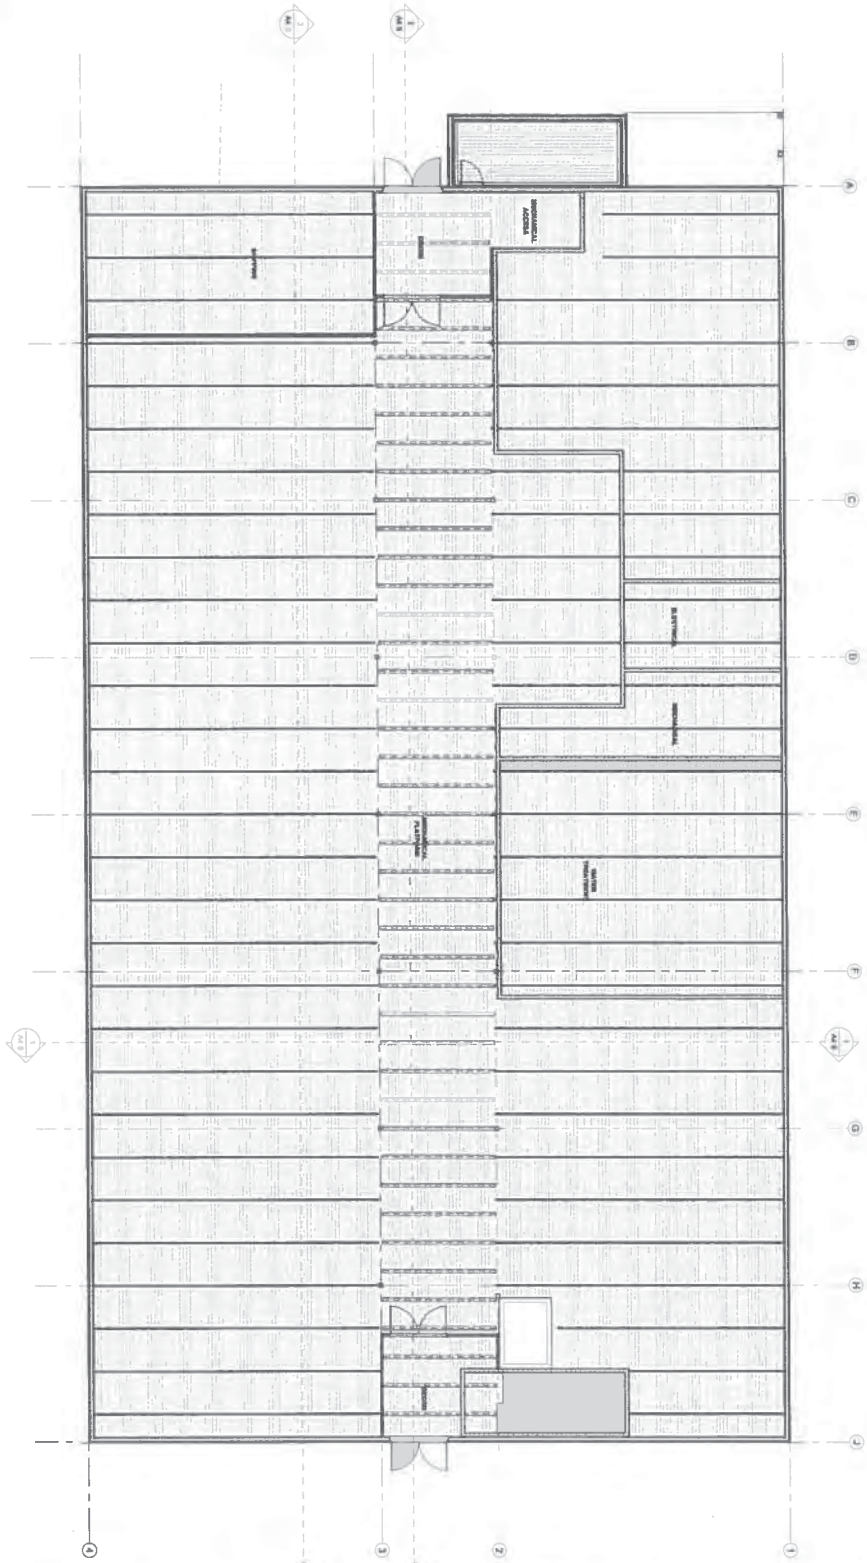
DRAWING BY: JDR
CHECKED BY: TK
SCALE: AS NOTED
DATE: SEP 11, 18
SHEET NO: A1.4b
DATE PLOTTED: 01/29/2018 3:41:59 PM

1 MAIN FLOOR PLATFORM - RCP

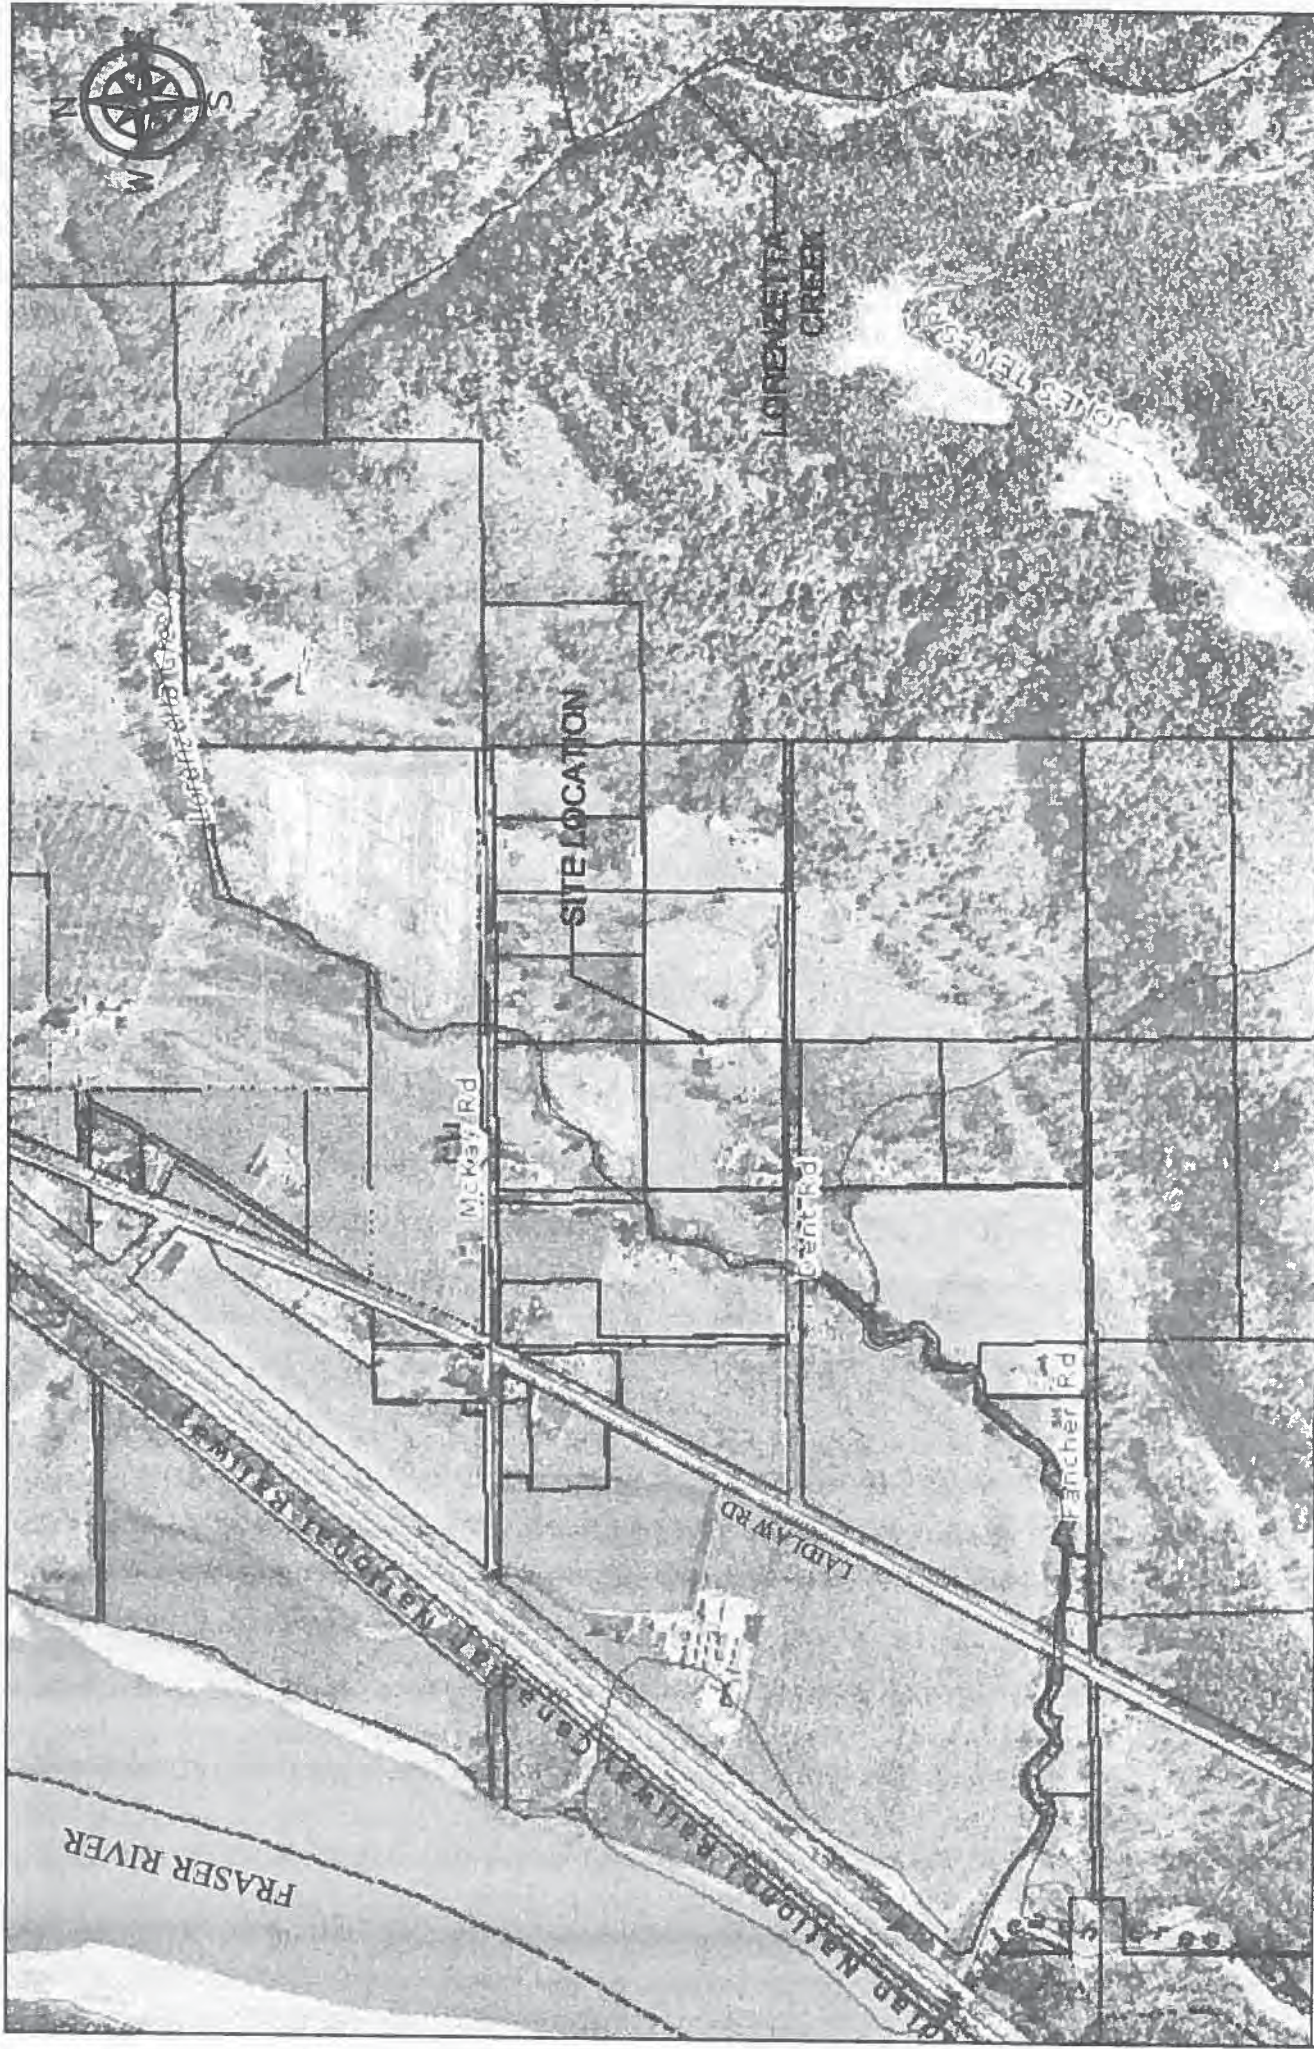
Overall Site Plan

KALLEY GEOTECHNICAL ENGINEERING SERVICES LTD. Unit 15 20279 97th Avenue Langley BC, V1M 4B9 Phone: (604) 882-8475 Fax: (604) 882-8476	Client: Michael Watson		SEAL		REV DATE DESCRIPTION	Global Map Site Plan		
	Location: 58551A Dent Road, FVRD, BC					Drawn: SC	Dwg No. 1 of 2	
	FILE No. 43921-01	DATE November 07, 2013	Checked: AJ	Scale: 1:10000

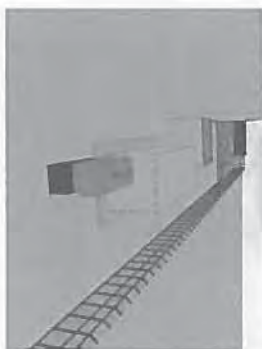
7 NORTH CAMERA - SITE YARD
SCALE: 1" = 10'

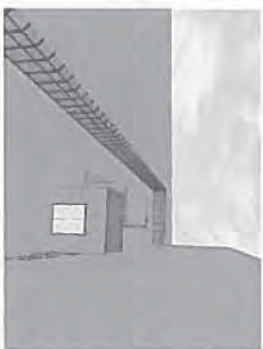
3 SOUTH CAMERA - SITE YARD
SCALE: 1" = 10'

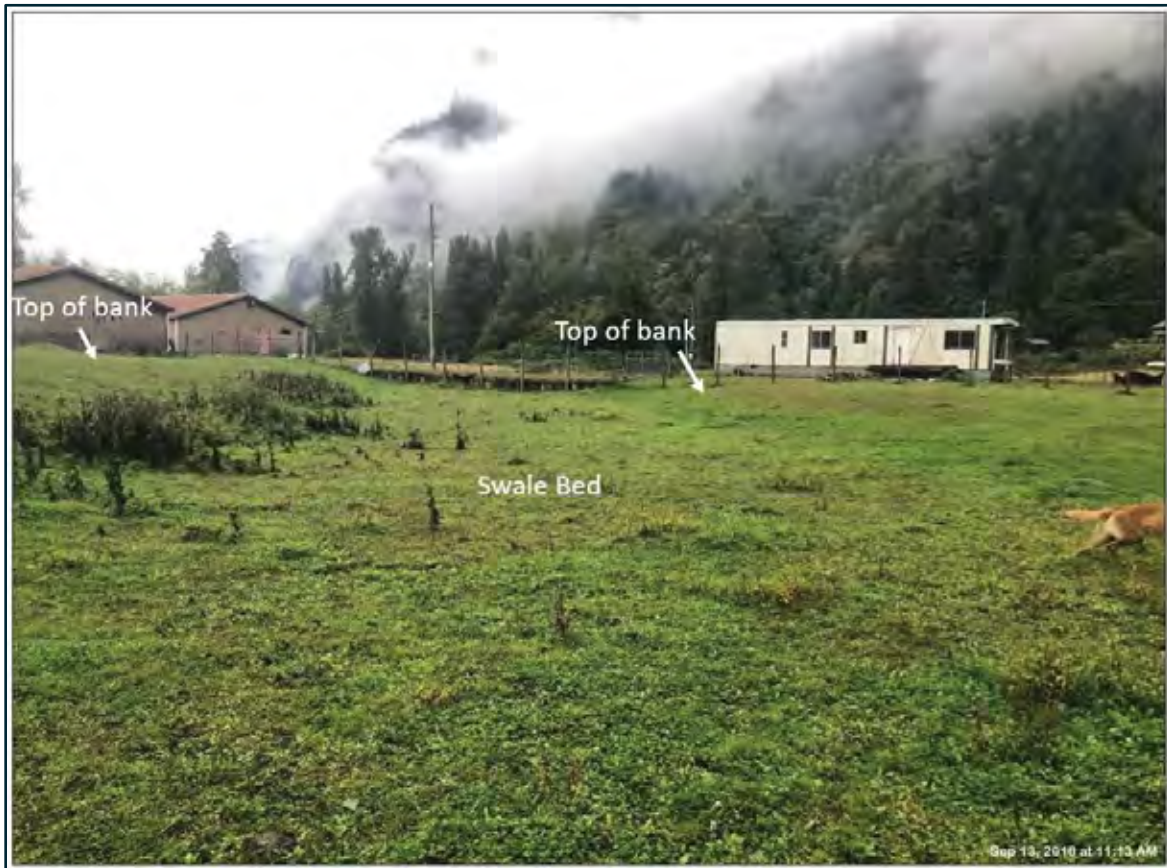
Figure 1. Shallow and wide swale which is a remnant channel of Lorenzetta Creek, has no visible evidence of water flow. Photo looking northward from Dent Road.

A topographic swale or channel is evident on the property. The swale is a shallow depression on the landscape, 11 to 14 m wide at top of bank, and about 1.5 to 2 m deep (*Figure 1*). It is a remnant topographic feature as part of an alluvial fan of Lorenzetta Creek. Lorenzetta Creek was diked a few decades ago so that this swale no longer carries flows from Lorenzetta Creek. Overland and surface flows of water from the adjacent mountainside spread out across the landscape, flooding several of the local farm properties in the winter during heavy rainfalls. This swale collects some of this overland flow from the base of the mountain and may also receive some backup flood waters from the adjacent properties through the culvert at Dent Road. The swale has no natural boundary, high water mark, bed or scour to indicate that water flows through this channel. There is no evidence of sorting or rafting of material or vegetation characteristic of high moisture or water filled conditions. In the area of the proposed building development the swale does have a top of bank emphasized by the creation of farm roads within the property.

Vegetation found in the swale (grasses and herbs) are not species typical of streams or wetlands that would provide evidence that water flows through the swale at any time of year. However, the property owner has indicated that the swale pools water in the wintertime. Water within the swale at this time may be due to overland flooding on a neighbour's property and improperly sized drainage systems and culverts.
