31 October 2008

Re: Geotechnical Investigation & Report
Proposed 42 Lot Development
Lot 3 – 1760 Columbia Valley Highway, Chilliwack, BC
Lot 4 – 1536 Frost Road, Chilliwack, BC
Lot 2 – 1766 Columbia Valley Highway, Chilliwack, BC
VGES Project No. 42906-04

VGES Project No. 42906-04

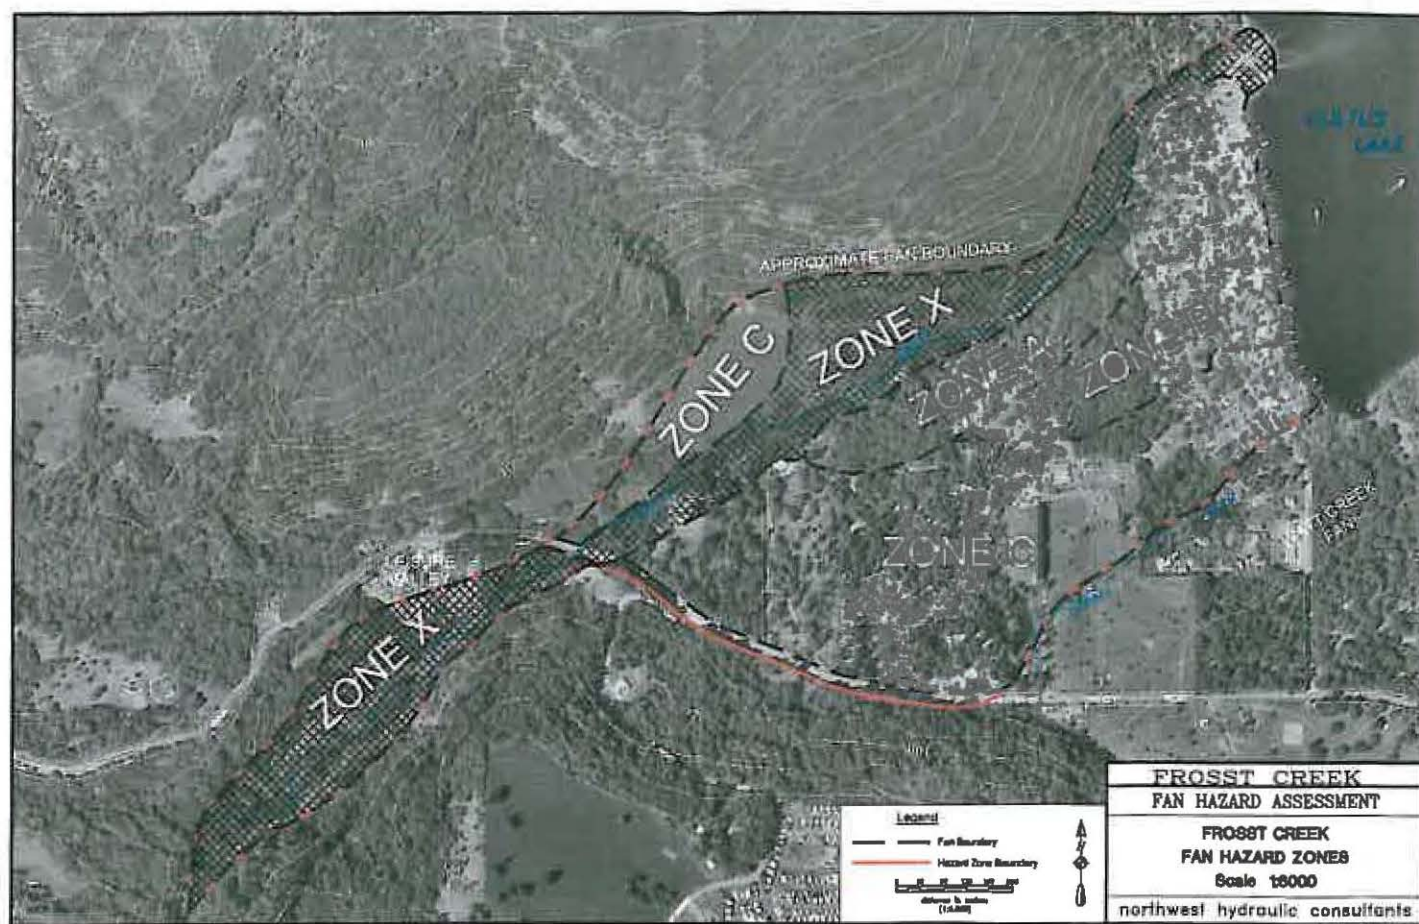
FIGURE 3

Relative hazard zones have been established based on a range of factors and are presented in Figure 3. Table 4 summarises the potential hazards for each zone.

The NHC (2006) report delineated four zones on the alluvial fan formed by Frosst Creek as shown on the attached figure (labelled **Figure 3** in the original report). Zone 'X' was originally defined as follows:

Adoption of the recommendations outlined above would effectively negate the linework presented in **Figure 3** from the NHC (2006) report, but **ONLY** for the 'X' Zone/'A' Zone boundary within Lindell Beach lying to the south of Frosst Creek and to the east of Vera Road. The other boundaries shown on this figure remain valid until such time that the dike extending upstream of Vera Road is similarly upgraded to the required standard and a professional opinion regarding the advisability of reconsidering the boundary is obtained. The 'X' Zone/'A' Zone boundary within Lindell Beach would henceforth be defined by the physical extents of the existing dike.
