THURBER ENGINEERING LTD.

File: 14463

**45900 SLEEPY HOLLOW ROAD, CULTUS LAKE
GEOTECHNICAL RECOMMENDATIONS FOR SITE DEVELOPMENT
REVISION 1**

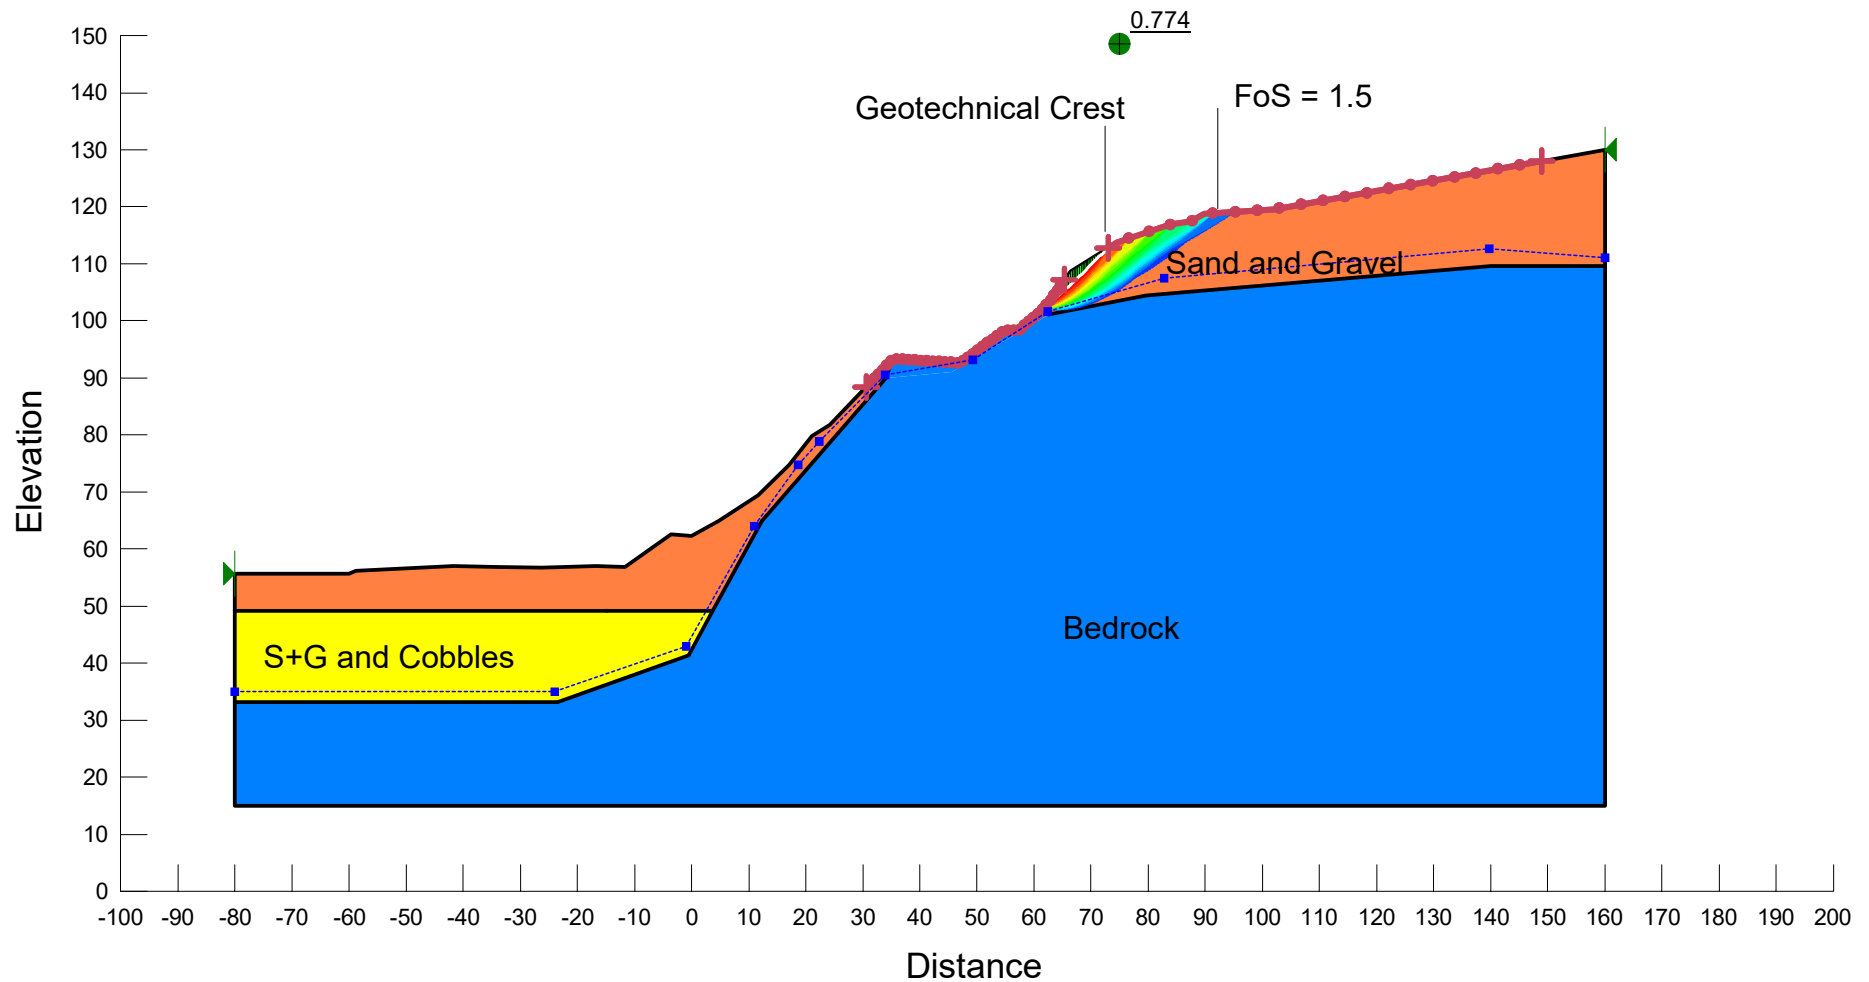
Slope Stability
Morgenstern-Price
11/1/2017
Section A-A

Name: Sand and Gravel Unit Weight: 19 kN/m³ Cohesion: 0 kPa Phi: 36 °
Name: S+G and Cobbles Unit Weight: 20 kN/m³ Cohesion: 0 kPa Phi: 36 °
Name: Bedrock Unit Weight: 24 kN/m³ Cohesion: 1e+006 kPa Phi: 1e+006 °

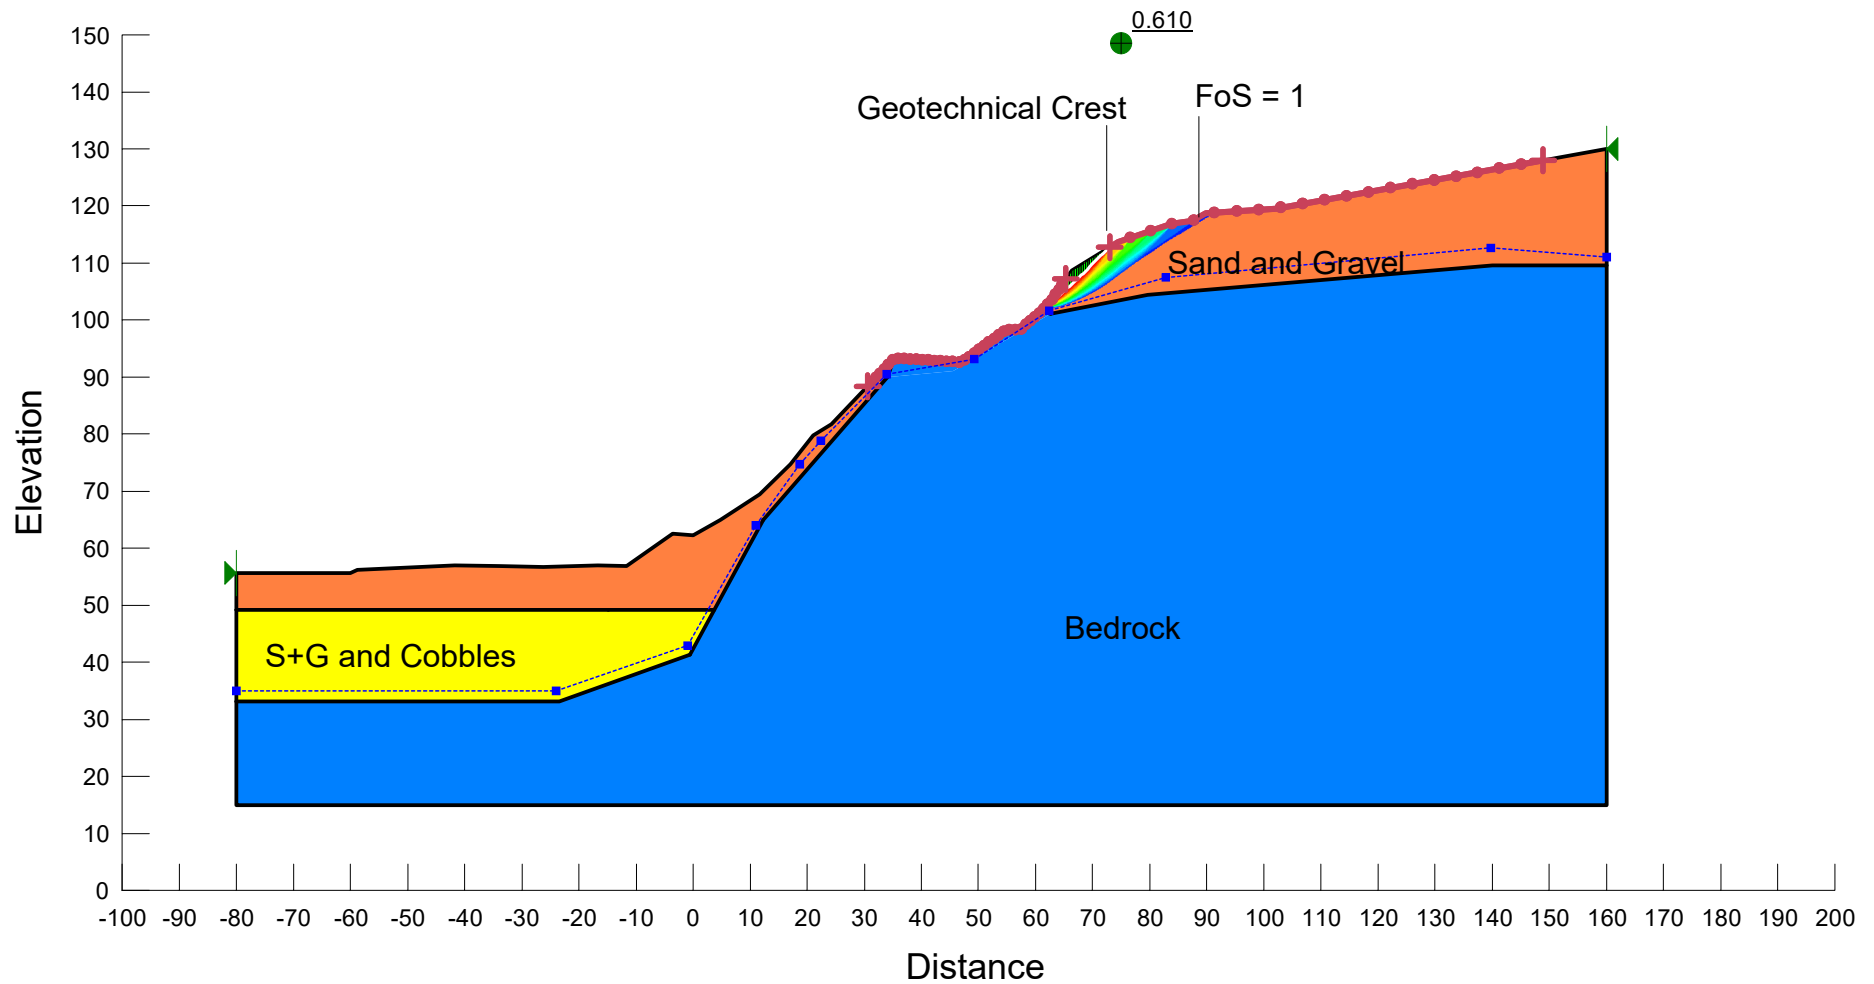
Slope Stability (Seismic - $k=0.12$)
Morgenstern-Price
11/1/2017
Section A-A

Name: Sand and Gravel Unit Weight: 19 kN/m^3 Cohesion: 0 kPa Phi: 36°
Name: S+G and Cobbles Unit Weight: 20 kN/m^3 Cohesion: 0 kPa Phi: 36°
Name: Bedrock Unit Weight: 24 kN/m^3 Cohesion: $1\text{e}+006 \text{ kPa}$ Phi: $1\text{e}+006^\circ$

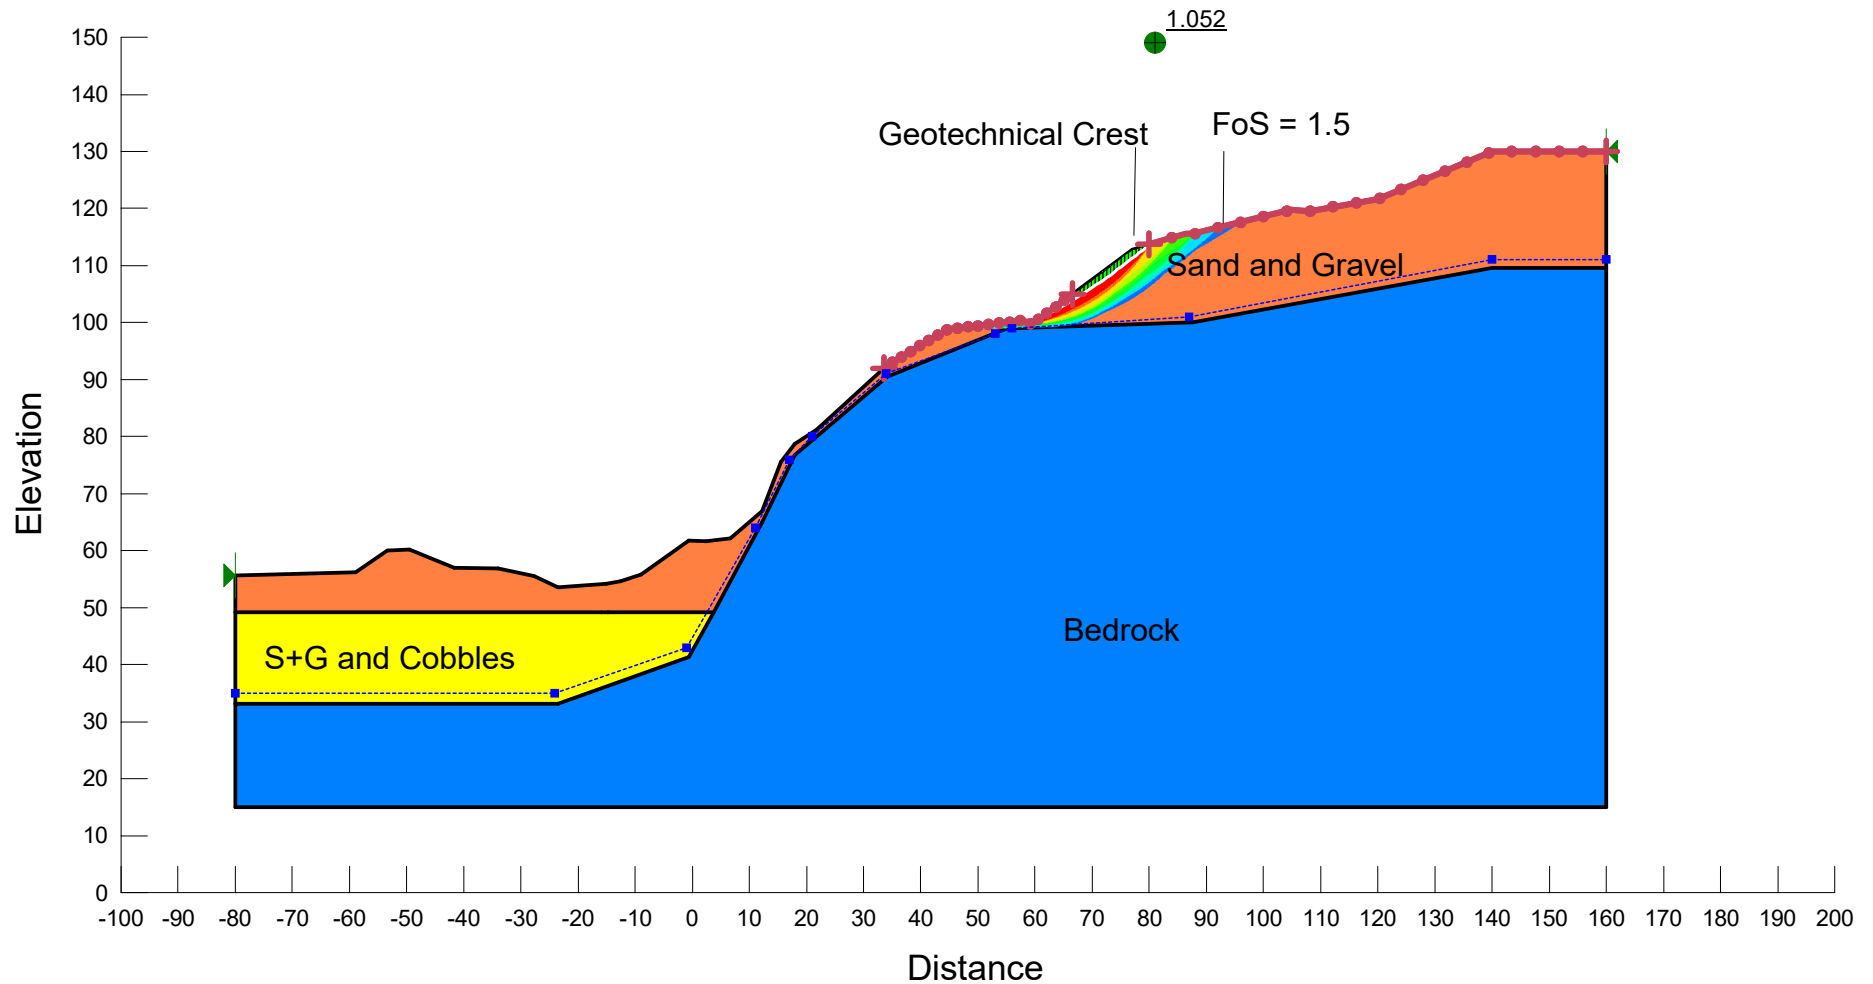
Slope Stability
Morgenstern-Price
11/3/2017
Section B-B

Name: Sand and Gravel Unit Weight: 19 kN/m³ Cohesion: 0 kPa Phi: 36 °
Name: S+G and Cobbles Unit Weight: 20 kN/m³ Cohesion: 0 kPa Phi: 36 °
Name: Bedrock Unit Weight: 24 kN/m³ Cohesion: 1e+006 kPa Phi: 1e+006 °

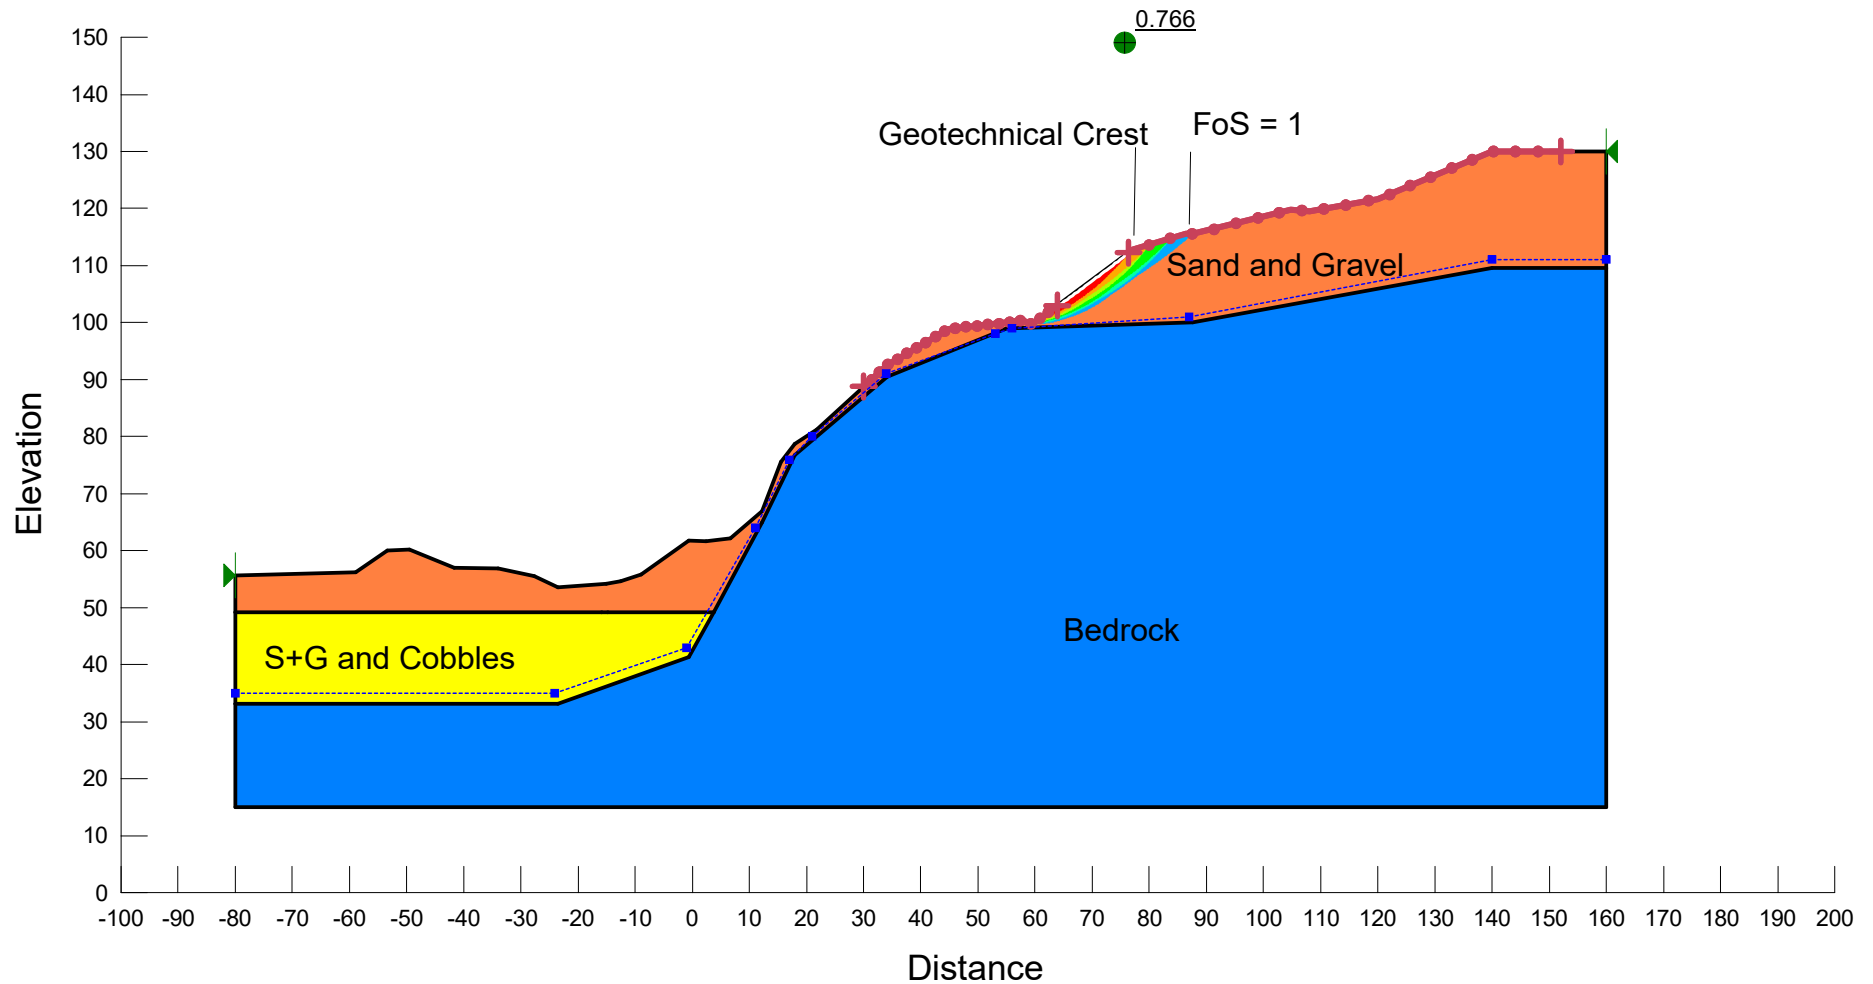
Slope Stability (Seismic - $k=0.12$)

Name: S+G and Cobbles Unit Weight: 20 kN/m^3 Cohesion: 0 kPa Phi: 36°

Name: Bedrock Unit Weight: 24 kN/m^3 Cohesion: $1\text{e}+006 \text{ kPa}$ Phi: $1\text{e}+006^\circ$

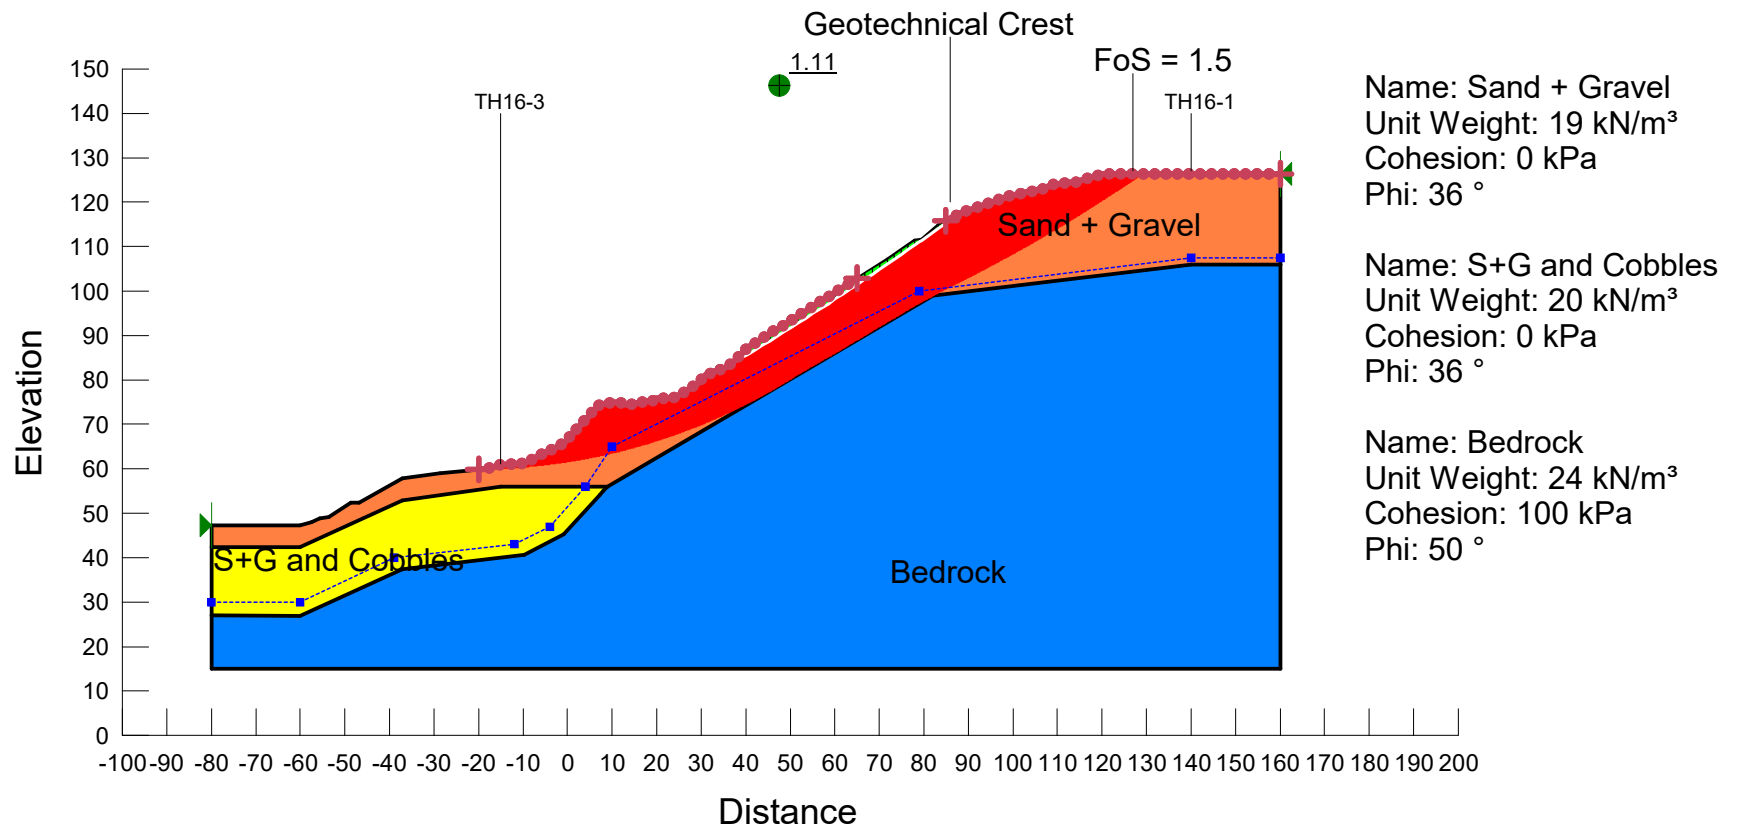
SLOPE/W Analysis
Morgenstern-Price
11/3/2017
Section C-C

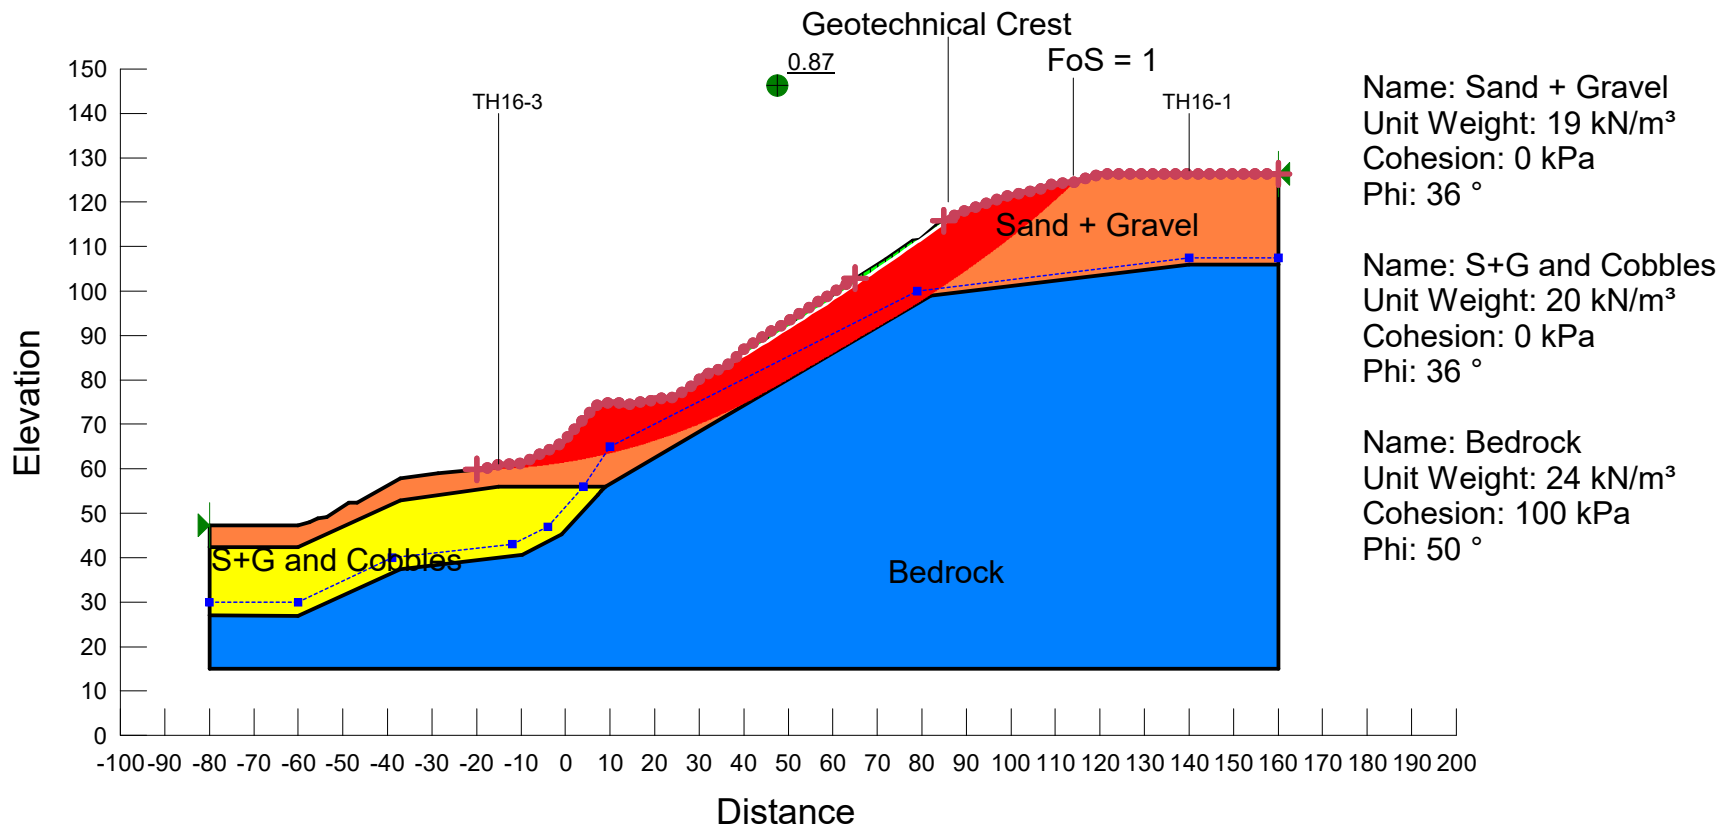
SLOPE/W Analysis - seismic (k=0.12) higher water table
Morgenstern-Price
11/3/2017
Section C-C
