FVRD Electoral Areas A and B Geohazard Mapping Project

Prepared by BGC Engineering Inc. for:

June 18, 2025

Project 0409009

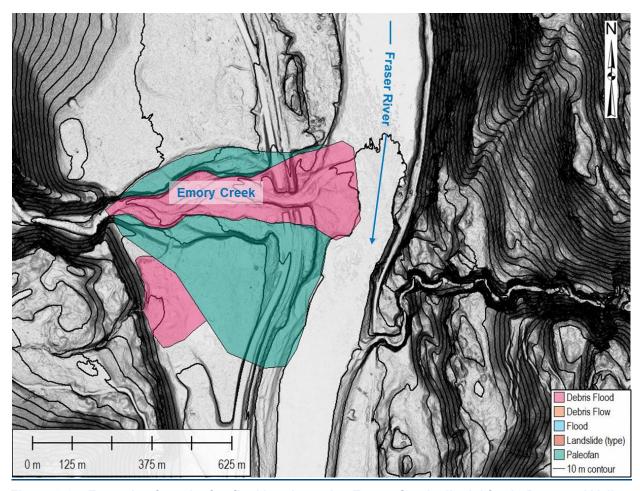
The term "paleofan" was used to describe portions of fans interpreted as no longer active (under present climate and geomorphic/geological setting) and entirely removed from active channel processes as well as avulsions due to deep channel incision (Kellerhals & Church, 1990). BGC mapped one paleofan in the study area (Figure 3-3).

Figure 3-3 Example of a paleofan flanking the active Emory Creek alluvial fan in Dogwood Valley. Lidar from FHIMP (Government of Canada, n.d.) and dated Fall 2023 with 10-meter contours shown.

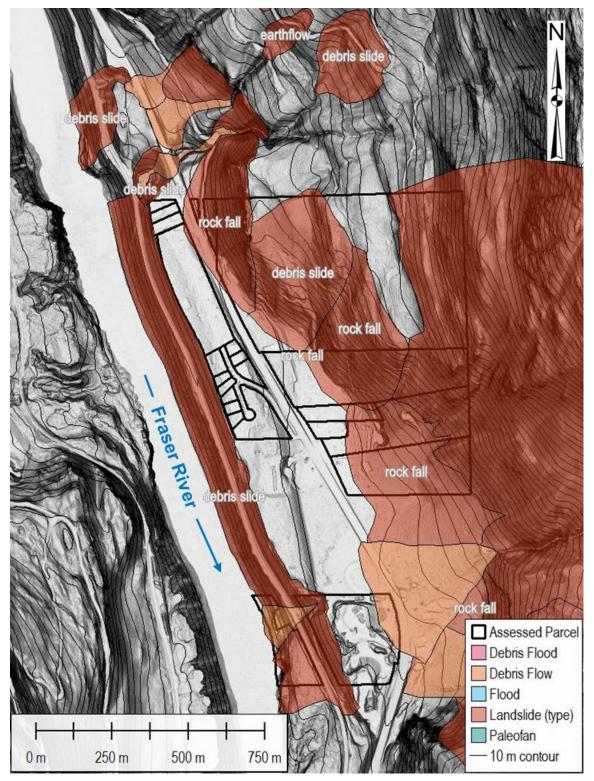
Figure 4-1 Mapped geohazards in the Canyon Alpine study area. Lidar from FHIMP (Government of Canada, n.d.) and dated Fall 2023 with 10-meter contours shown.

In summary, the Canyon Alpine study area contains the following geohazards (Figure 4-1):

- Alluvial fans subject to debris flows
- Rockfall from mountainous slopes above the developed area (Photo D-1, Photo D-2)
- Earth/soil slides on the west bank of the Fraser River
- An earth flow sourced in the mountainous slopes in the southern part of the community.

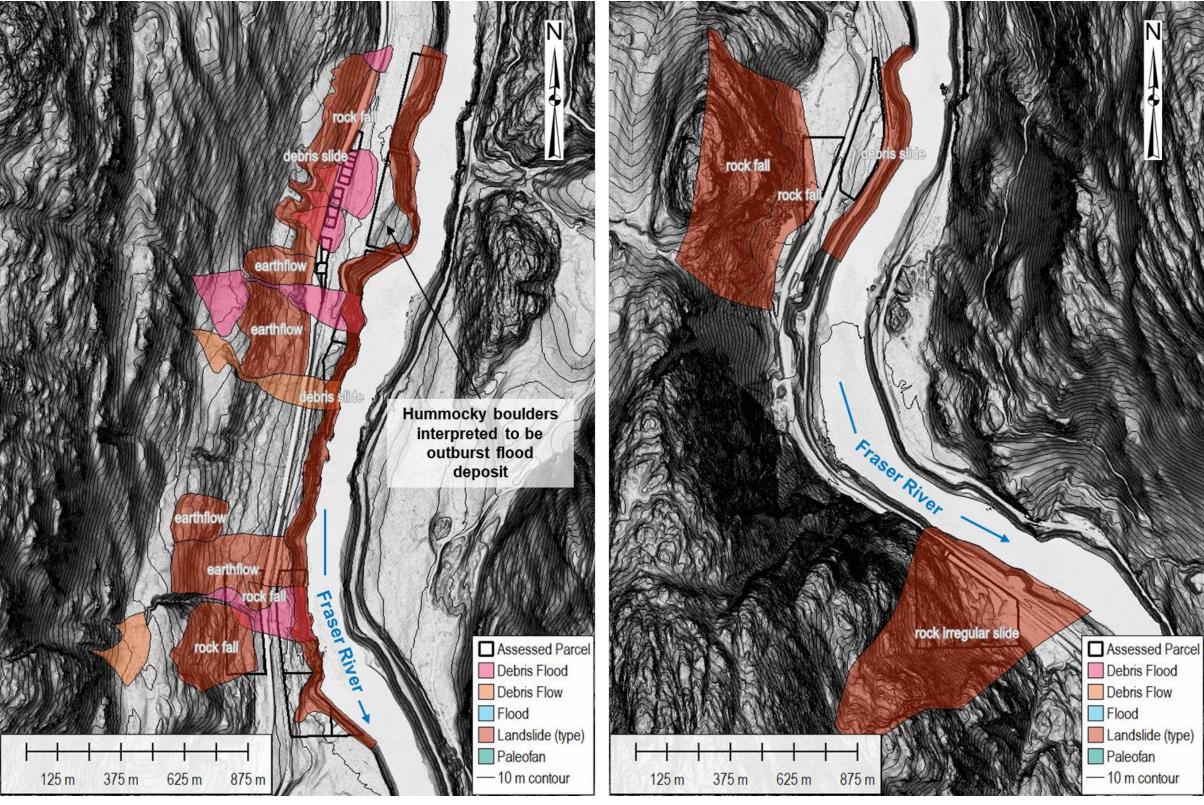
In summary, the Spuzzum study area contains the following geohazards (Figure 4-4):

- Alluvial fans subject to debris flows and debris floods (Photo D-11)
- Rockfall from mountainous slopes above the developed area, particularly near the Sailor Bar and Saddle Rock Tunnels (e.g., Photo D-12)
- Earth flows on the fluvial terrace slopes
- Earth/soil slides on the west bank of the Fraser River on terraces above the developed area.

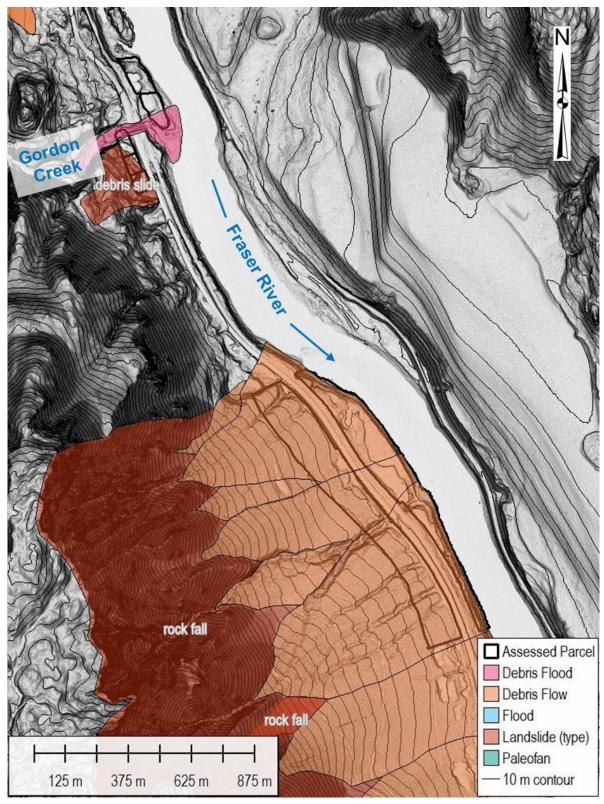
Figure 4-5 Mapped geohazards south of Yale and north of Dogwood Valley. Lidar from FHIMP (Government of Canada, n.d.) and dated Fall 2023 with 10-meter contours shown.

In summary, these parcels are subject to (Figure 4-5):

- Alluvial fans subject to debris flows and debris floods (Photo D-13, D-14, D-15, D-16)
- Rockfall and rock slides from mountainous slopes
- Earth/soil slides above the parcels and along the banks of the Fraser River.

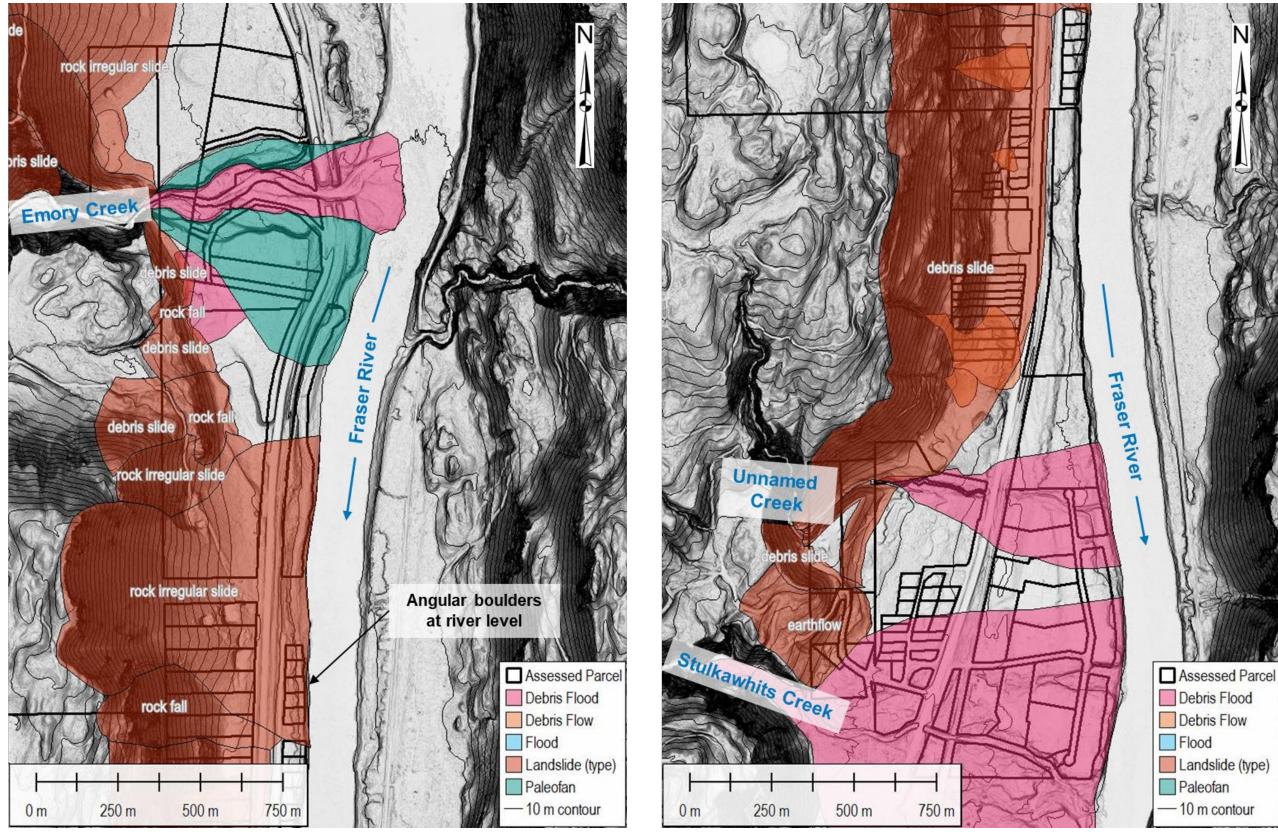
Figure 4-6 Mapped geohazards in the Dogwood Valley study area. Left panel shows mapped geohazards in the northern half of Dogwood Valley, right panel shows mapped geohazards in the southern half of Dogwood Valley.

In summary, the Dogwood Valley study area contains the following geohazards (Figure 4-6):

• Earth flows and soil slides form the slopes above the developed area (Photos D-28, D-29, D-30, D-31).

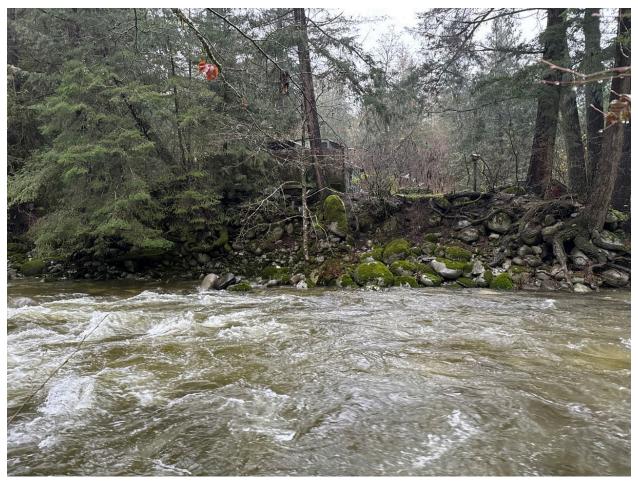
Photo D-21 Looking north across Emory Creek from the right (south) bank. Photo taken by BGC on November 14, 2024.

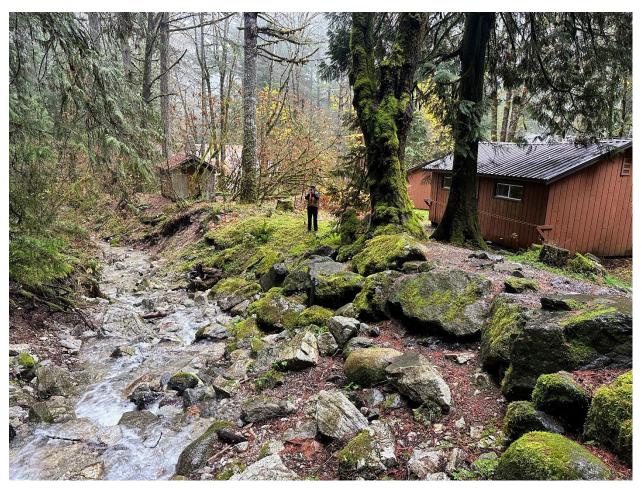
Photo D-22 Looking east and downstream along a steep creek in Camp Squeah. Photo taken by BGC on November 14, 2024.

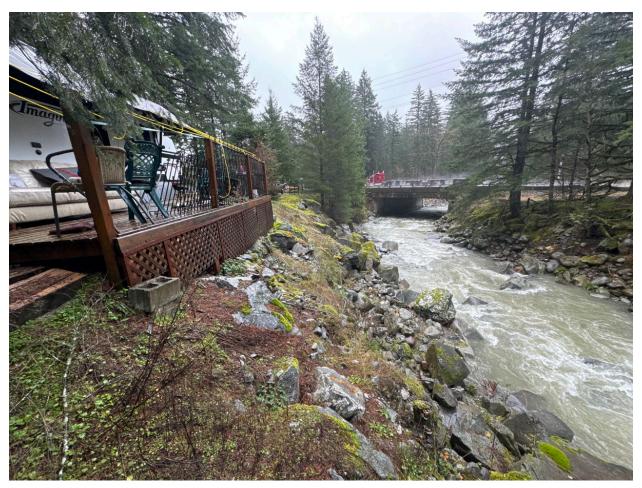
Photo D-32 Looking downstream along the left (north) bank of Stulkawhits Creek upstream of the Highway 1 bridge. Photo taken by BGC on November 14, 2024.
