NHC Ref. No. 3003939

6 August 2018

**Re:**             **51515 Chilliwack Lake Road Natural Hazards Assessment**

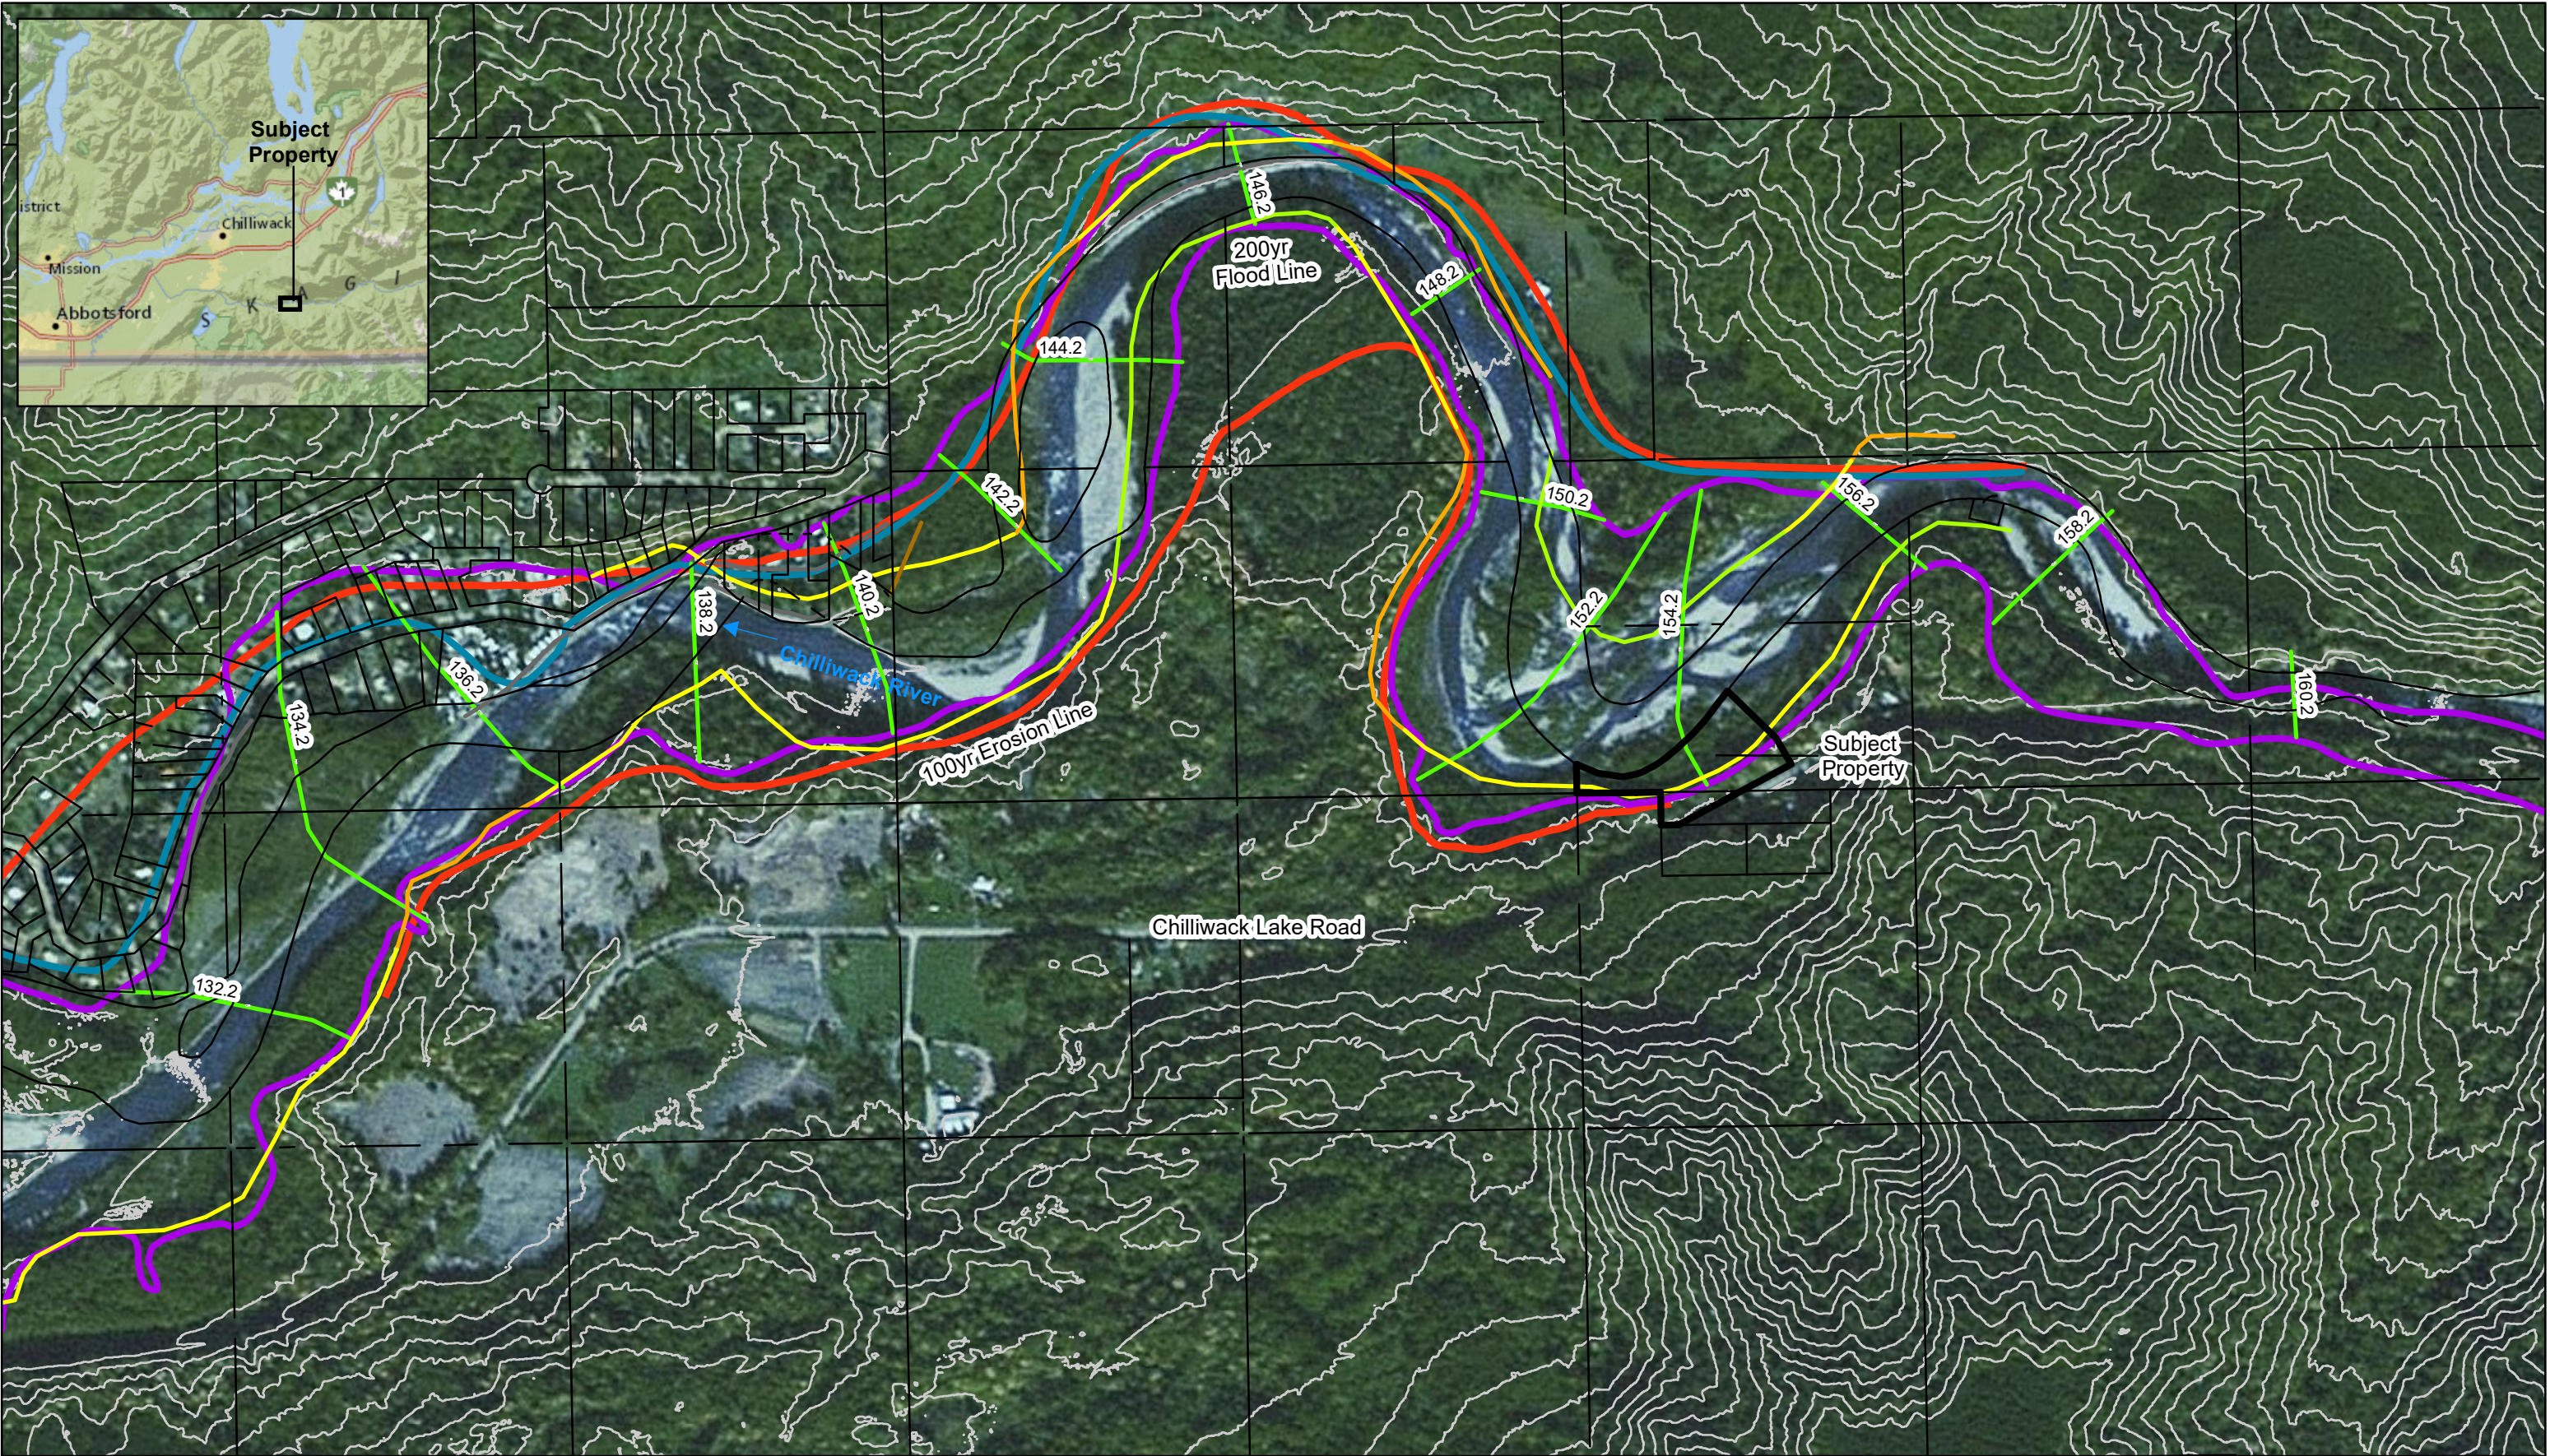
<div><div>nhc</div><div>northwest hydraulic consultants</div></div>			<div><div>Job: 3002291</div><div>Date: 01-NOV-2016</div></div>	<p>FIGURE 1</p>

Figure 1 shows the study area with orthoimagery and 10 metre contour data and Figure 2 shows the study area with Lidar hillshading showing shaded relief. The Lidar data is from the Ministry of Forests, Lands and Natural Resource Operations (FLNRO) from 2015 and was provided to NHC by the FVRD. The contours were generated by NHC using the Lidar data. The Lidar hillshading image illustrates the relic side channels throughout the floodplain, the upland areas on the floodplain and the active channel. The imagery also shows well-defined banks and terraces that cannot be seen from the areal imagery due to the thick forest canopy. This Lidar data can be considered representative of current conditions as there have been no significant channel or bank changes over the past year.

Figure 1 and Figure 2 shows the 100 year erosion limit and the 'single event' erosion setback line established in 1992 and 1993, respectively by Hayco as well as the 1:200 year floodplain limit. The 1:200 year floodplain limit was established based on floodplain mapping developed by the Ministry of the Environment in 1981 and utilized air photography from 1976. The floodplain limits assume the absence of all dykes.

property (Figure 1 and Figure 2). The Hayco report identified the left bank adjacent to the subject property as having 'medium existing erosive stress' and absent of any dyke, berm or bank protection. However bank protection was identified adjacent to the property during the site visit as discussed below in Section 4.

In 2009 EBA Engineering Consultants evaluated the various alignments of channel occupancy based on air photos from 1940 to 2008 for the Chilliwack River from the Vedder Crossing Bridge to just upstream of the subject property. This information is shown on Figure 3 and it illustrates that since 1940 the river in proximity to the property has occupied a large area extending over most of the 200 year floodplain boundary. The earliest air photos show that the active channel of the river was relatively narrow and occupied the left side of the floodplain adjacent to the subject property. The left bank of the active channel appears to have defined the northern boundary of the lot when this area was initially subdivided. Evidence of this is shown on Figure 1 and Figure 2 as the line defining the river is the same as the northern property boundary. However the historical air photos show this left bank continued to erode south until it reached the current bankline as defined approximately by the 200-year floodplain limit which cuts through the middle of the subject property as shown on Figure 1, Figure 2 and Figure 3.

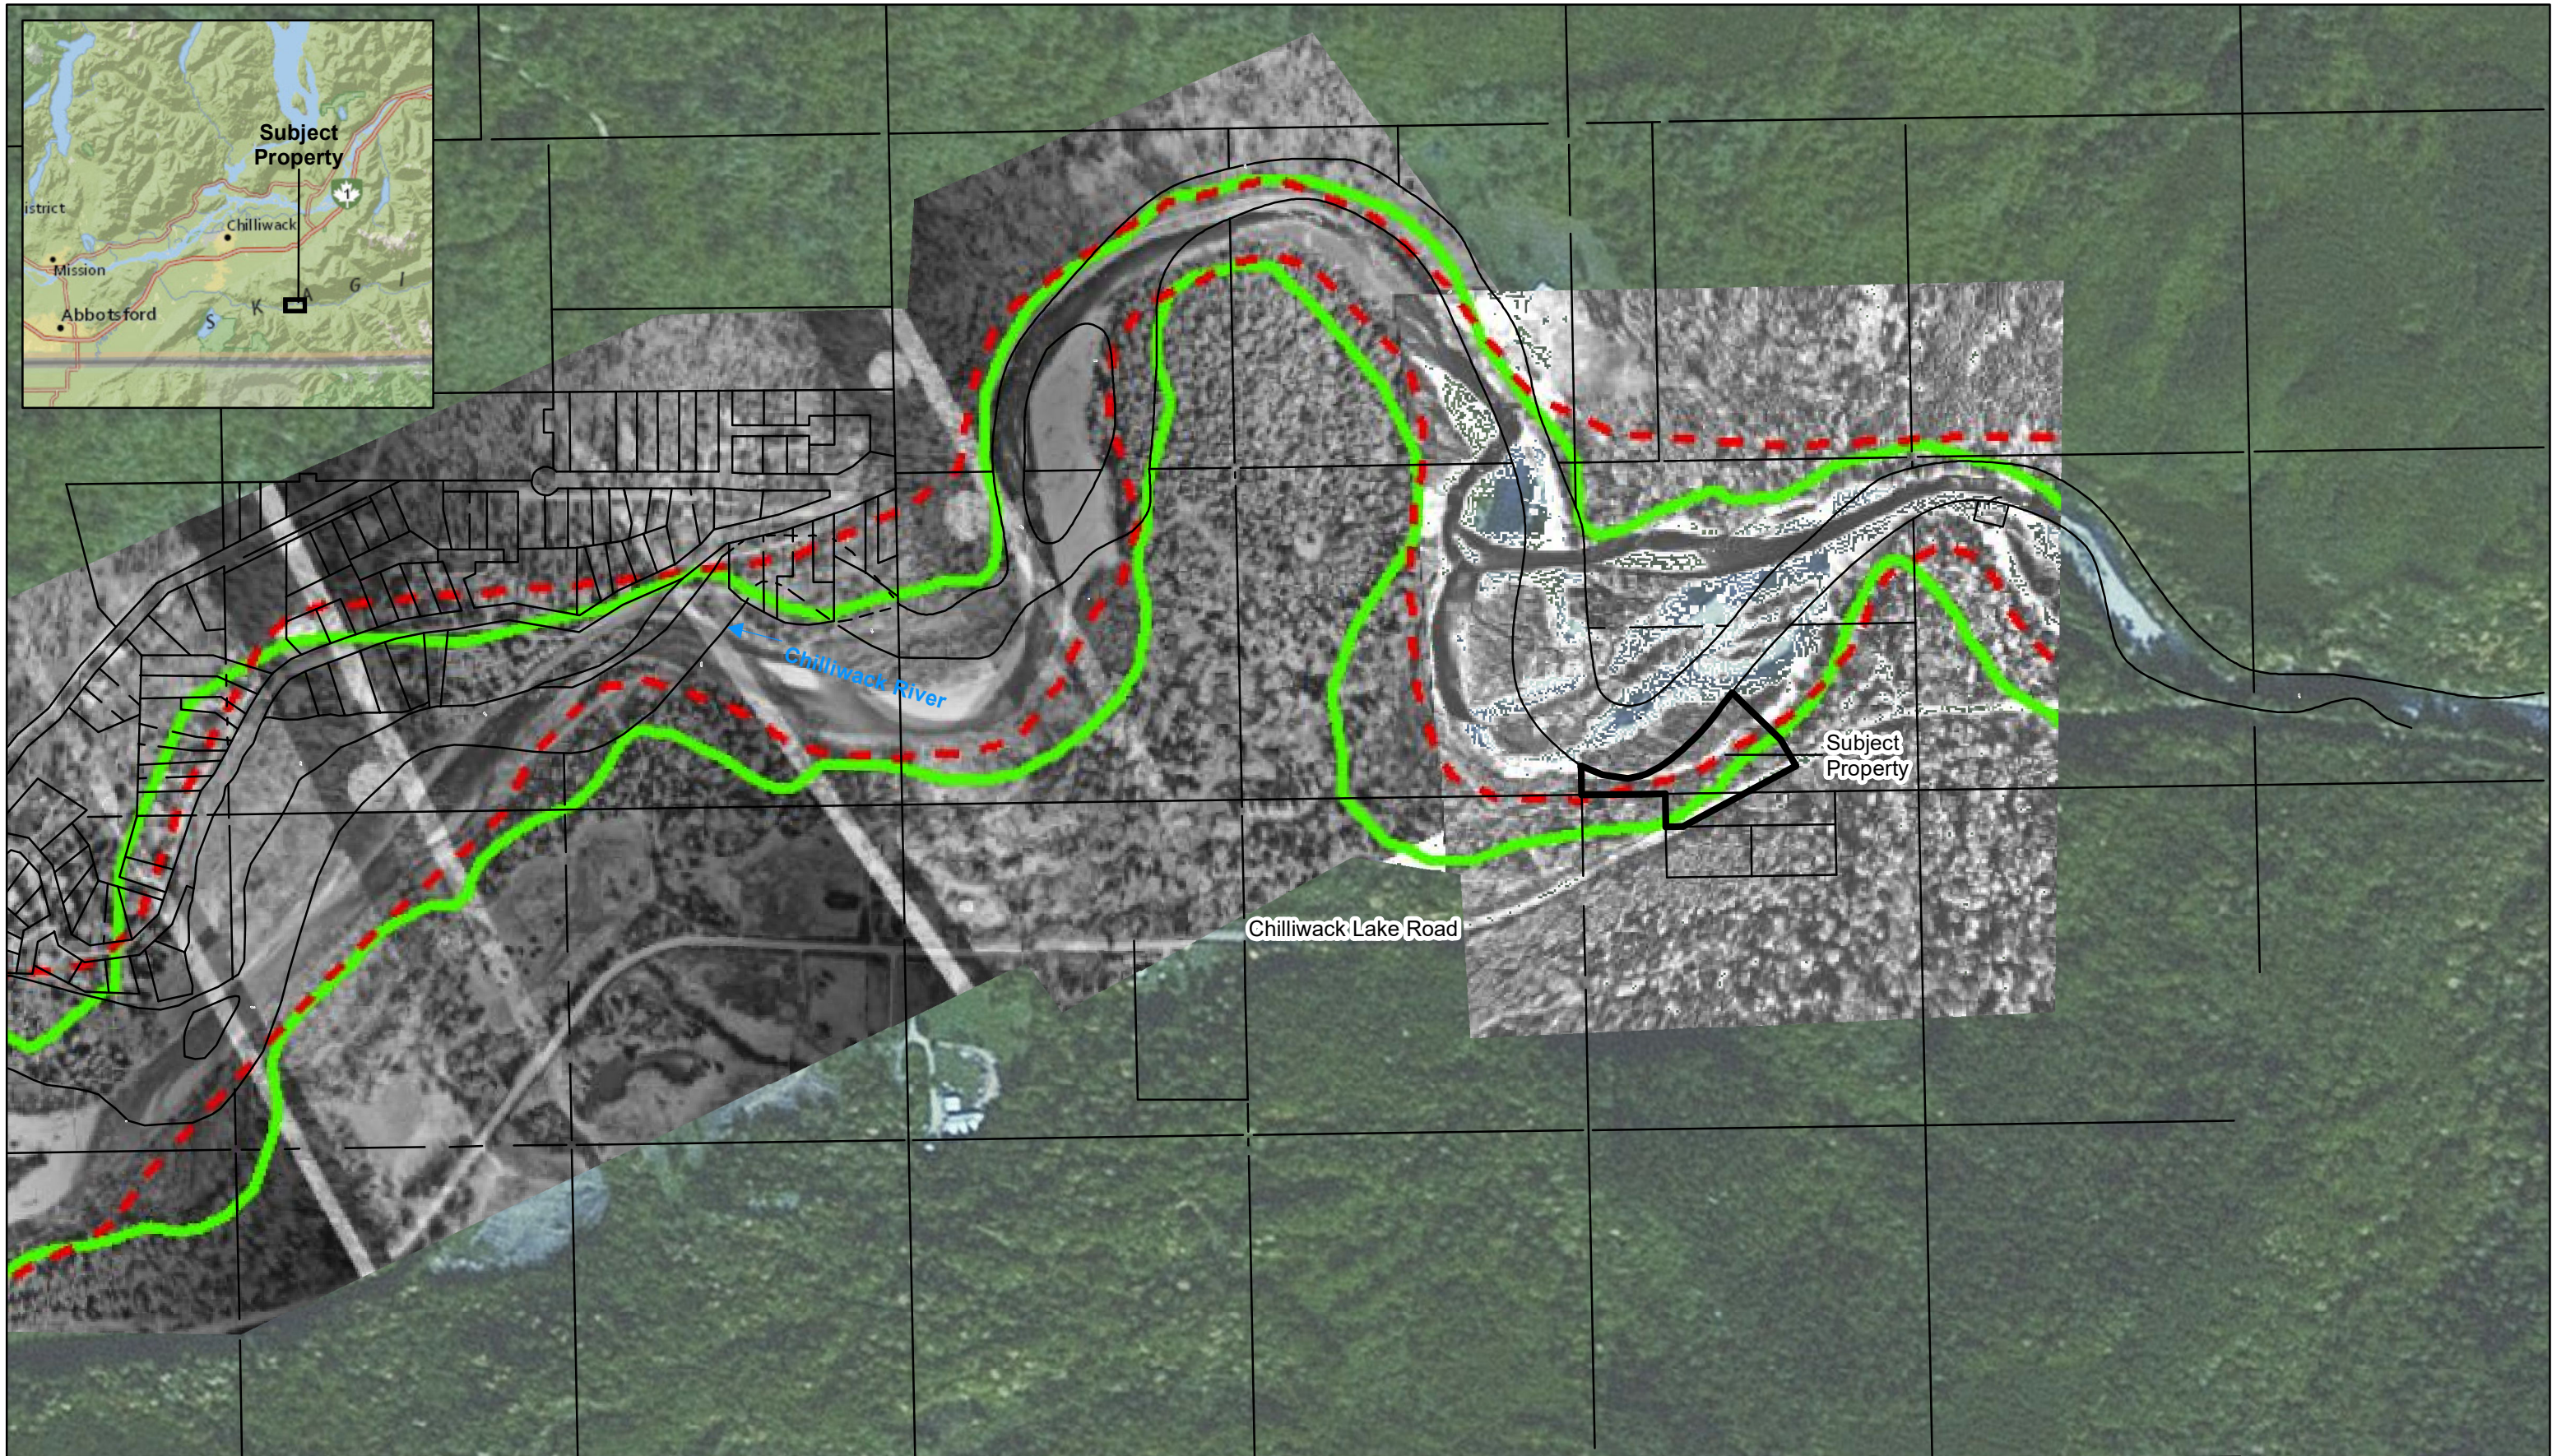
Between 1963 and 1979 the active channel of the Chilliwack River started to migrate away from the left bank as a large bar formed along the toe of the slope adjacent to the subject property. Then between 1979 and 1983 the active channel avulsed to approximately the middle of the floodplain and further away from the left side of the floodplain and hence the subject property. By 1993 the active channel was well established in the centre of the floodplain but by 2004 the river avulsed to the right (north) side of the floodplain. By 2008 the active channel was well established along the right side of the floodplain and the large bar along the left bank adjacent to the subject property was well established and heavily vegetated. Currently the active channel remains along the right side of the floodplain and the left side of the floodplain continues to support mature vegetation. Figure 4 shows the EBA determined maximum extent of active channel occupancy from 1940 to 2008 as well as the 200 year floodplain limit. This analysis demonstrates that the Chilliwack River in proximity to the subject property is very active and covers a wide floodplain. It is important to note that the EBA analysis is an overall general assessment of the river system and has limited application at a detailed site specific large scale due to the scale of the historical air photos used for the analysis. For example, the 1983 active channel

Upslope of the 3 m high armoured bank is a bench which averages 3 m wide (Photo 37). This flat bench can be easily identified on both the large scale contour figure (Figure 5) and the Lidar figure (Figure 6). The flat bench is less defined at the upstream end of the property where several large boulders used for the bank armouring are situated on the bench in proximity to photo reference points 21, 23 and 39 (Figure 5 and Figure 6). Upslope from the bench and downslope of the road, the hillside in the middle of the property has an average slope of 30 degrees. The slope averages 26 degrees toward the eastern end of the property. At the upslope end of the property there is a bench in the middle of the lot where the small cabin is located (Photo 10). There is also a small bench near the eastern end of the property between photo reference points 19 and 20 (Figure 4 and Figure 5).

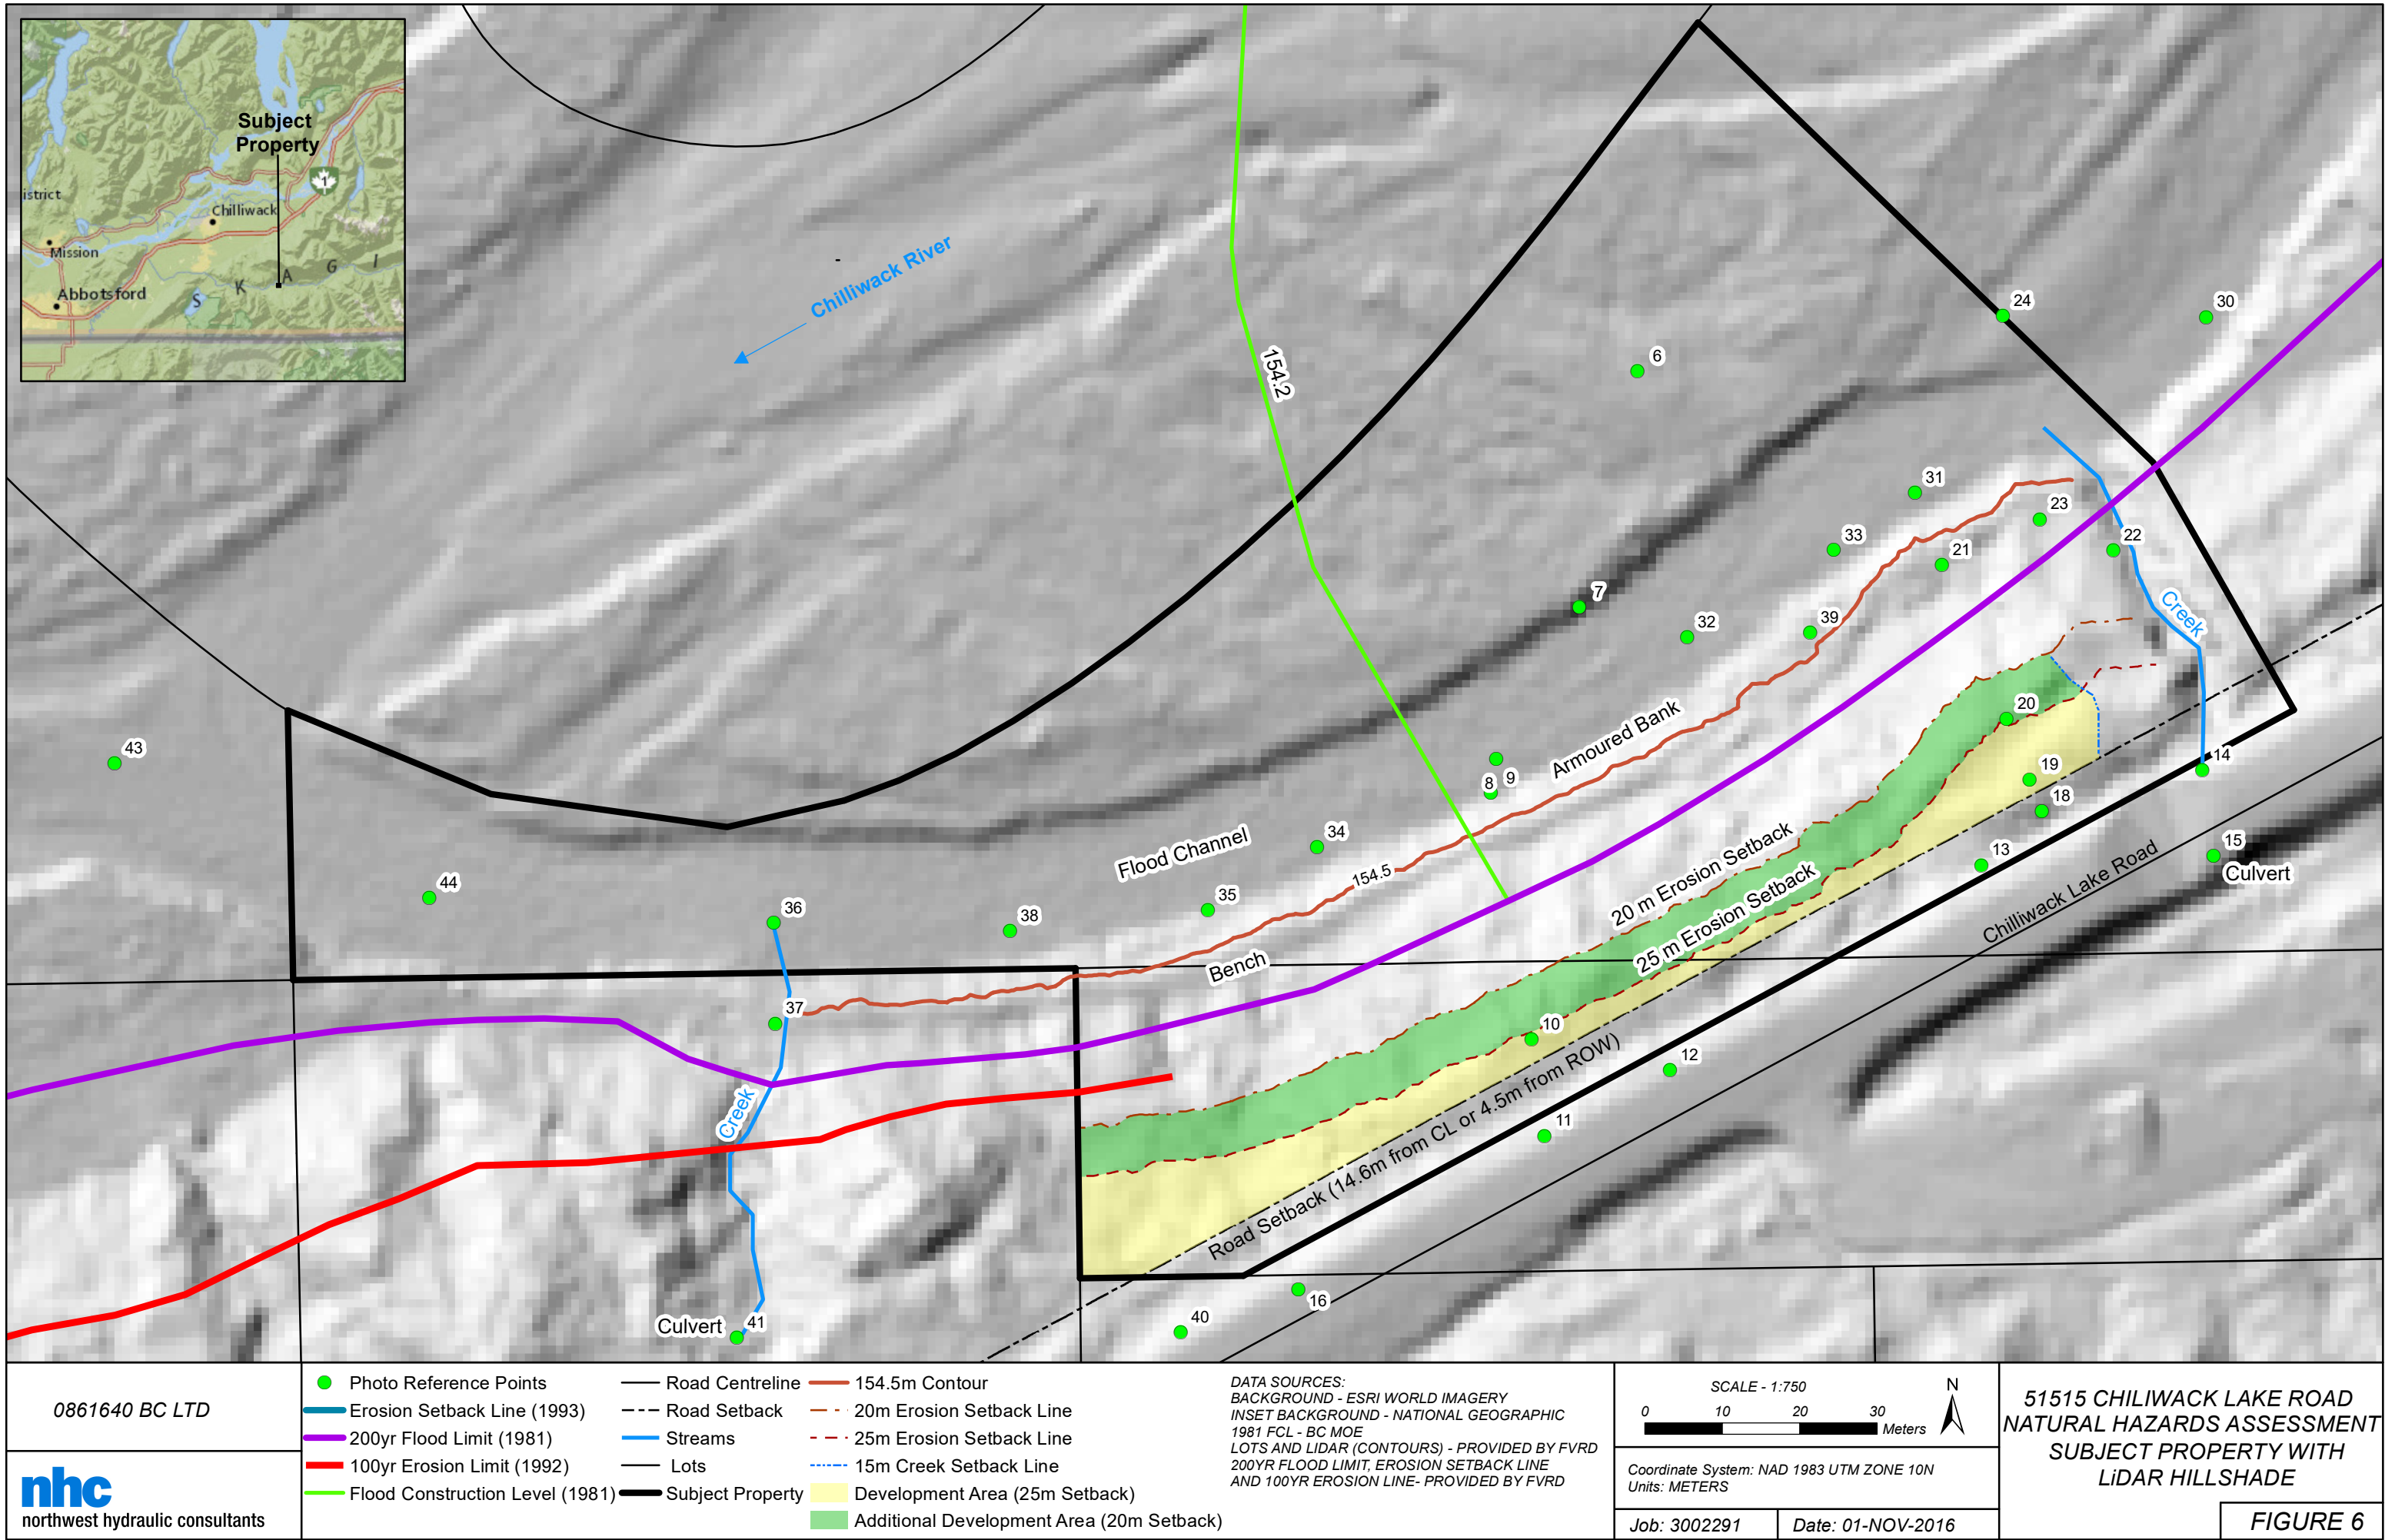
<p><b>51515 CHILLIWACK LAKE ROAD NATURAL HAZARDS ASSESSMENT SUBJECT PROPERTY WITH 1M CONTOURS</b></p>				<p><b>FIGURE 5</b></p>

The study area was walked and photo documented with georeferenced pdfs on a tablet. Notes were also collected on the tablet. The locations of all key areas of interest are provided on Figure 5 and Figure 6 and a selection of photos from some of these points are provided in the photo section of this report. The photo numbers are based on the reference points of the areas of interest. Figure 5 shows the subject property with 1 m contours overlaying satellite imagery and Figure 6 show the subject property with Lidar hillshading.

As mentioned in Section 4 the armoured bank may not have been engineered, may not be to current standards and is not owned or maintained by a level of government. The 25 m setback, which is measured from the 154.5 m contour line, is shown on Figure 5 and Figure 6. A detailed inspection of the existing armouring is recommended to determine if the protection is adequate. If deficiencies are identified in the existing bank protection then some upgrading will be required in order to implement the 25 m setback. Possible deficiencies include sections of the bank where the armour rock is too small, not thick enough, does not have an appropriate underlayer, is too steep, or where armouring is absent altogether.
