**Subject: Chilliwack River Erosion Setback Line Update – Slesse Park Area**

The report by Kerr Wood Leidal Associates Ltd. *Chilliwack River Slesse Park Erosion Setback Line Update* and dated March 2, 2020 is attached as Appendix A.

Fraser Valley Regional District  
Slesse Park Erosion Setback Line Update

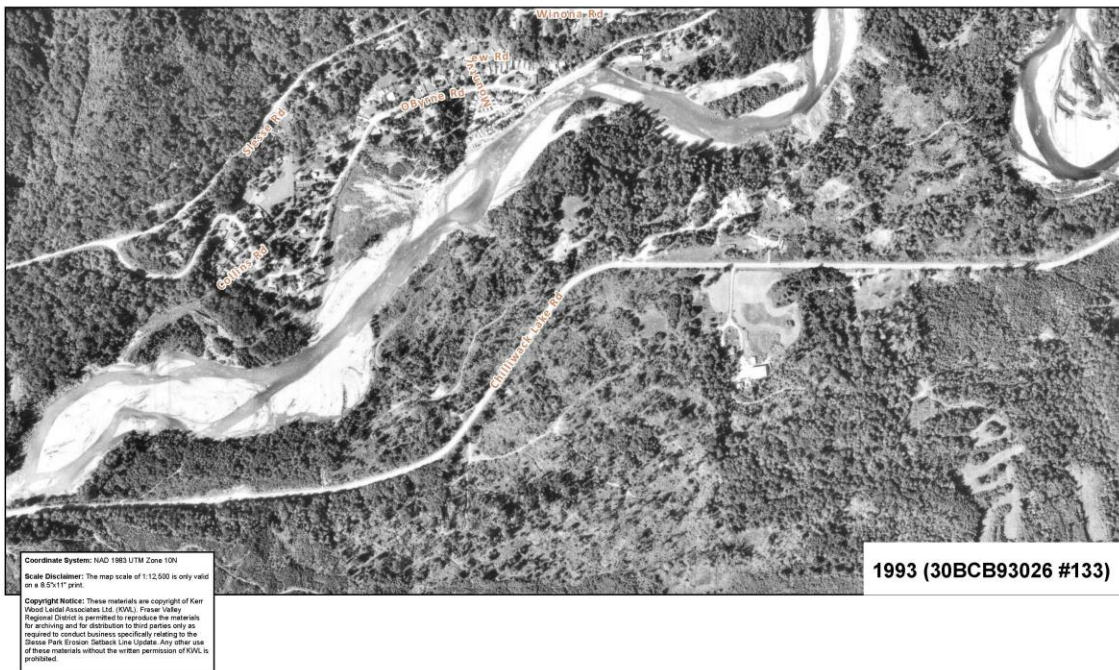
Slesse Park: 1986 vs 1993  
Georeferenced Air Photos

As indicated in Table 1, the largest morphologic change captured in the historical air photo record occurred in the 1990s: Hay & Co. et al. (1992) indicate that this change occurred during the November 1990 flood. Figure 3 shows a comparison of the Slesse Park reach from before (1986) and after (1993) the November 1990 event. As shown, there was a notable change in alignment (rather than progressive erosion at the outside of existing bends), as part of which two meander bends were cut off, resulting in a much straighter channel alignment.

Figure 3 illustrates the dynamic nature of the Chilliwack River and the potential for change within the study reach in a single, large flood event. In addition, the air photo review indicates that there are old
