# Wildfire Risk Assessment Report

44390 Bayview Road Fraser Valley Regional District

September 25, 2020

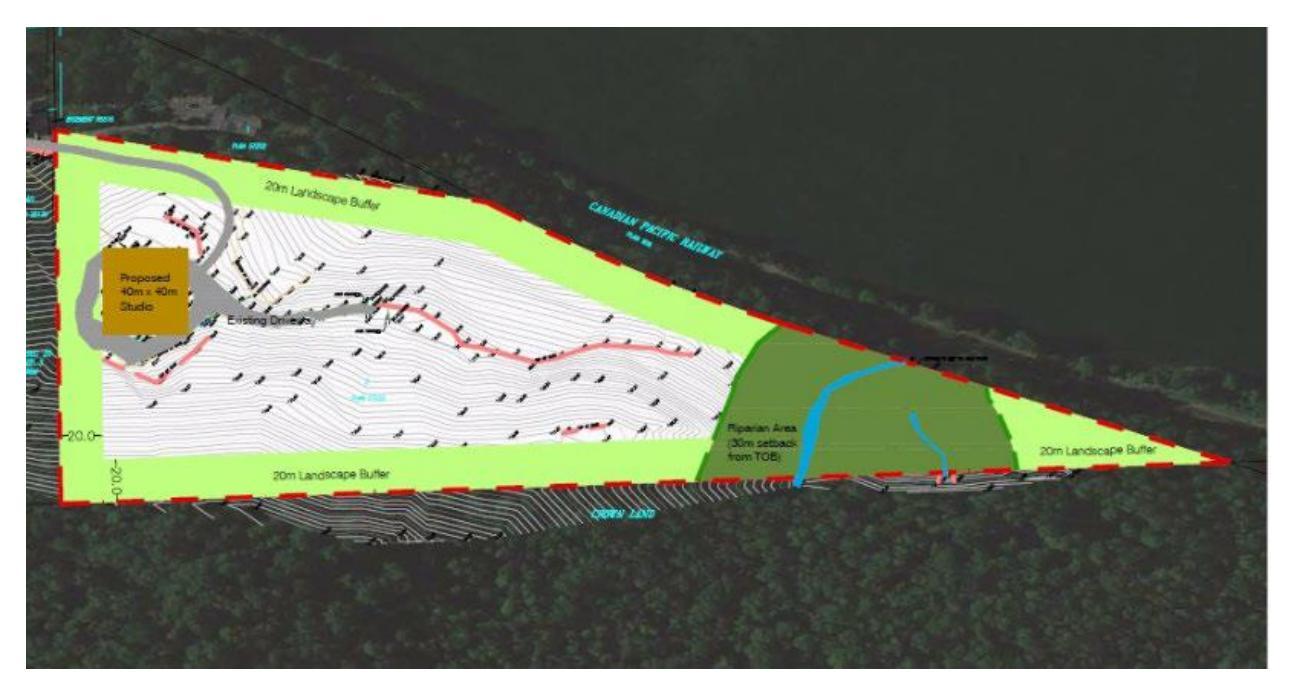
Figure 1. Location of proposed development (red outline) and preliminary site plan.

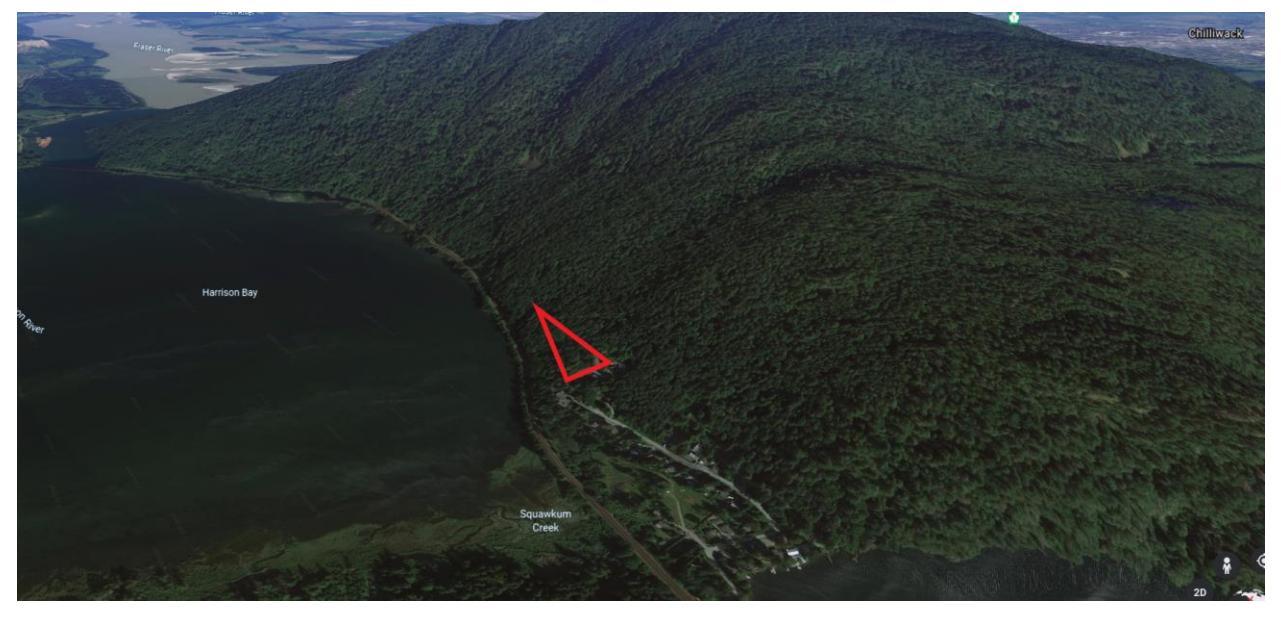
Figure 2: Photogrammetry of the site showing the local topography and the assessment area, roughly outlined in red. The subject slope has northern aspect. Image courtesy of Google Earth.

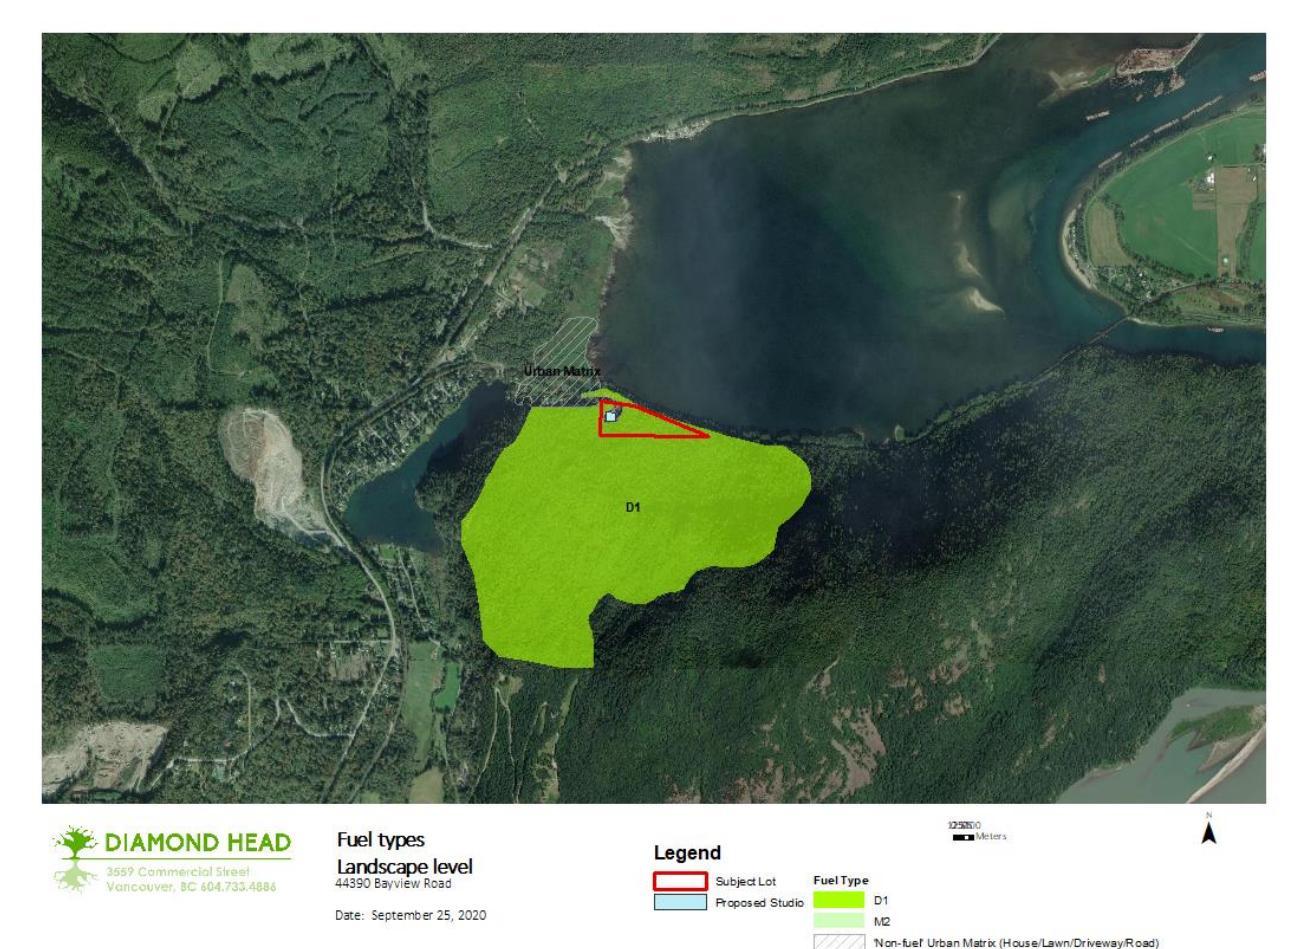
Forested areas within approximately 200 m of the proposed development site were classified into the fuel types mapped in Figure 3. There are no fuel classifications specific to the coastal region in the Canadian Fire Behaviour Prediction System; instead, the site has been classified as the fuel type that best represents the fire behavior potential of the forest types most accurately. Two fuel types were identified and are described in Appendix 2. The plot characteristics are summarized in Appendix 1. Note that a majority of the cleared areas are occupied by managed grass and/or pasture. These are not considered potential fuel as management and grazing limits flammability.

Figure 3: Assessment of fuels at a landscape level.

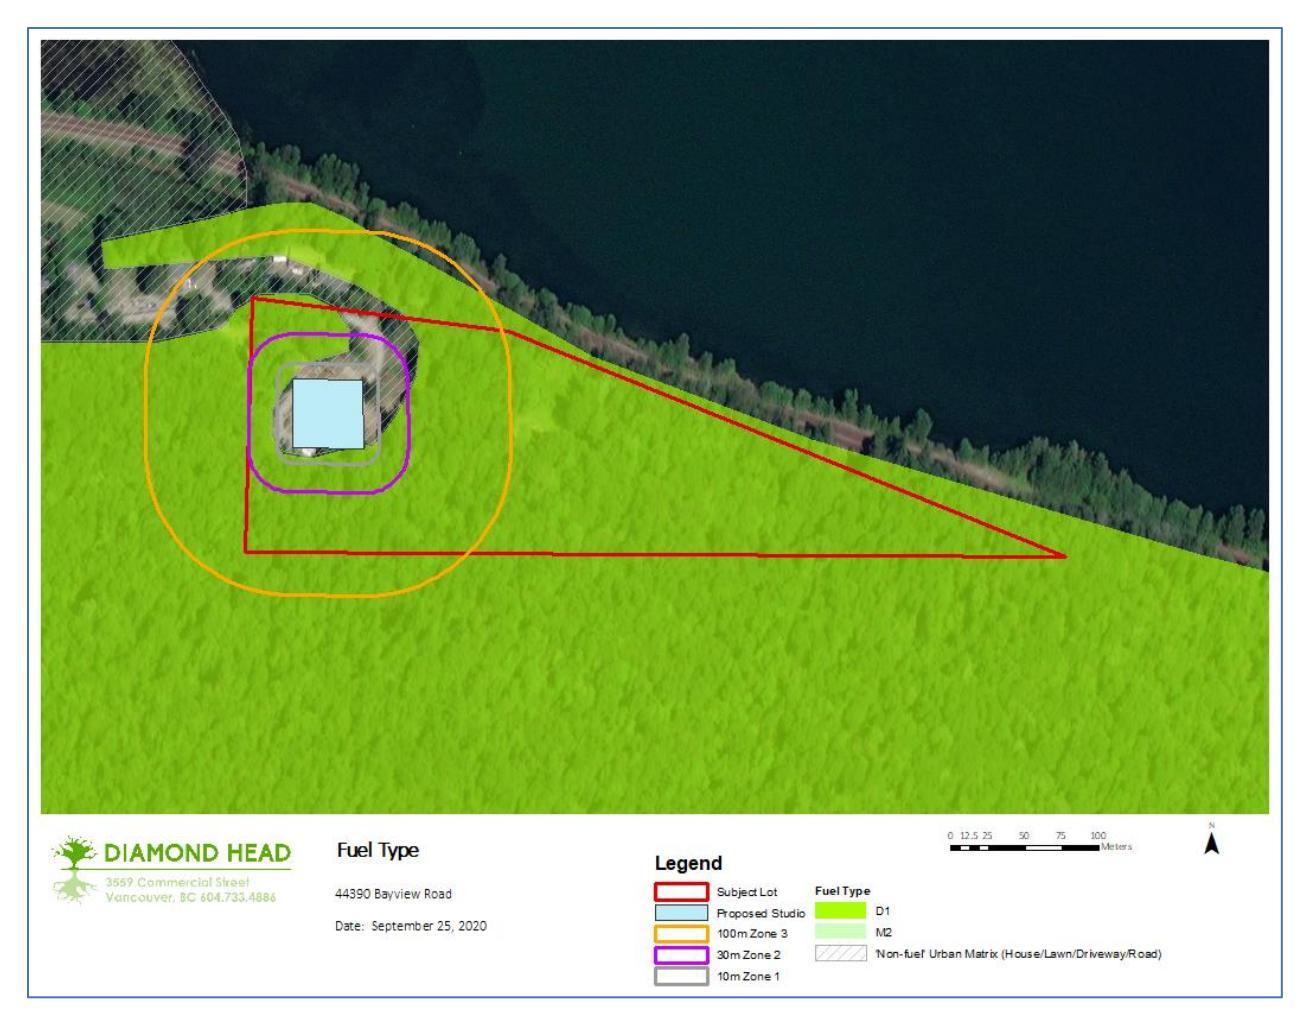
Figure 4.Fuel type map. Note that the property lines are approximate and have been traced from other documentation.

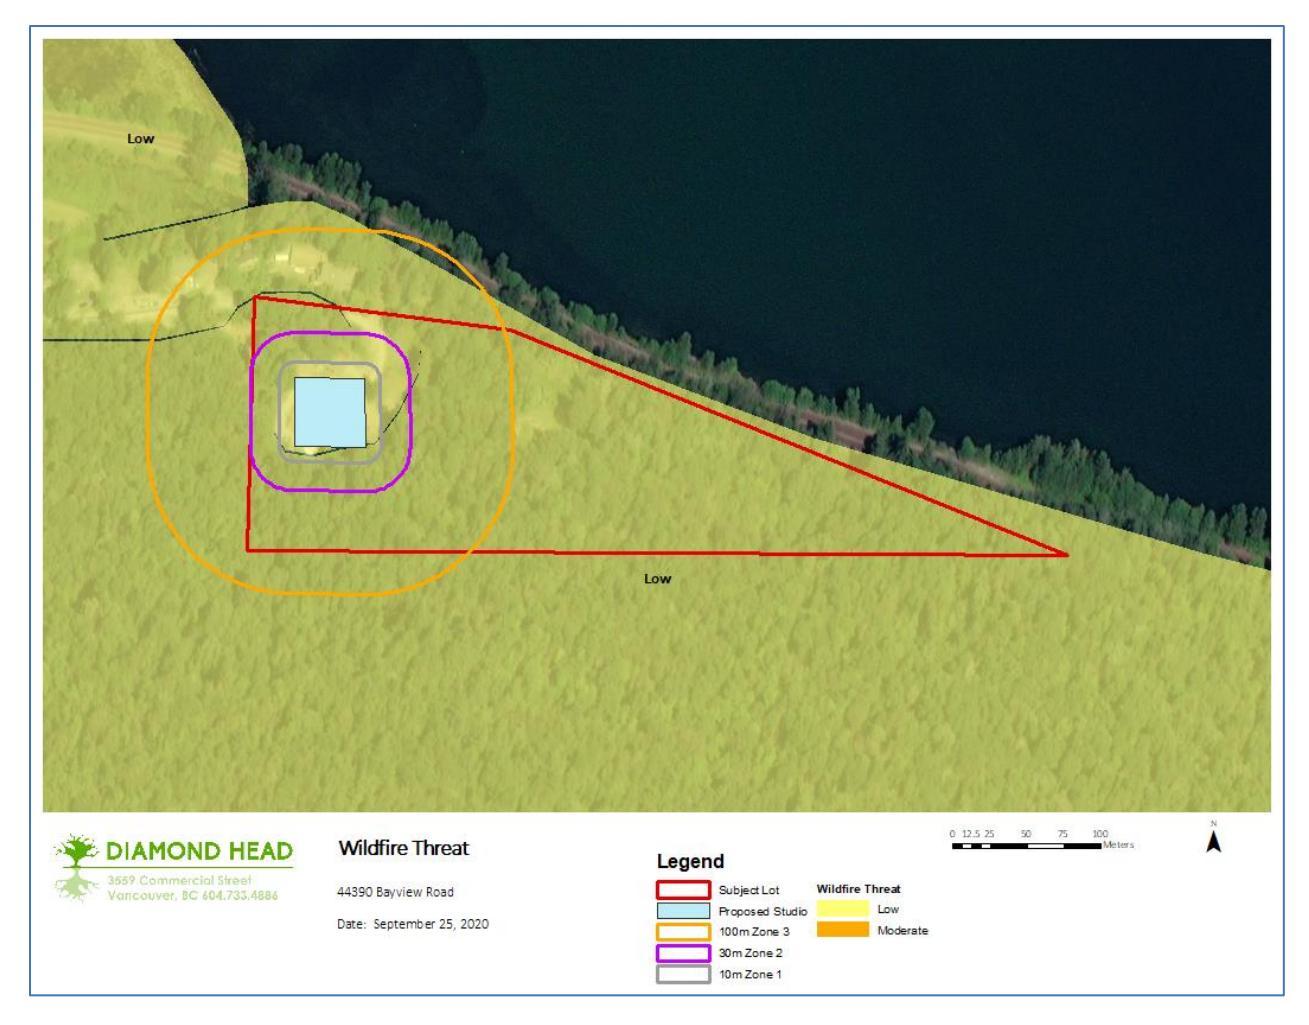
Each fuel type and distinct stand was assessed for wildfire threat using the Wildfire Urban Interface worksheet (MFLNRO 2020). Based on this ranking system, most of the surrounding fuel types pose a **low wildfire threat to the subject site**. **Figure 5** outlines the wildfire threat in context with the preliminary building plans for the subject property. The wildfire threat ratings and plot forms are summarized in Appendix 1.

The fuels in the D1 fuel type found around the subject site have a low risk due primarily to the limited flammability of the fuel. The lack of coniferous vegetation is the critical factor in determining the risk. Slope and aspect are other factors that affect the wildfire risk. The slope is steep but the structure is near the base of the slope, minimizing the likelihood of fire spreading from below. A northern aspect typically results in cooler temperatures and higher moisture content in the vegetation.

Figure 5. Wildfire threat mapping and plot locations. Note that the property lines are approximate and have been traced from other documentation.

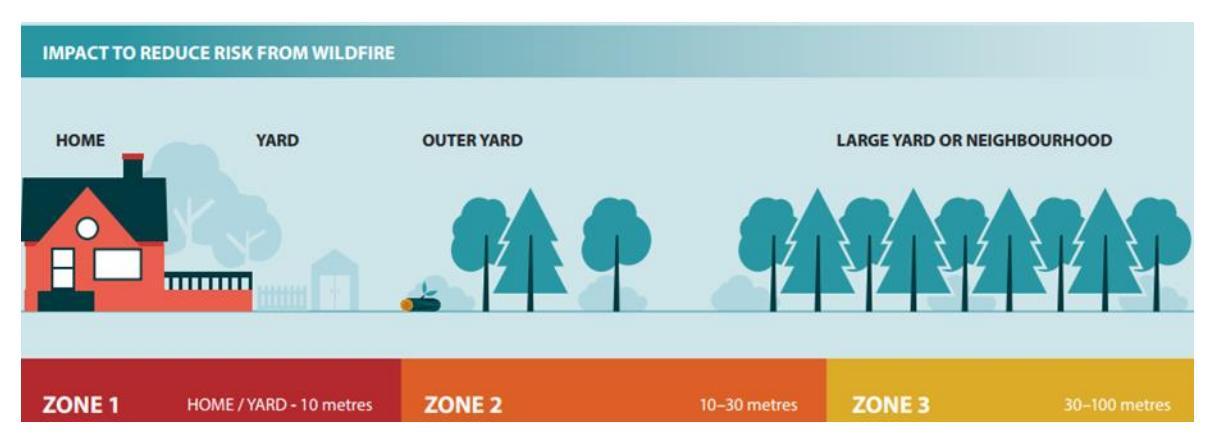
Figure 6. FireSmart Priority Zones defined in the FireSmart Homeowners Manual (Partners in Protection and Province of BC, 2016).

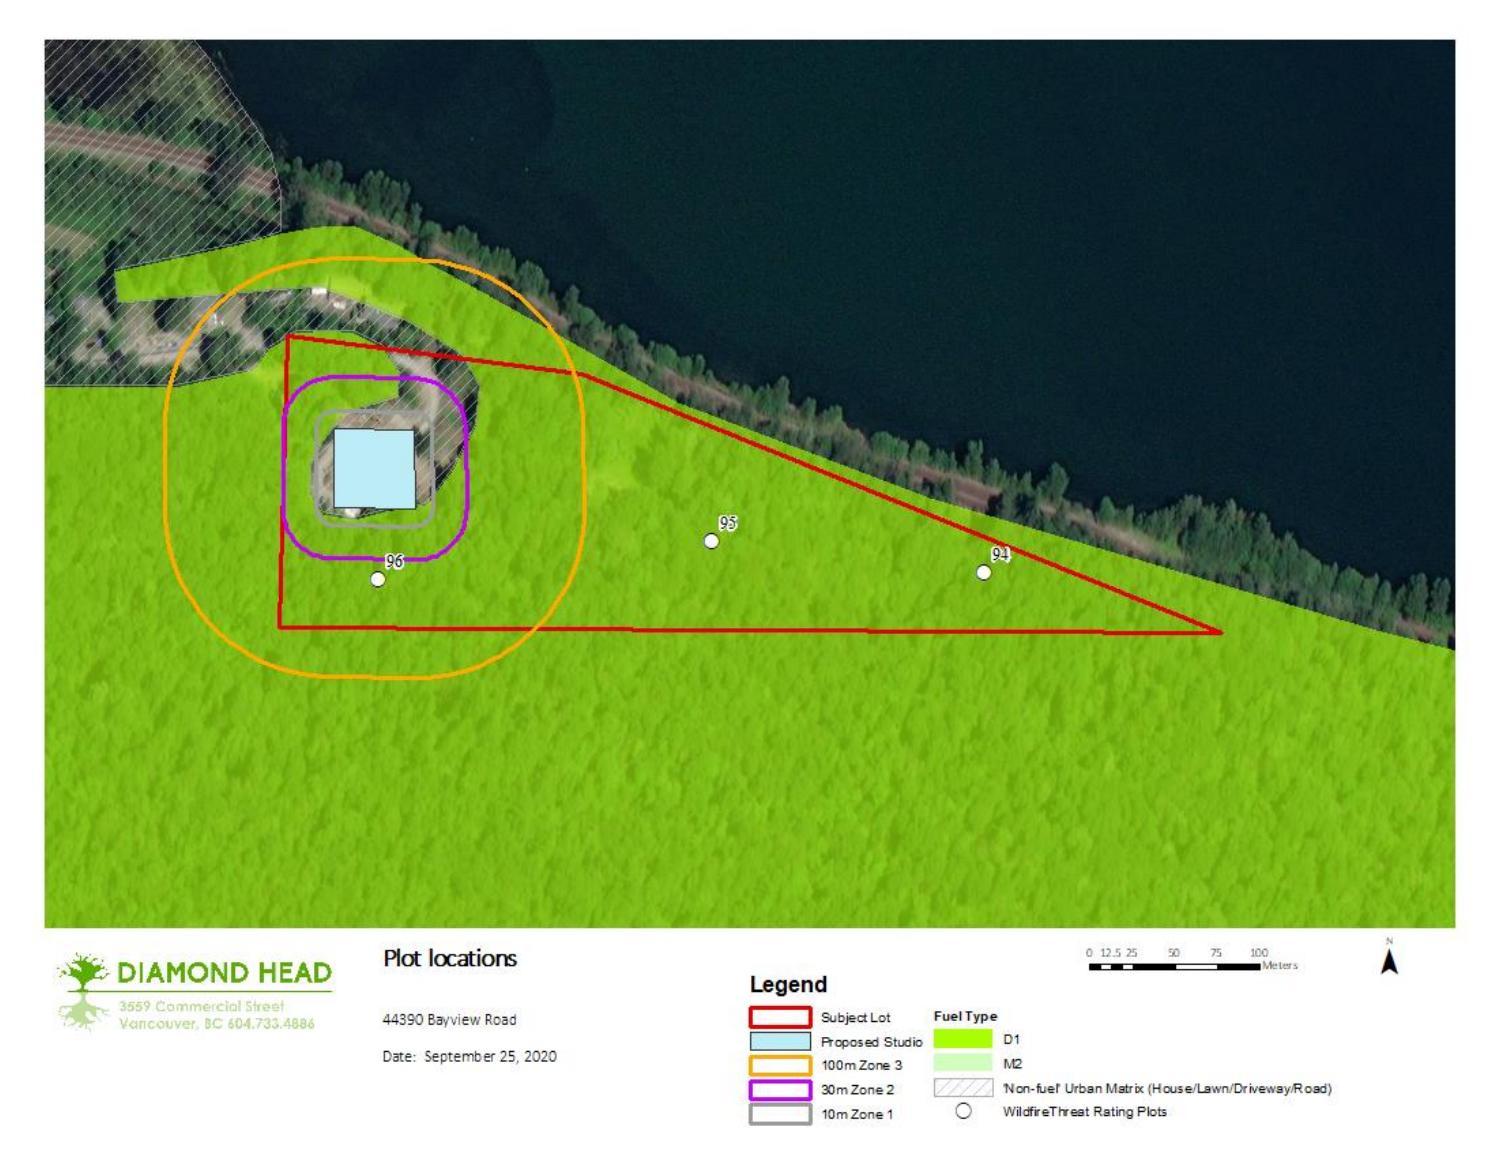
Figure 7. Wildfire Threat Plots. Note that the property lines are approximate and have been traced from other documentation.

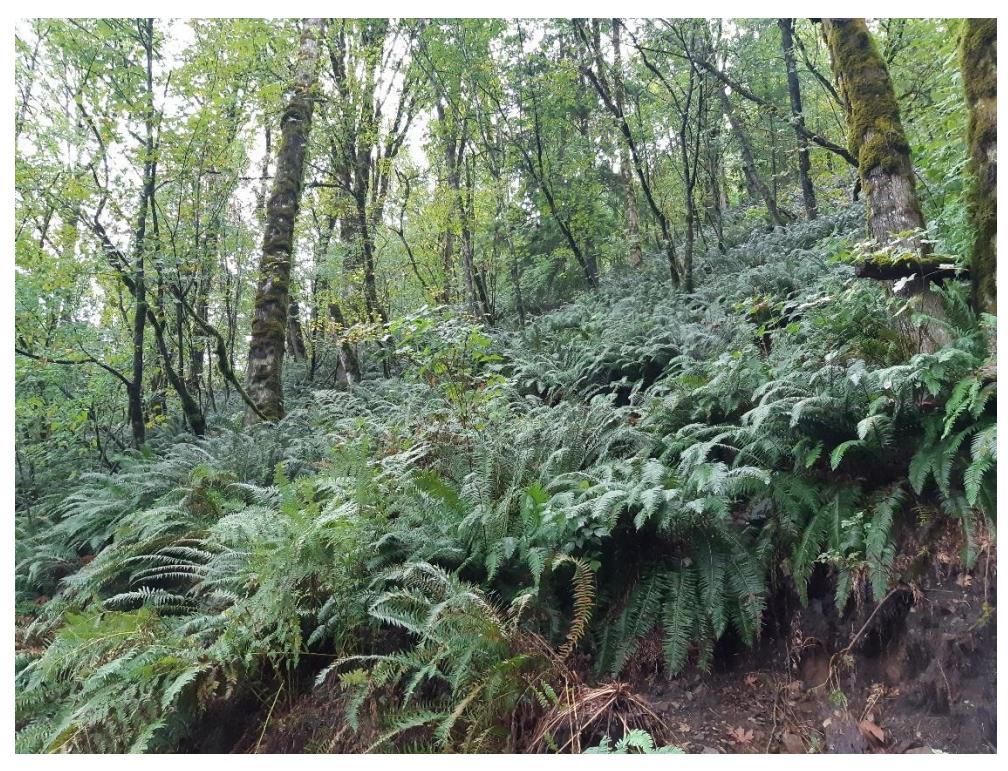
Photo 1. Ground cover and understory in the assessment area is mostly sword fern and vine maple – this vegetation has low flammability.

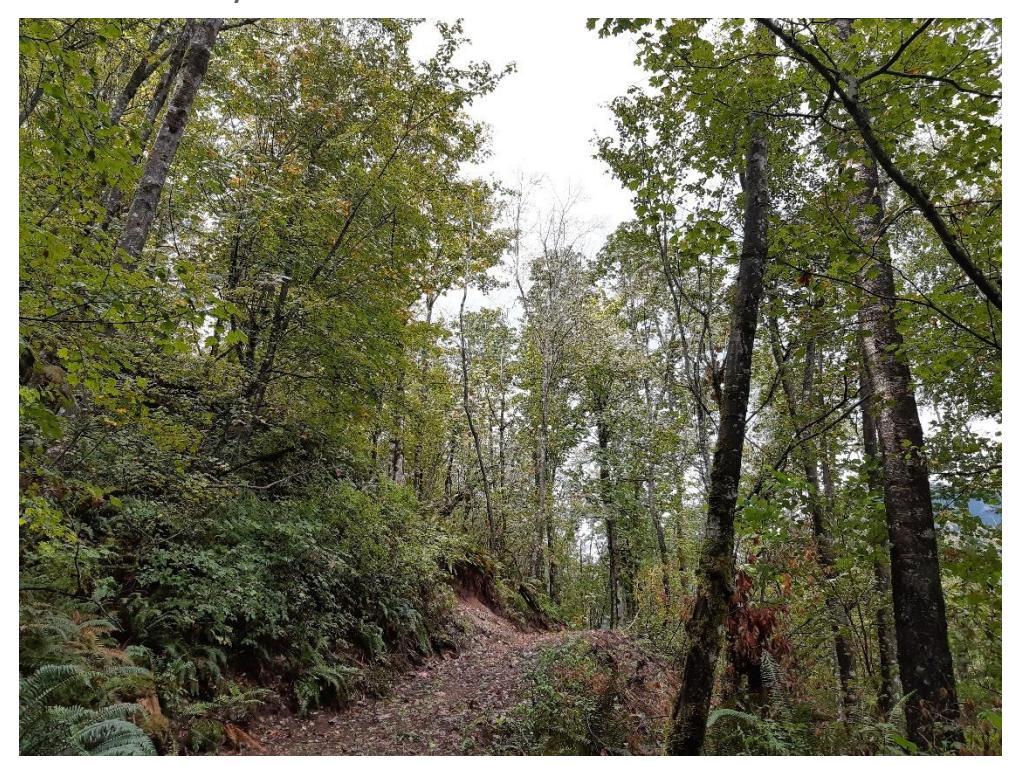
Photo 2. Crowns of the deciduous stand. This stand type is homogenous across the assessment area.

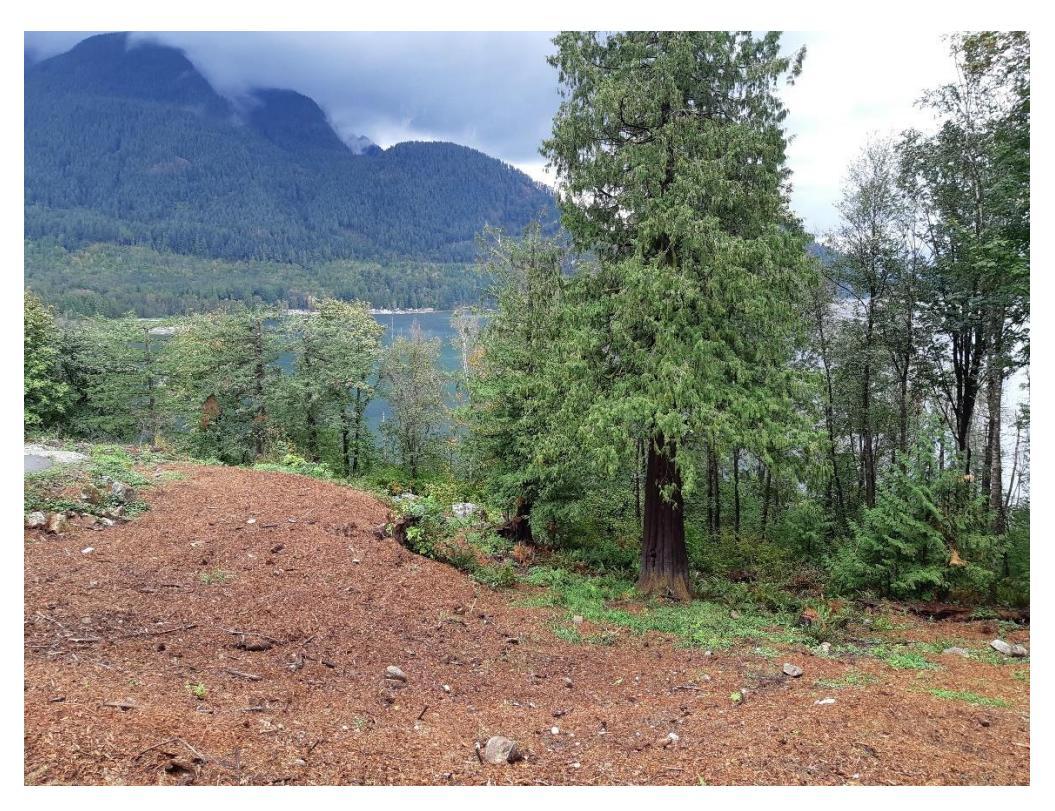
Photo 3: A large, vegetation-free buffer has been cleared on the site. Coniferous trees like the cedar in the background are scattered across the site and generally isolated.

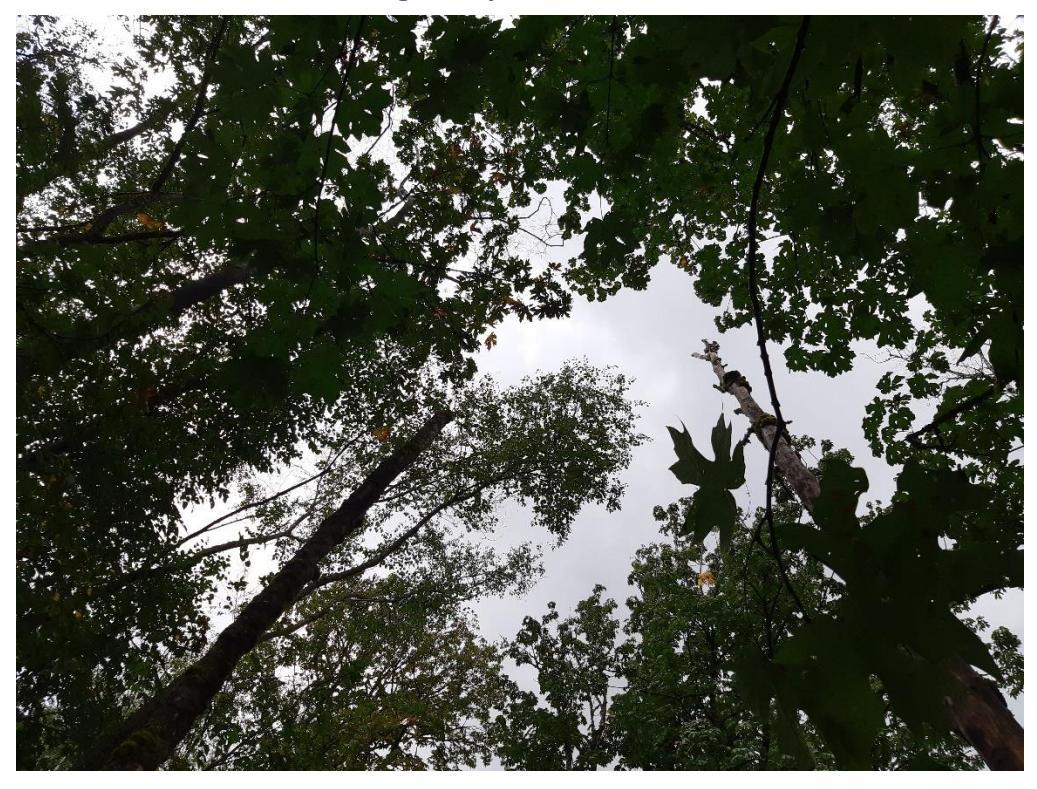
Photo 4: The canopy of the forest typically has 40-60% closure.

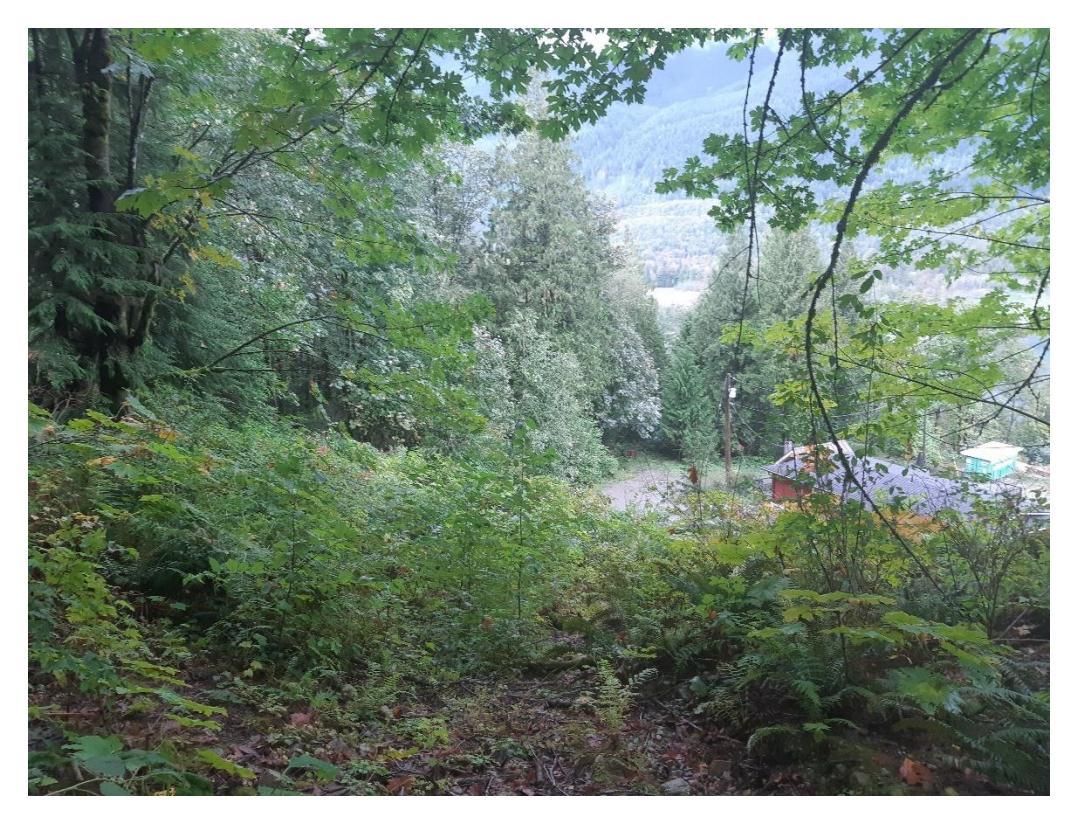
Photo 5: Viewing the existing dwelling from above

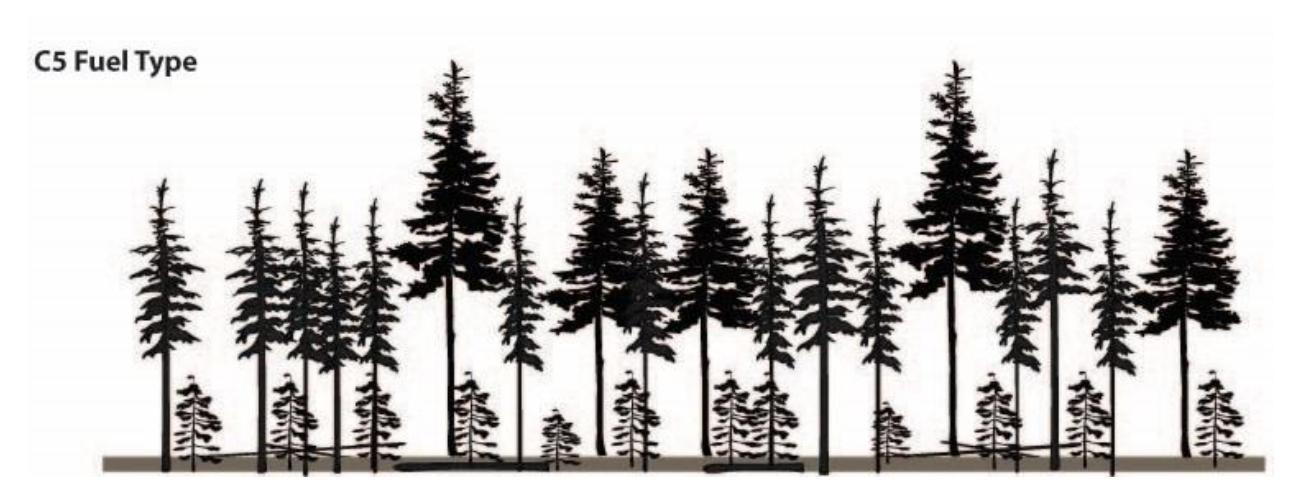
#### C5 – Uniform Second Growth Conifer Stand – Moderate Risk

This fuel type is characterized by mature second growth stands dominated by western redcedar (Thuja plicata) and western hemlock (Tsuga heterophylla). There can be small component of dominant Douglas-fir (Pseudotsuga menziesii) in the overstory. This fuel type is moderately dense (500-1000 stems per ha) and has a high crown base height of 10 to 15m. The understory is of moderate density, usually consisting of western redcedar and western hemlock regeneration. The ground fuel component consists of moderately dense fine fuel layer (>7cm) and a low percent cover of large woody debris (>7cm). It takes a large amount of energy to create a crown fire.

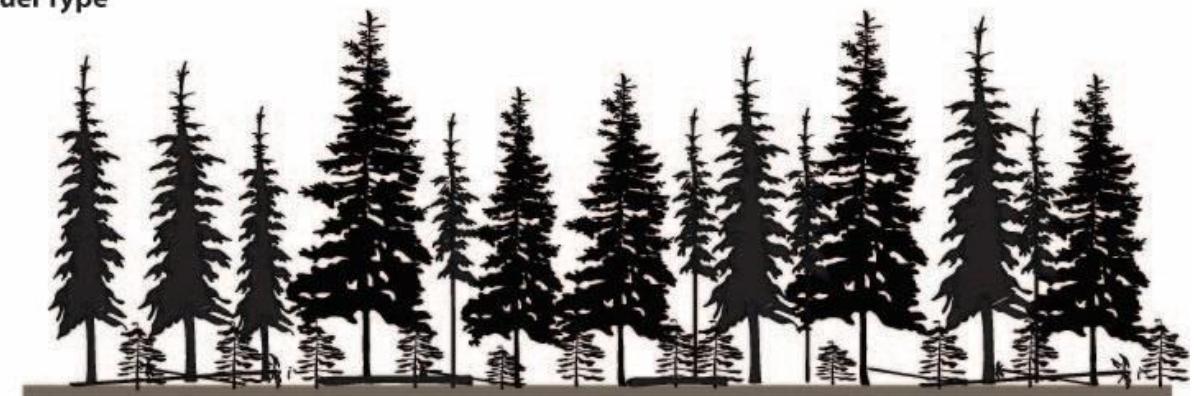
#### C3 Fuel Type

This fuel type is characterized by a uniform mature second growth conifer dominated stand. This stand consists of mature western redcedar (Thuja plicata) and western hemlock (Tsuga heterophylla). There is also a minor component of dominant Douglas-fir (Pseudotsuga menziesii) in the stand. Compared to a C5 stand, a C3 stand is more densely stocked (1000-2000 stems per ha) and there is a lower crown base height (usually 4-8 m). The understory is more densely stocked with western redcedar and western hemlock. The ground fuel component consists of moderately dense fine fuel layer (>7cm) and a low percent cover of large woody debris (>7cm). A crown fire in a C3 stand takes less energy to create than a C5 stand.

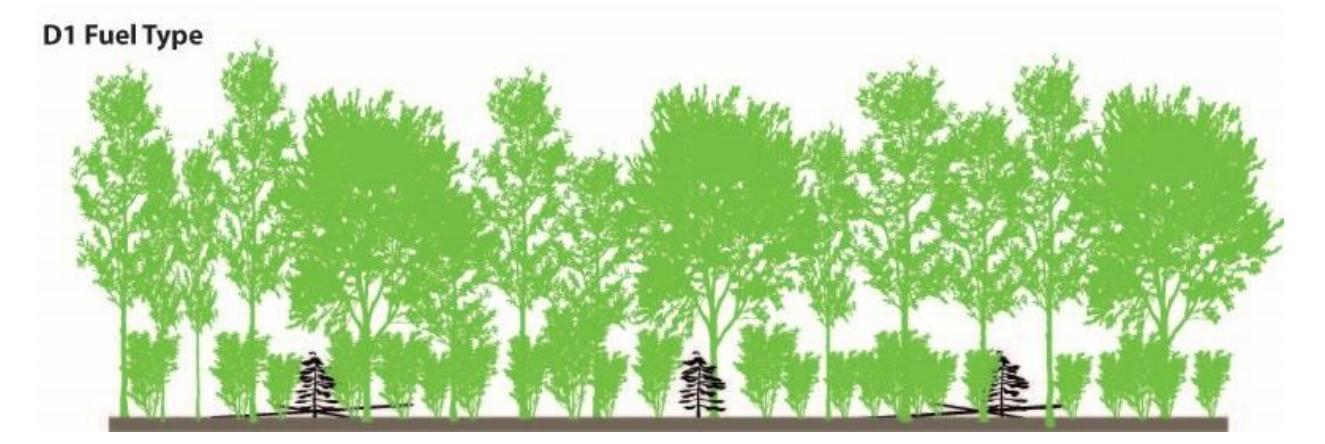
#### D1 – Deciduous Dominated Stands – Low Risk

This fuel type is dominated by deciduous trees consisting mostly of red alder (Alnus rubra), bigleaf maple (Acer macrophyllum), and paper birch (Betula papyrifera). D1 stand structure is not uniform with a wide variety of tree ages. There is a well-developed shrub layer, but is mostly composed of low-flammable species. Crown fires are not expected because of the deciduous fuel type. D1 stands on the coast can be used as fuel buffers as they present a low wildfire risk.
