To: Regional and Corporate Services Committee

Date: 2020-07-14

Subject: Bike Skills Park Wood Feature Upgrades at Island 22 Regional Park

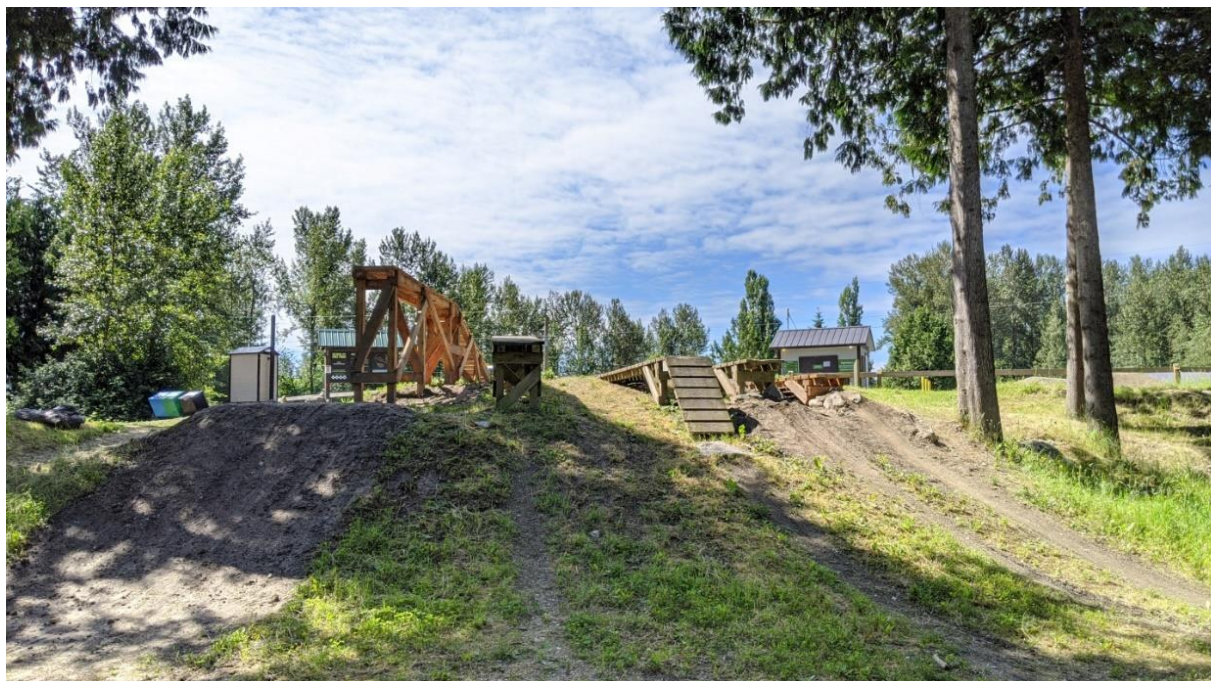
Drop Zone

This area has a set of five wood drops ranging from 1 to 6 feet for all levels of riders. The three original drops were still structurally sound so they remained in place. An additional small drop and large drop were added to upgrade the area (far right and far left, in the photo below).

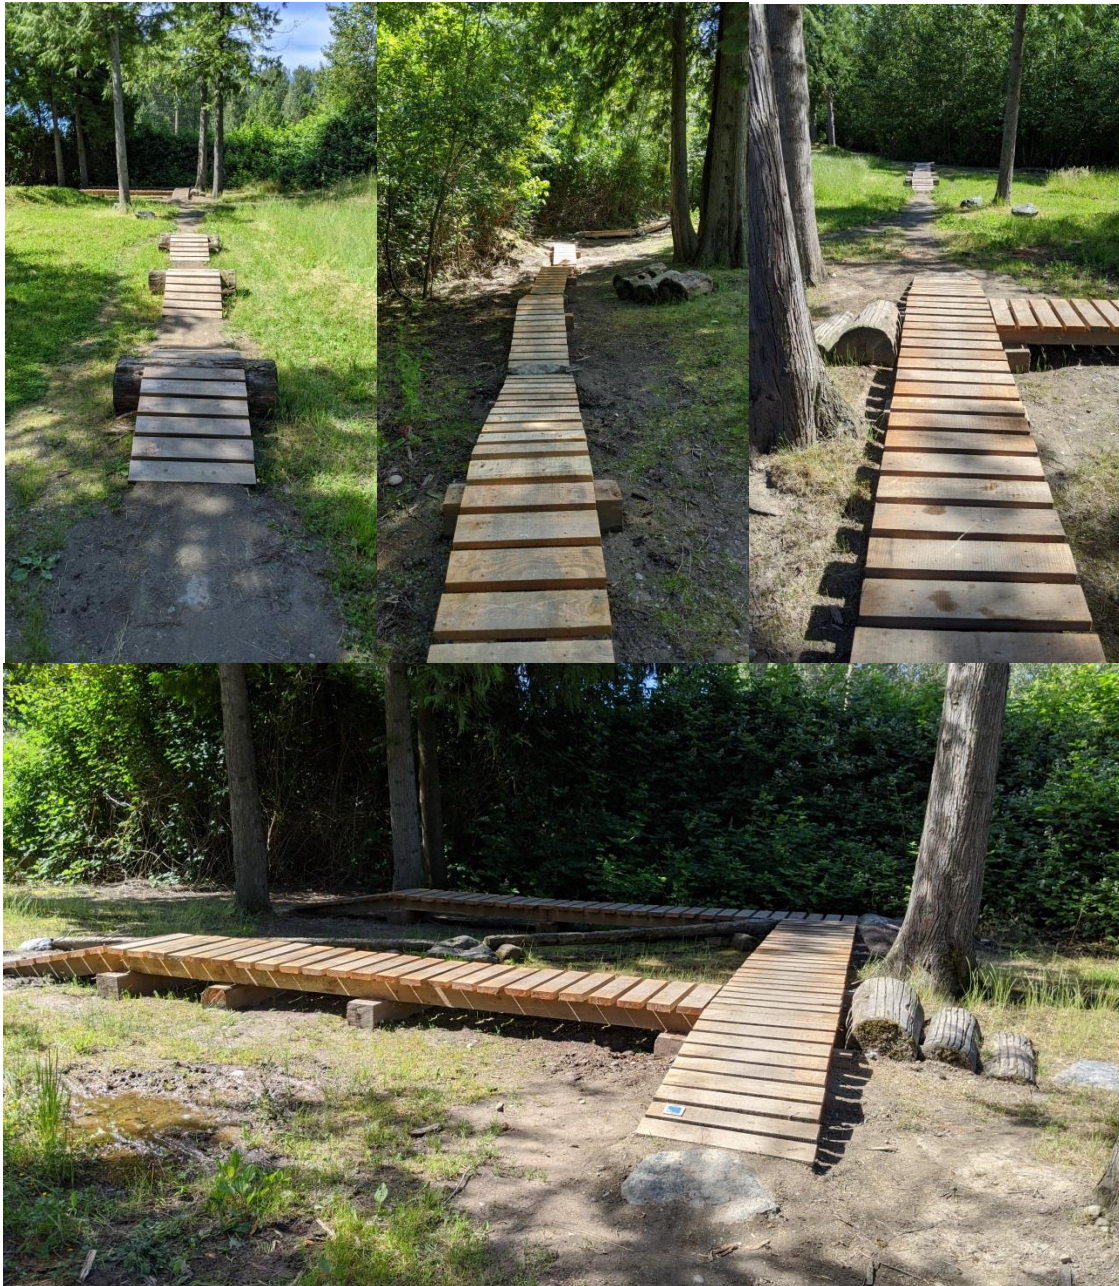
Boardwalks and Skinnies Zone

The boardwalks and skinnies make up the majority of wood features within the bike skill park. These structures see the most use since they are accessible by all skillsets of riders, hence were starting to show signs of degradation. Every wood slat and stringer was replaced, while some of the existing support logs could still be used, please see photographs below.
